Procedure, Field Replacement, PCU Motherboard PCB Kit, XX09 MK2 & XX10

Page 1 of 1	Sea Tel <small>COBHAM</small>	Document No 135275 Rev B
-------------	---	-----------------------------

Troubleshooting document for diagnosing a fault with and replacing the PCU Motherboard on the XX09 MK2 and XX10 series antennas.

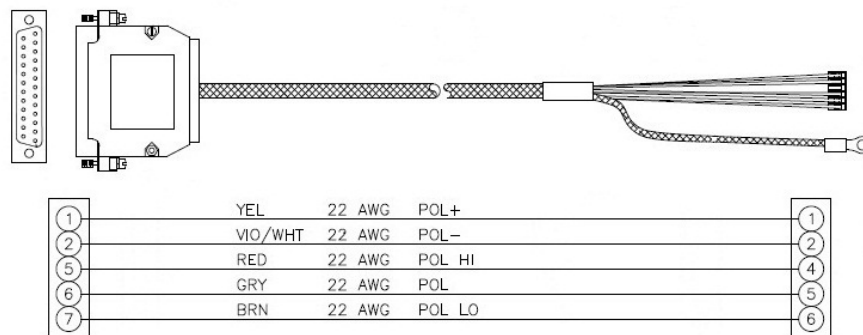
As the pol aux relay is integrated into the XX09 MK2 & XX10 PCU motherboard a fault with the pol alignment could potentially be caused by this PCB. If no pol drive is present set the pol type to manual mode (0009), apply drive to the feed assembly & measure the voltage to the motor on the IDC connector, 24VDC should be present. If voltage is present but the motor isn't driving the motor is defective & needs replacing.

If no voltage is present verify the connections of the reflector harness by measuring pin to pin as per the below diagram.

If the harness connections are good, then the PCU Motherboard isn't outputting the voltage to drive the motor & needs replacing.
