Field Service Spares Replacement Procedure – Level Cage Motor Kit, XX06-XX06RZA & 4003A

Page 1 of 1	Sea Tel	Document No 135314 Rev A
-------------	---------	-----------------------------

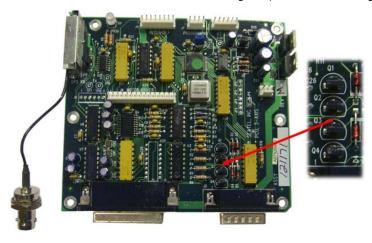
If the targeting issue still persists there is the possibility that the driver for the level cage motor on the PCU motherboard has failed. Test the four transistors on the PCU motherboard for damage as per the below image.

Any readings shorted to ground or out of the above tolerances mean the transistor is defective and the PCU needs to be replaced.
