**Field Service Spares Replacement Procedure – Pol Aux Relay Kit,
XX97, XX97A, XX97B, XX00, XX00B**

Document No 135324 Rev A
-------------	---	-----------------------------

Field Service Procedure - Pol Aux Relay Kit, XX97, XX97A, XX97B, XX00, XX00B

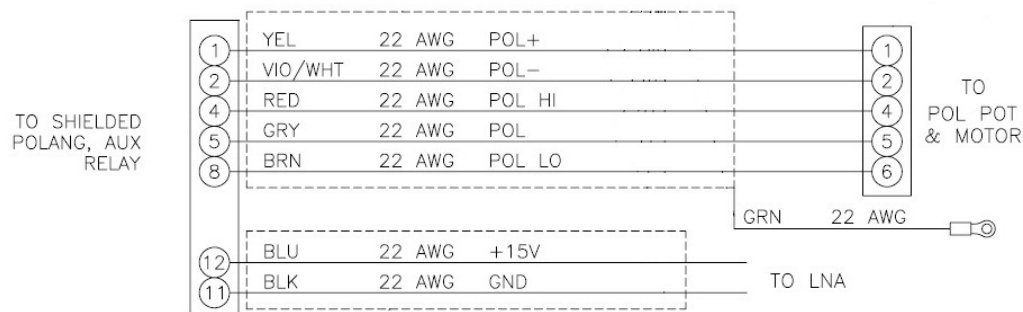
Next check continuity on the harness pins to verify it's not damaged. If the harness is good then the pol aux relay isn't outputting the voltage to drive the motor and needs replacing.

As long as the pol range is within the pot limits the DAC will issue the pol drive command to the PCU motherboard, based on the antenna targeting, a change in the vessels GPS position or operator inputs. The PCU motherboard will then issue the command to switch the pol aux relay to drive the pol motor. The motor will then drive the feed until the correct output from the pot has been received, at which point the feed will be in the correct reception position (providing the system is functioning and calibrated correctly). Therefore there is also the possibility for a pol drive fault to be caused by the PCU motherboard.
