**Field Service Spares Replacement Procedure – Motion Platform PCB
Kit, USAT**

Field Service Procedure – Replacement Motion Platform PCB Kit, USAT

Page 1 of 6	Sea Tel COBHAM	Document No 135542 Rev A
-------------	--------------------------	-----------------------------

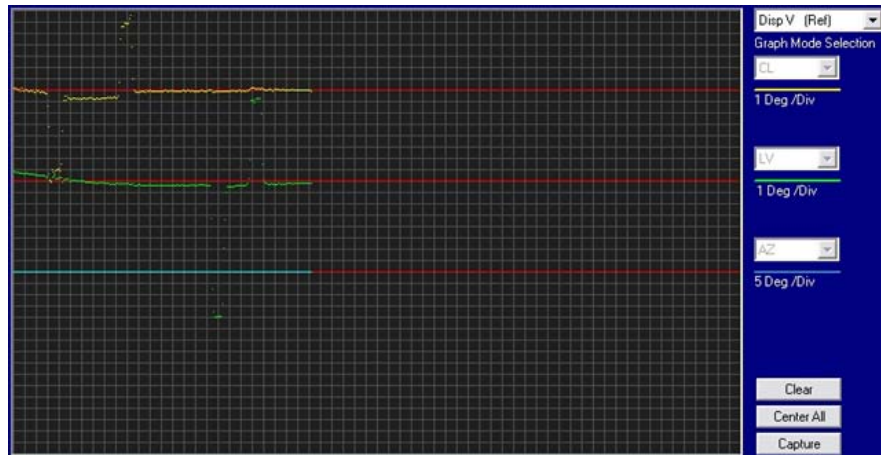
Push the Reflector up in Elevation (CCW) and hold it in position. Verify that the LV trace on DacRemP moves down an equal amount to the movement exerted on the axis. Release the Axis and verify the DacRemP trace returns (or the systems axis returns) back to its original position instantly, without deviating or taking time to settle. Push the Reflector down in Elevation (CW) and hold it in position. Verify that the LV trace on DacRemP moves up an equal amount to the movement exerted on the axis. Release the Axis and verify the DacRemP trace returns (or the systems axis returns) back to its original position instantly, without deviating or taking time to settle.

If using DacRemP the elevation trace should look similar to this image, note how after each movement the system returns to its level position efficiently without taking time to settle. Should the system take time to settle, or not stabilize to the original position (not necessarily on the red line) then this is an indication that the antenna isn't maintaining its horizon reference correctly and further troubleshooting will need to be undertaken.

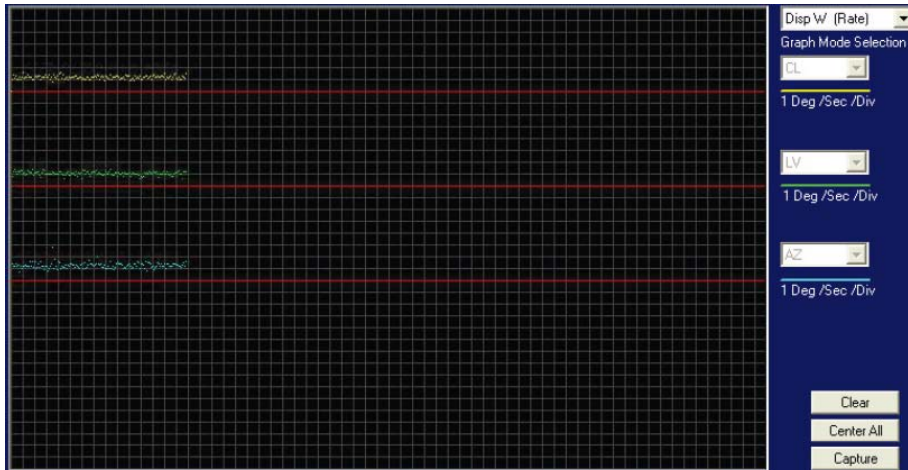
Rate sensor outputs can also be monitored using the DISP_W screen of DacRemP to verify any deviations under static conditions. The traces should remain consistent, any drifting or spikes are an indication the sensors voltage output is changing and the sensor is defective (provided no forces are being exerted on the system). Normal trace is +/- 1 division from red line.
