Field Service Replacement Procedure – 75W, 24VDC Power Supply Kit

Page 1 of 1	<h1 style="margin: 0;">Sea Tel</h1> <p style="margin: 0; font-size: small;">COBHAM</p>	Document No 136827 Rev A
-------------	--	-----------------------------

Field Service Procedure – Replacement 75W, 24VDC Power Supply Kit

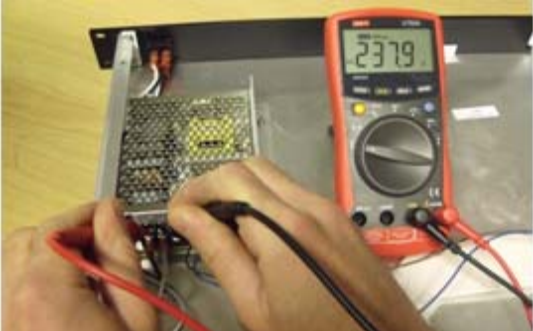
<p>1. Measure the input voltage into the power supply on the connectors for the black (-) and white (+) cables on the left of the connection block, 110 - 240 volts AC should be present. If no AC voltage is present verify the unit is switched on. If there is still no voltage present troubleshoot the source.</p>

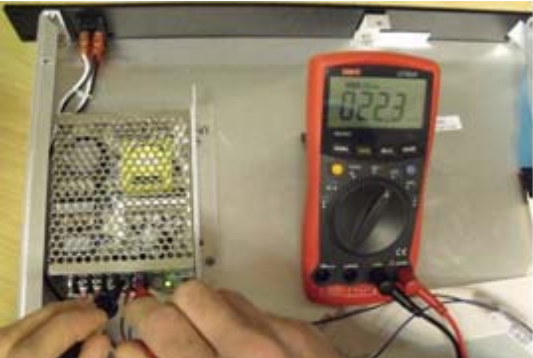
<p>2. Now measure the output voltage from the power supply on the connectors for the red (+) and black (-) cables on the right of the connection block, the output should be 24VDC.</p>

If the units AC input has been verified and the 24VDC is not present, the power supply is defective and needs to be replaced. If the power supply is outputting the 24VDC consistently then the power supply is operational and the problem lies elsewhere (possible failure with the MXP motherboard or harness connection).
