Field Service Spares Replacement Procedure - Pol Motor Kit, 4012

Troubleshooting document for diagnosing a fault with and replacing the pol motor on the 4012 antenna.

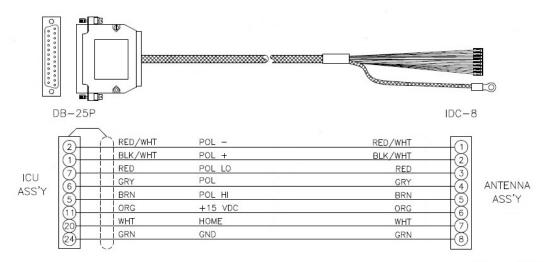
Leaving the polang setting in manual mode apply drive to the feed assembly and measure the voltage to the motor on the IDC connector, 24VDC should be present. If voltage is present but the motor isn't driving the motor is defective and needs replacing. If no voltage is present verify the connections of the reflector harness by measuring pin to pin as per the below diagram.

If the harness connections are good, then the ICU main PCB isn't outputting the voltage to drive the motor and needs replacing. As long as the pol range is within the pot limits the ICU will issue the voltage to drive the motor based on the antenna targeting, a change in the vessels GPS position or operator inputs. The motor will then drive the feed until the correct output from the pot has been received, at which point the feed will be in the correct reception position (providing the system is functioning and calibrated correctly). Therefore there is also the possibility for a pol drive fault to be caused by the ICU main PCB.
