**Field Service Spares Replacement Procedure – AZ Motor Kit, XX04,  
6003A/6004, 4003A & XX06**

# ***Field Service Procedure – Replacement Azimuth Motor Kit, XX04, 6003A/6004, 4003A & XX06***

Troubleshooting document for diagnosing a fault with and replacing the azimuth motor on the XX04, 6003A/6004, 4003A and XX06/R/RZ/RZA series antennas.

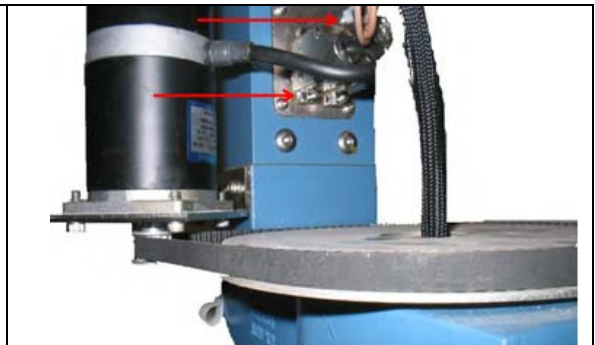
1. Using snips, cut the tie wrap holding the AZ motor harness and pedestal interface harness together.
2. Now using a 2mm flat blade screwdriver, loosen the two retaining screws on AZ motor harness and remove the connector from the AZ post connection panel.

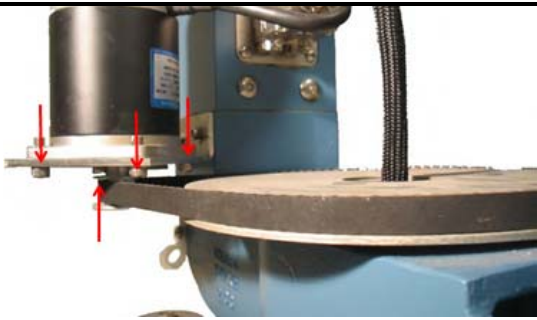
<p>3. Using a 9/64" Allen wrench, remove the four Allen head screws (bottom side of motor bracket) securing AZ motor and remove Motor Assembly. Save the hardware for future use.</p> <p>4. Apply Loctite 638 to the shaft of the replacement motor and fit the pulley in the same position as the one on the defective motor. Fit the set screws into the pulley with Loctite 222 using a 1/16" Allen wrench.</p> <p><b>*Note:</b> For further information refer to the Loctite Procedure 121730 provided with this kit.</p>

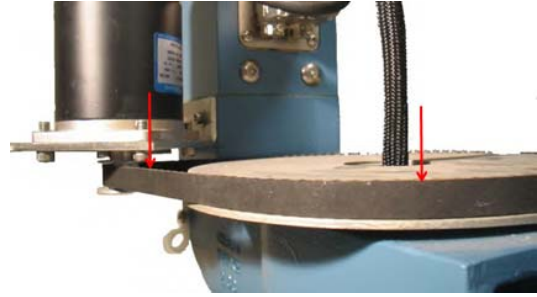
<p>5. Insert the replacement motor assembly into mounting bracket with the cable harness pointing towards the AZ sprocket.</p> <p>6. Place the AZ belt around the main sprocket and motor pulley and tension the belt by pulling the motor to the bracket using Loctite 242.</p> <p>7. Increase the belt tension until the belt can only be easily twisted just ¼ turn with your fingers.</p>

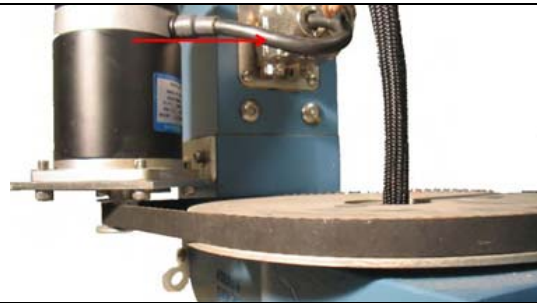
<p>8. Re-connect the AZ motor harness to the AZ post connector panel and secure the two harness retaining screws.</p>
