Field Service Spares Replacement Procedure – AZ Motor Kit, XX09

Field Service Procedure – Replacement AZ Motor Kit, XX09

Troubleshooting document for diagnosing a fault with and replacing the azimuth motor on the MK1 and MK2 XX09 antennas.

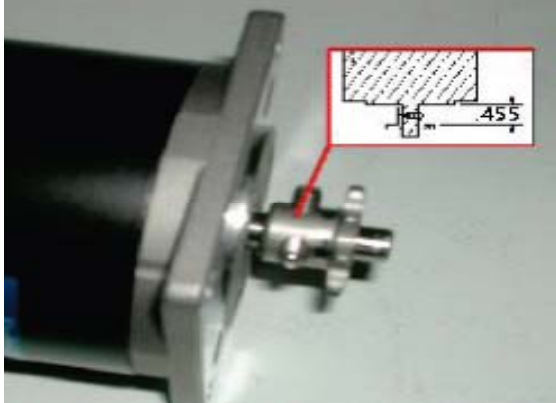
<p>*CAUTION: Power down the pedestal before following this procedure.</p> <ol style="list-style-type: none">1. Apply Loctite 638 to the internal hub of sprocket and place onto motor shaft spaced .455" from the motor case as shown in the graphic to the right. Or compare the position to the defective motor.2. Apply Loctite 222 onto the set screws and secure sprocket to motor shaft using a 1/16" Allen wrench. <p>*Note: For further information refer to the Loctite Procedure 121730 provided with this kit.</p>

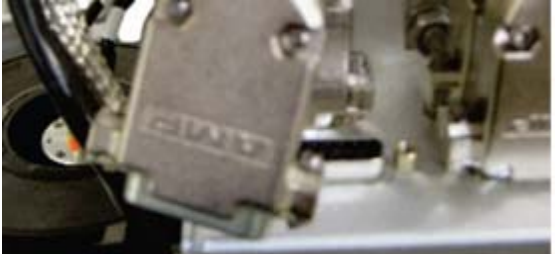
<ol style="list-style-type: none">3. Using a small flat blade screwdriver remove the azimuth motor cable from the MDE.

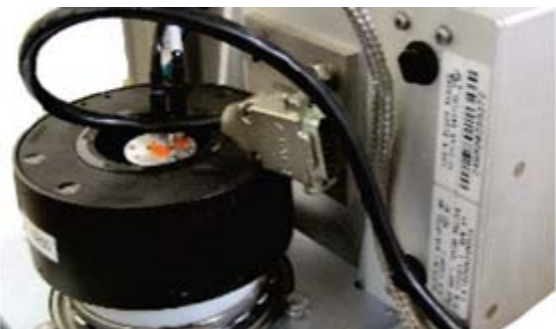
<ol style="list-style-type: none">4. Using snips, carefully cut the tie wraps that secure the azimuth motor cable to the home sensor interface cable and the MDE.

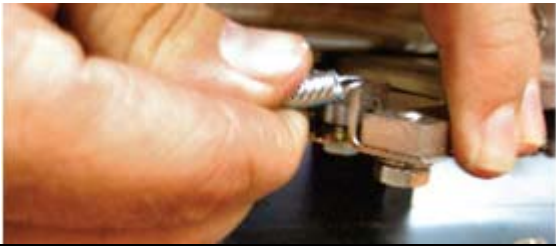
<p>5. Remove one side of the spring tensioner.</p>

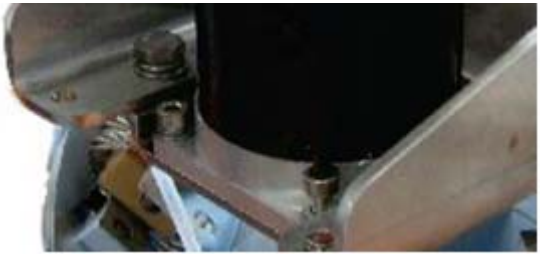
<p>6. Using a 3mm Allen wrench, remove the hardware that secures the azimuth Motor to its mounting bracket. Retain hardware for future use.</p> <p>7. Remove the motor and set aside.</p>

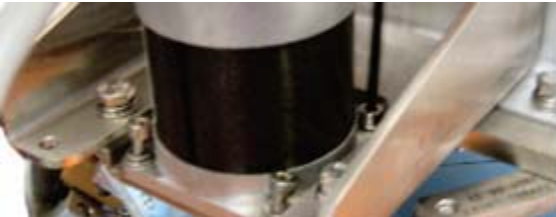
<p>8. Using the hardware removed earlier, install and secure the replacement azimuth motor to its bracket. Do not forget to apply Loctite 242 to hardware.</p>

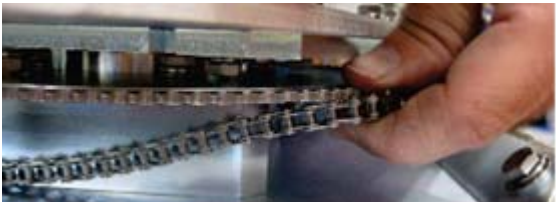
<p>9. Wrap the other side of the chain to the azimuth drive pulley.</p>

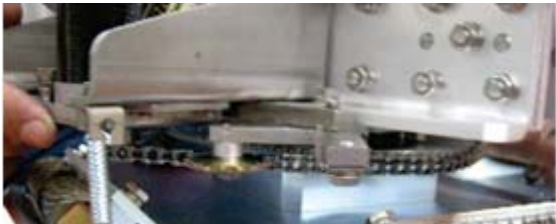
<p>10. By hand rotate the antenna in azimuth to fully engage chain to the main drive pulley.</p>
