## **Field Service Spares Replacement Procedure – Coax Switch XX09 MK2 & XX10**

# **Field Service Procedure – Replacement Coax Switch Kit XX09 MK2 & XX10**

Troubleshooting document for diagnosing a fault with and replacing the coax switch on the XX09 MK2 and XX10 series antennas.

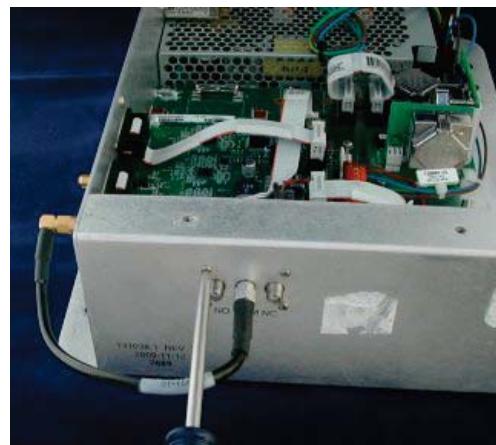
6. Using a 5/16" (8mm) wrench remove the L-Band SMA cables from the ports on the switch.
7. From the outside of the PCU enclosure, remove the 4 Phillips screws that mount the switch in the enclosure.

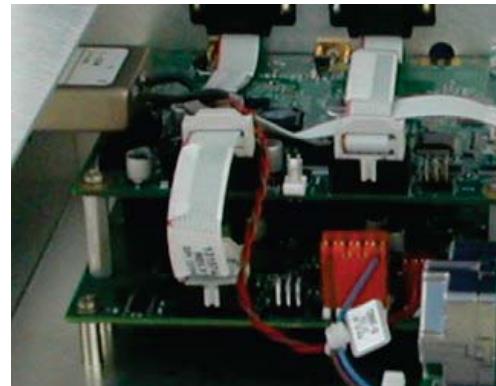
8. From inside the PCU enclosure, unplug the Red-Brown twisted pair wire IDC connector (J10).
9. Remove the defective switch from the enclosure.
10. Install the replacement Co-Pol/Cross-Pol switch assembly while assuring that the Normally Open/NO/Co-Pol and Normally Closed/NC/Cross-Pol SMA connectors are in the correct holes as marked on the outside of the PCU enclosure.
11. Apply Loctite 242 to, and re-install, the 4 Phillips screws to secure the switch from the outside of the enclosure.
12. Plug in the Red-Brown twisted pair wire IDC connector.
13. Reconnect the L-Band cable to the "COM" port (center) on the switch.
14. If all repair work is now completed reinstall the PCU cover.
