**Procedure, Field Replacement, Motion Platform PCB Kit, XX09 MK2 & XX10**

Troubleshooting document for diagnosing a fault with and replacing the motion platform PCB on the XX09 MK2 and XX10 series antennas.

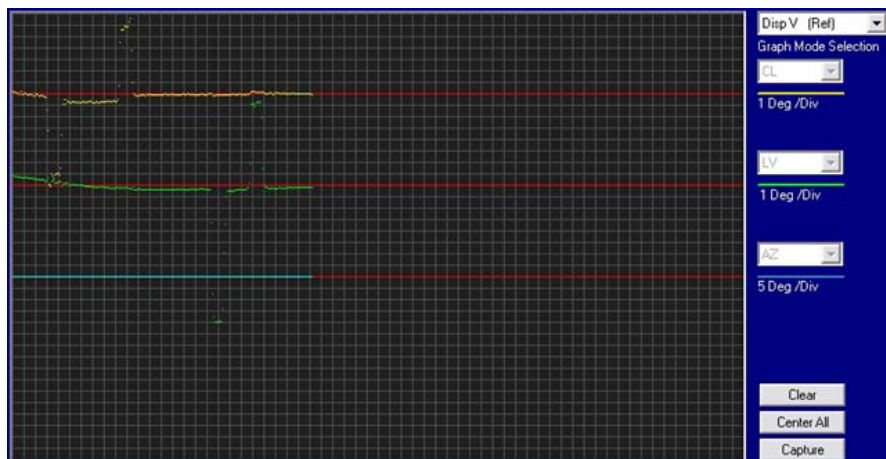
4. In DacRemP, the trace should look similar to the below image. Note how after each movement the system returns to its level position efficiently without taking time to settle.

Push the reflector up in elevation and hold it in position. Verify that the LV trace on DacRemP moves down an equal amount to the movement exerted on the axis. Release the axis and verify the DacRemP trace and system axis both return back to their original positions instantly, without deviating or taking time to settle. Push the reflector down in elevation and hold it in position. Verify that the LV trace on DacRemP moves up an equal amount to the movement exerted on the axis. Release the axis and verify the DacRemP trace and system axis both return back to their original positions instantly, without deviating or taking time to settle.

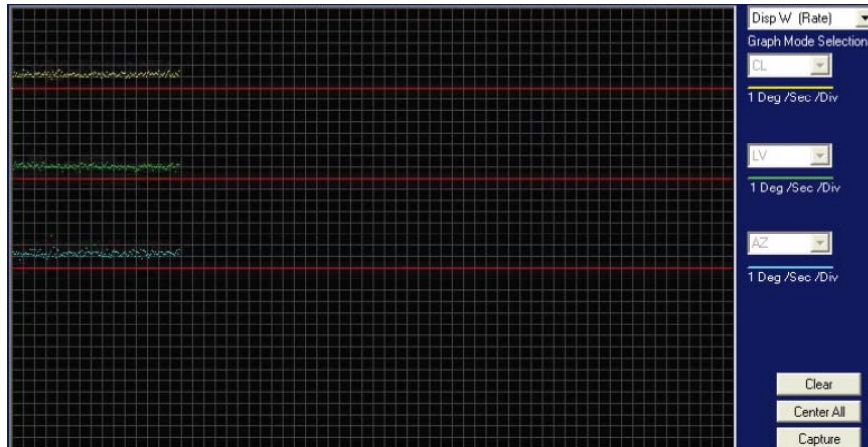
Rate sensor outputs can also be monitored using the DISP\_W screen of DacRemP to verify any deviations under static conditions. The traces should remain consistent; any drifting or spikes are an indication the sensors voltage output is changing and the sensor is defective (provided no forces are being exerted on the system).

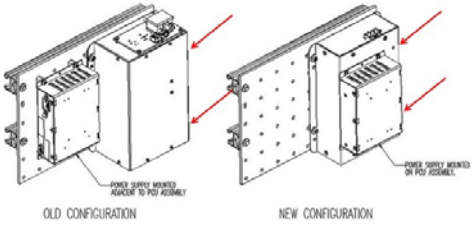
<p><b>*CAUTION:</b> Power down the pedestal before following this procedure.</p> <p><b>*Note:</b> PCB components are static sensitive and correct handling procedures must be adhered to.</p> <p>1. Using a #1 Phillips screwdriver, remove the 2 Phillips screws in the lip edge above the connectors.</p>

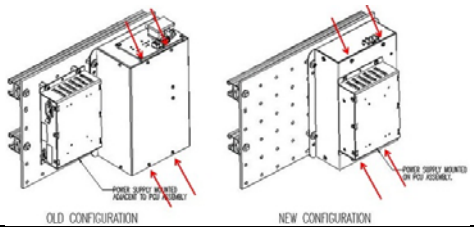
<p>2. Remove the 4 Phillips screws on the top of the PCU.</p>

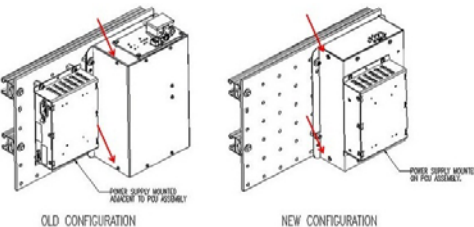
<p>3. Remove the 2 Phillips screws on the back side of the PCU. 4. Retain all of the screws for later reuse. 5. Remove the cover off of the PCU</p>

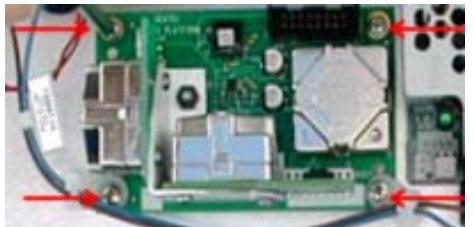
<p>6. Disconnect the ribbon cable from the Motion Platform PCB. 7. Using a #1 Phillips screwdriver, remove the 4 Phillips screws that mount the Motion Platform PCB. Retain all of the screws for later reuse.</p>

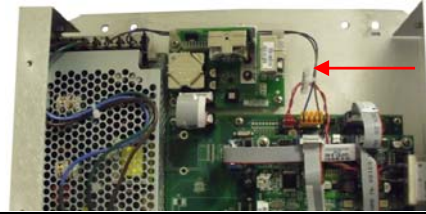
8. Remove the defective Motion Platform PCB.
9. Install the replacement Motion Platform PCB.
10. Apply Loctite 242 to, and reinstall, the 4 Phillips screws to mount the Motion Platform PCB.
11. Reconnect the ribbon cable to the Motion Platform PCB.
12. Reinstall the PCU cover, applying Loctite 242 to the hardware.
