Field Service Spares Replacement Procedure – Receive Path Troubleshooting

Page 1 of 1	Sea Tel <small>COBHAM</small>	Document No 135294 Rev B
-------------	---	-----------------------------

Field Service Procedure – Receive Path Troubleshooting

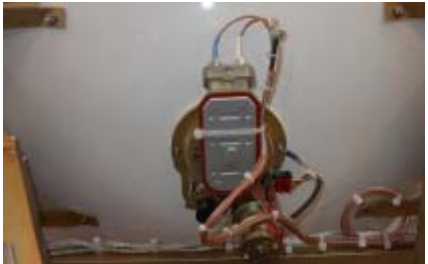
<p>*CAUTION: Power down the pedestal before following this procedure.</p> <p>1. Set the pol type to manual pol (0009) and drive the LNB to 120 counts. At this position the LNB should be vertical (with a pol offset of 0030).</p> <p>2. Cut the tie wrap securing the coax cables to the body of the LNB and using a 7/16" wrench remove the coax connections from the LNB (it's advisable to photograph their order for future reference).</p>

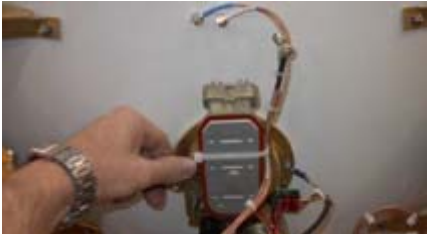
<p>3. Loosen the 3 Allen set screws securing the LNB to the mounting collar using a 5/64" Allen key and extract the LNB.</p> <p>4. Install the replacement LNB in exactly the same orientation (vertical) and tighten the set screws, applying Loctite 242 to the threads.</p>

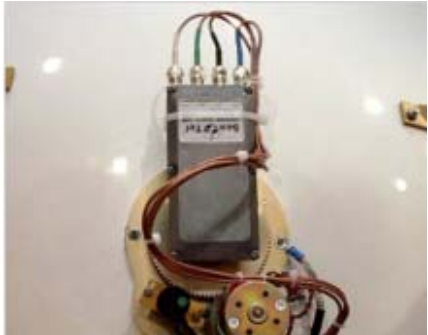
<p>5. Reconnect the coax cables, if changing the LNB to another (i.e. circular to linear) the port orientation is as below and should be matched to the connections on the multi-switch...</p>

Dual Circular	Dual Linear	Quad Linear	RHCP (Blue)	Vertical (Blue)	Horz High (Black)	LHCP (White)	Horizontal (White)	Vert High (Green)			Horz Low (White)			Vert Low (Blue)

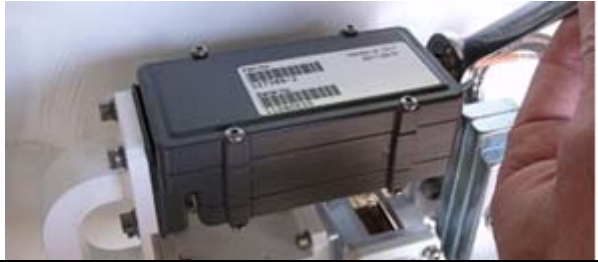
<p>*CAUTION: Power down the pedestal before following this procedure.</p> <p>1. Using a 7/16" wrench disconnect the coax cable from the LNB.</p>

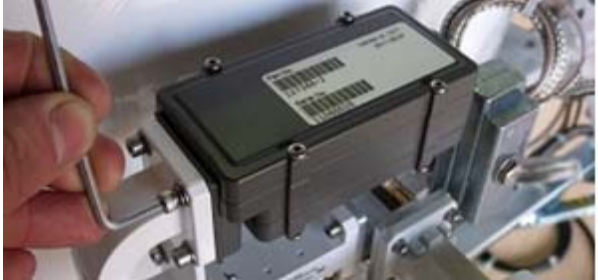
<p>2. Using a 3mm Allen wrench undo the hardware securing the LNB to the waveguide and remove the LNB. Save the hardware for future use.</p>

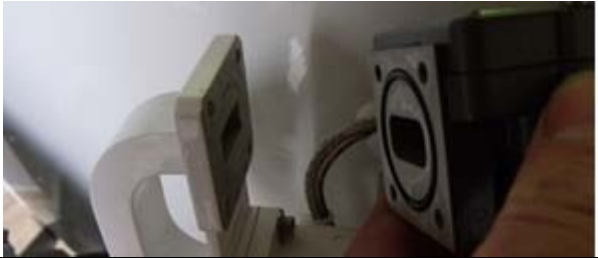
<p>3. Ensure the 1/2 thickness gasket is correctly located in the replacement LNB and install it to the waveguide.</p> <p>4. Install the replacement LNB making sure the RX port of both the LNB and the waveguide are correctly aligned.</p>

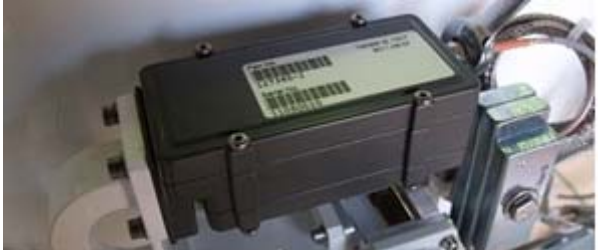
<p>6. Install the four sets of hardware to secure the LNB to the waveguide. Ensuring that both the lock washer and flat washers are installed on each screw (no need to Loctite).</p> <p>7. Reinstall the coax cable, tightening with a 7/16" wrench.</p>

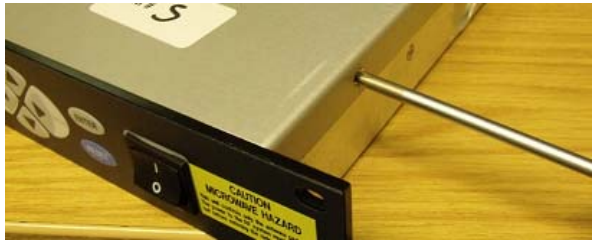
<p>*CAUTION: Disconnect the AC Voltage to supply to control unit prior to performing the below procedure.</p> <p>*Note: PCB components are static sensitive and correct handling procedures must be adhered to.</p> <p>1. Using a #1 Phillips screwdriver, undo the 6 screws retaining the DAC lid and remove it.</p>

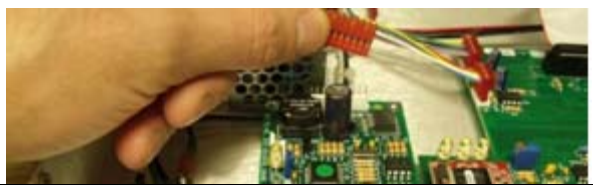
<p>2. Disconnect the IDC connector from the tracking receiver.</p>

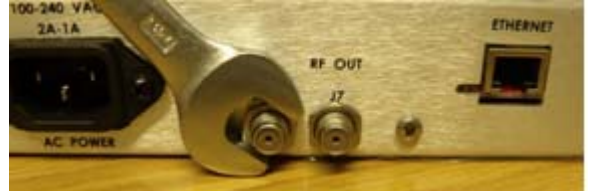
<p>3. Now using a ½" wrench or socket, remove the 2 securing nuts and lock washers from the F-connectors on the receiver and save for future use.</p>
