**Field Service Spares Replacement Procedure – EL & CL Motor Kit,
XX04 & XX06, EL Motor Kit, 6003A/6004**

Field Service Procedure – Replacement EL & CL Motor Kit, XX04 & XX06, EL Motor Kit, 6003A/6004

Troubleshooting document for diagnosing a fault with and replacing the elevation or cross level motor on the XX04 and XX06 series antennas, or the elevation motor on the 6003A/6004 antennas.

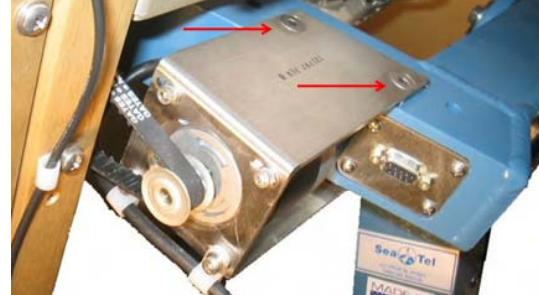
<p>2. Using a 5/32" Allen wrench, remove the four Allen head screws attaching elevation motor bracket to CL beam and remove motor assembly.</p>

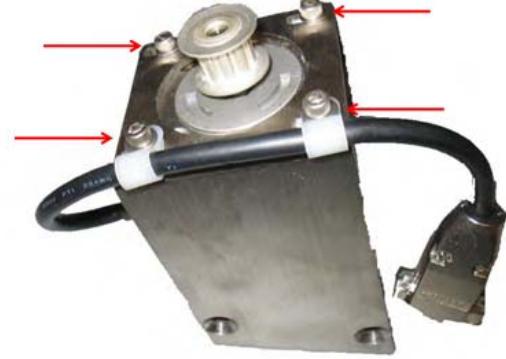
<p>3. Observe the cable orientation and remove the motor from the bracket. Using a 9/64" Allen wrench, remove the four Allen head screws attaching the motor to the bracket.</p> <p>4. Fit the pulley to the replacement motor shaft using Loctite 638 in the same position as the original motor to maintain alignment with the main sprocket. Secure the set screw with Loctite 222 and tighten with a 1/16" Allen wrench.</p> <p>Note: For further information refer to the Loctite Procedure 121730 provided with this kit.</p> <p>5. Install the replacement motor and cable onto the bracket (noting cable orientation). Install the hardware with Loctite 242, but do not tighten at this time.</p>

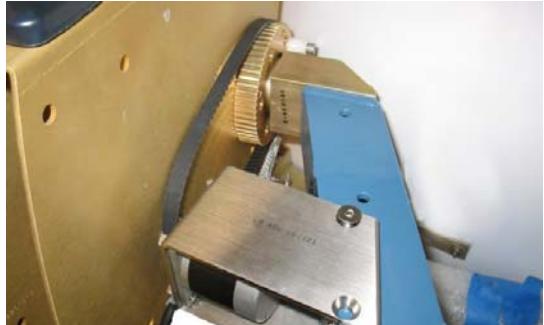
<p>6. Re-install the bracket onto the CL beam using two of the Allen head screws, do not fully tighten. Place the belt around the elevation drive sprocket and then elevation motor pulley.</p> <p>7. Install the other two Allen head screws and secure the motor bracket onto CL Beam using Loctite 242 on all four screws.</p> <p>8. Increase the belt tension until the belt can only be easily twisted just $\frac{1}{4}$ turn with your fingers.</p>

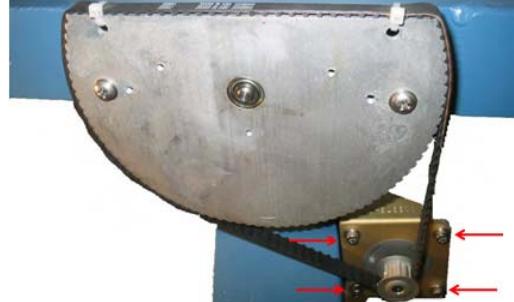
2. Using a 9/64" Allen wrench, remove the four Allen head screws securing the CL motor to its bracket and remove it.

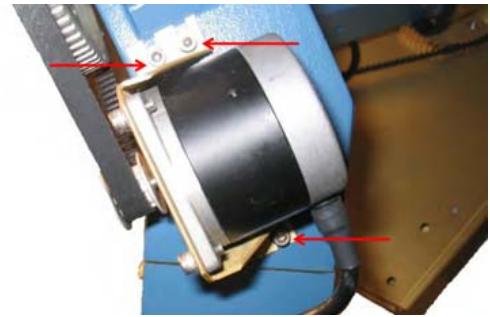
3. Apply Loctite 638 to the shaft of the replacement motor and fit the pulley in the same position as the one on the defective motor. Fit the set screws into the pulley with Loctite 222 using a 1/16" Allen wrench. *Note: For further information refer to the Loctite Procedure 121730 provided with this kit. 4. Install the replacement motor assembly onto the CL motor bracket with Loctite 242. 5. Loosen the four Allen head screws securing the CL motor bracket to the AZ post, complete removal of the hardware is not required.

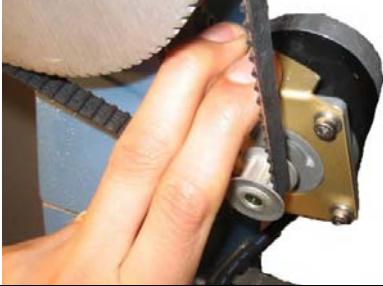
6. Install the belt around the CL motor pulley and tension it by pulling the motor bracket down towards the antenna base and tighten the four screws. 7. Increase the belt tension until the belt can only be easily twisted just $\frac{1}{4}$ turn with your fingers.

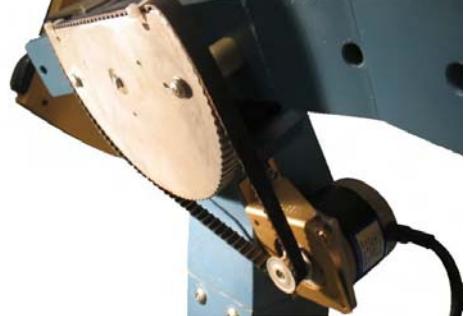
8. Rotate the CL beam from the CCW stop to the CW stop (Left to right) and verify the CL belt does not rub against the AZ post and runs in line with both sprockets. *Note: Failure of this step is normally due to incorrect sprocket placement on the CL motor shaft.
