**Field Service Spares Replacement Procedure – EL & CL Motor Kit,
XX09**

Field Service Procedure – Replacement EL & CL Motor Kit, XX09

Troubleshooting document for diagnosing a fault with and replacing the elevation and cross level motor on the MK1 and MK2 XX09 antennas.

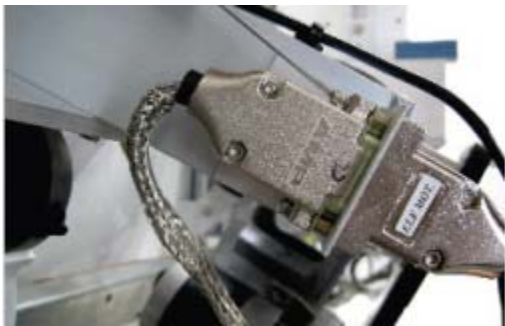
<p>*CAUTION: Power down the pedestal before following this procedure.</p> <p>1. Using a small flat blade screwdriver remove the EL motor cable from the elevation motor interface harness that routes to the MDE.</p>

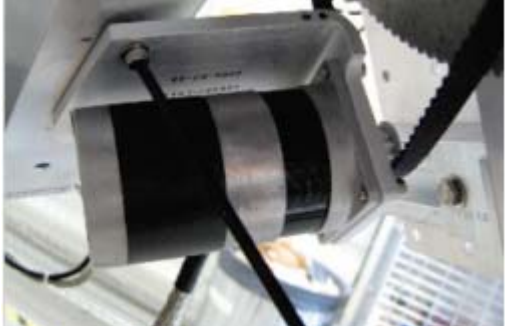
<p>2. Using a 5/32" Allen wrench remove the screws that secure the bracket to the elevation beam. Retain the hardware for future use.</p>

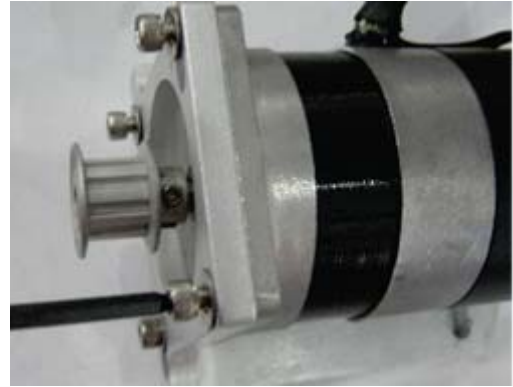
6. MK2 belt tension – loosen the tensioning bolt locking nut and loosen/unthread tensioning bolt.

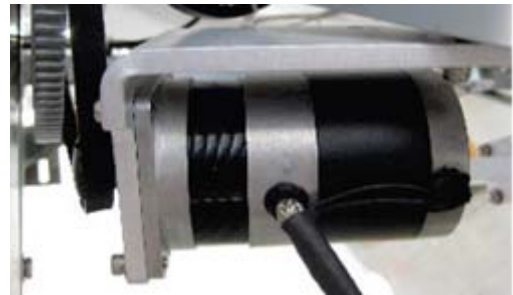
8. Loosely install one of the bracket mounting screws and the slide belt onto motor pulley.

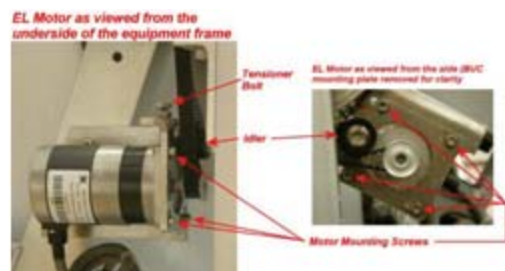
MK2 motor tension (idler and tensioning screw).

12. Tighten the tensioning bolt and check the belt tension by twisting the belt with your fore finger and thumb.

13. Increase the belt tension until the belt can only be easily twisted just 1/4 turn with your fingers & tighten the locking nut on the tensioning bolt.

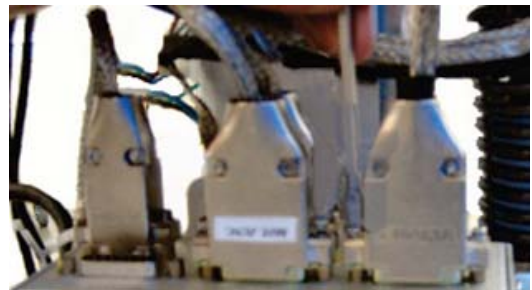
1. Using a small flat blade screwdriver loosen the hardware that secures the CL motor harness to the MDE and disconnect the D-sub connector.

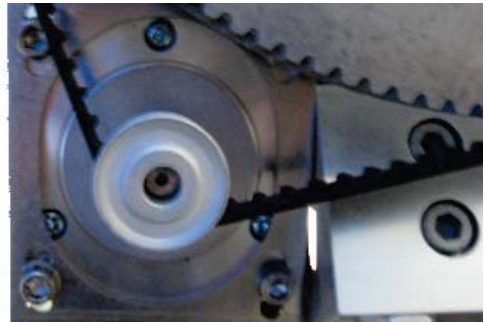
2. Using a 5/32" Allen wrench remove 3 of the four screws that secure the CL motor to its bracket.

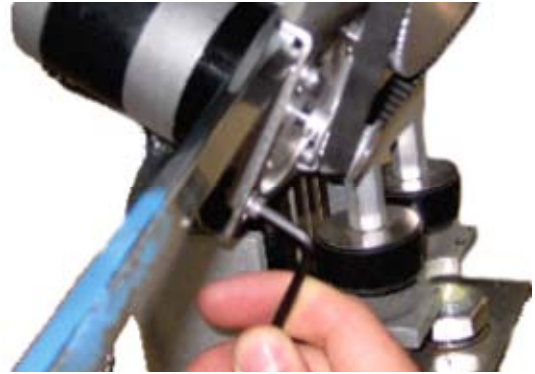
MK1 motor tension (no idler or tensioning screw).

7. Using a long screwdriver or similar as a pry-bar (between the motor body and mounting bracket lip). Apply downward pressure to apply belt tension and tighten all 4 motor mounting screws.

8. Check belt tension by twisting the belt with your fore finger and thumb.

10. Increase the belt tension until the belt can only be easily twisted just ¼ turn with your fingers.

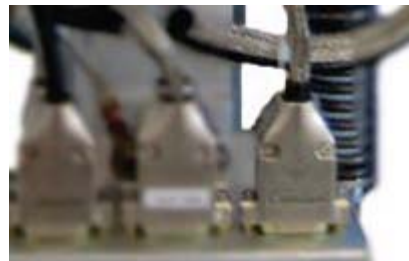
11. Connect and secure the CL motor harness to the MDE.
