**Field Service Spares Replacement Procedure – EL & CL Motor Kit,
XX10**

Field Service Procedure – Replacement EL & CL Motor Kit, XX10

Troubleshooting document for diagnosing a fault with and replacing the elevation and cross level motor on the xx10 series antennas.

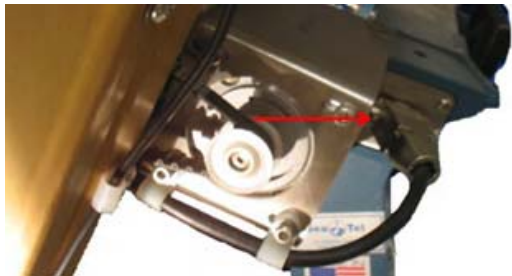
<p>*CAUTION: Power down the pedestal before following this procedure.</p> <p>1. Using a 2mm flat blade screwdriver, loosen the two retaining screws on the EL motor harness and remove it from the CL beam.</p>

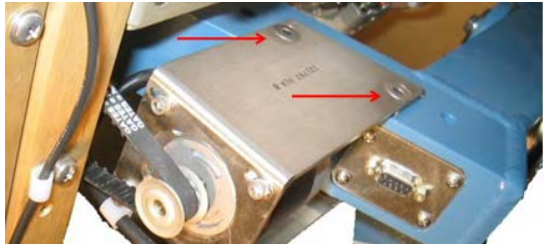
<p>2. Using a 5/32" Allen wrench, remove the four Allen head screws attaching elevation motor bracket to CL beam and remove motor assembly.</p>

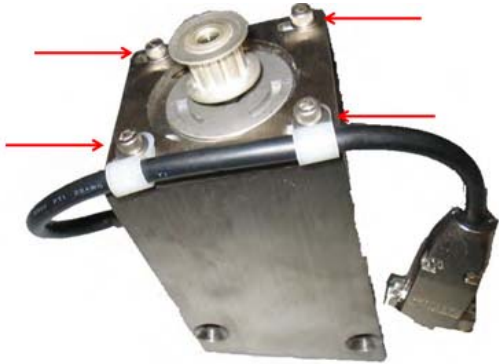
<p>3. Observe the cable orientation and remove the motor from the bracket. Using a 9/64" Allen wrench, remove the four Allen head screws attaching the motor to the bracket.</p> <p>4. Apply Loctite 638 to the shaft of the replacement motor and fit the pulley in the same position as the one on the defective motor. Fit the set screws into the pulley with Loctite 222 using a 1/16" Allen wrench.</p> <p>*Note: For further information refer to the Loctite Procedure 121730 provided with this kit.</p> <p>5. Install the replacement motor and cable onto the bracket (noting cable orientation). Install the hardware with Loctite 242, but do not tighten at this time.</p>

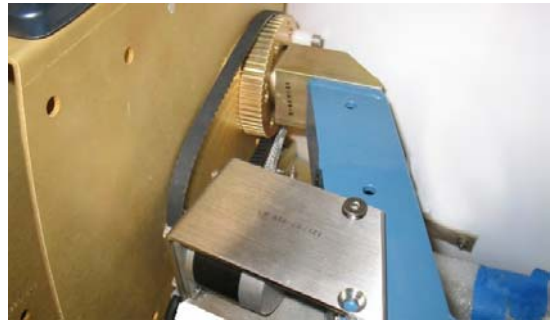
6. Re-install the bracket onto the CL beam using two of the Allen head screws, do not fully tighten. Place the belt around the elevation drive sprocket and then elevation motor pulley then Install the other two Allen head screws and secure the motor bracket onto CL Beam using Loctite 242 on all four screws.

7. Increase the belt tension until the belt can only be easily twisted just $\frac{1}{4}$ turn with your fingers.

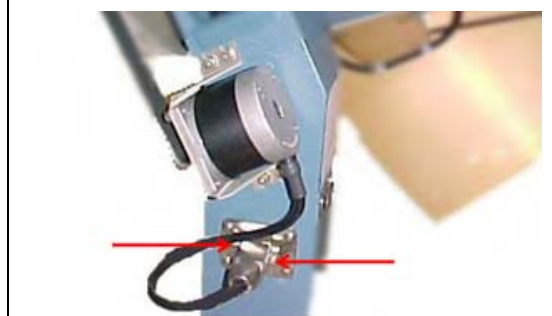
1. Using a 2mm flat blade screwdriver, loosen two retaining screws on the CL motor harness and remove it from the AZ post.

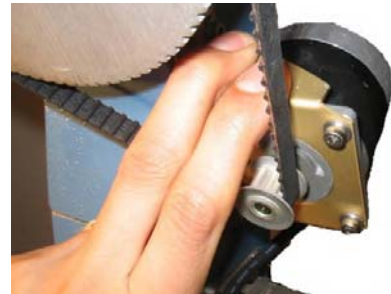
7. Install the belt around the CL motor pulley and tension it by pulling the motor bracket down towards the antenna base and tighten the four screws with Loctite 242.

8. Increase the belt tension until the belt can only be easily twisted just 1/4 turn with your fingers.

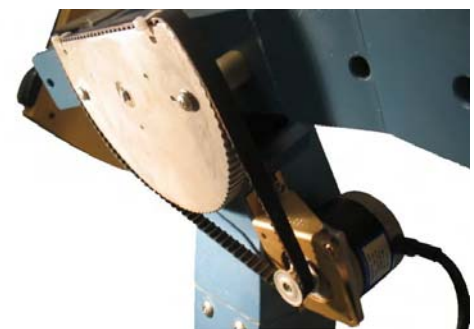
9. Rotate the CL beam from the CCW stop to the CW stop (Left to right) and verify the CL belt does not rub against the AZ post and runs in line with both sprockets.

***Note:** Failure of this step is normally due to incorrect sprocket placement on the CL motor shaft.
