**Field Service Spares Replacement Procedure – EL & CL Motor Kit,
4003A & 2406, CL Motor Kit, 6003A/6004**

Field Service Procedure – Replacement EL & CL Motor Kit, 4003A & 2406, CL Motor Kit, 6003A/6004

Troubleshooting document for diagnosing a fault with and replacing the elevation and cross level motors on the 4003A and 2406 antennas and the cross level motor on the 6003A and 6004 antennas.

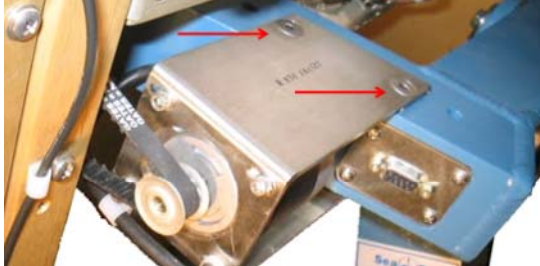
<p>2. Using a 5/32" Allen wrench, remove the four Allen head screws attaching elevation motor bracket to CL beam and remove the motor assembly.</p>

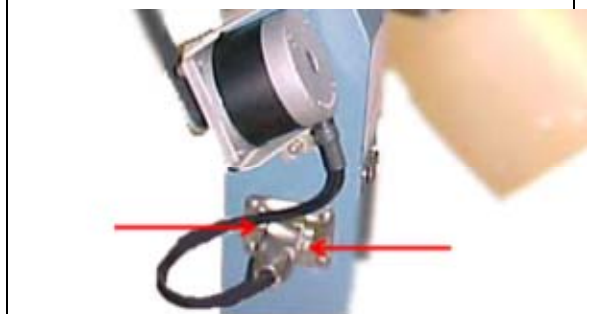
1. Using a 2mm flat blade screwdriver, loosen two retaining screws on the CL motor harness and remove it from the AZ post.

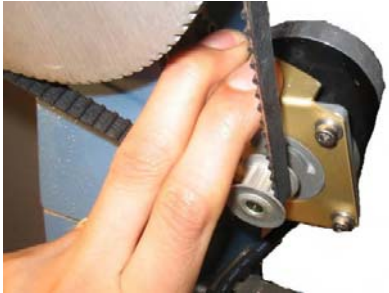
<p>5. Install the belt around the CL motor pulley and tension it by pulling the motor bracket down towards the antenna base and tighten the four screws.</p> <p>6. Increase the belt tension until the belt can only be easily twisted just 1/4 turn with your fingers.</p>
