Field Service Spares Replacement Procedure -- 70/140MHz Receiver Troubleshooting

Document No 135306 Rev A
-------------	---	-----------------------------

Field Service Procedure – 70/140MHz Receiver Troubleshooting

Troubleshooting document for diagnosing a fault with and replacing the 70MHz or 140MHz tracking receivers in the DAC-03 and 2302.

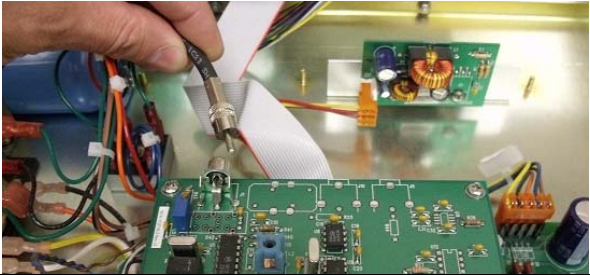
<p>*CAUTION: Power down the pedestal before following this procedure.</p> <ol style="list-style-type: none">1. Using a #1 Phillips screwdriver remove the lid of the DAC-03/2302.2. Disconnect the RCA cable from the SCPC receiver.

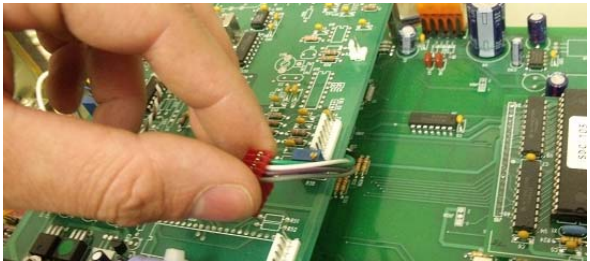
<ol style="list-style-type: none">3. Disconnect the IDC connectors from the PCB

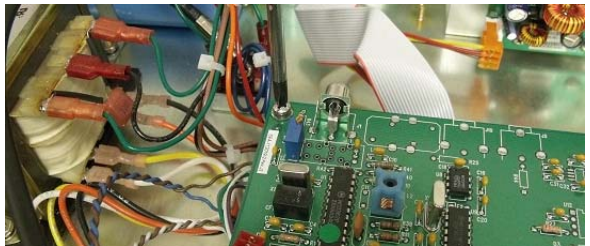
<ol style="list-style-type: none">4. Remove the 3 screws securing the SCPC receiver to the standoffs.
