Field Service Spares Replacement Procedure – FSK Modem Troubleshooting

Field Service Procedure – FSK Modem Troubleshooting

Troubleshooting document for diagnosing a fault with and replacing FSK modems on the XXo6 and XXg7 series antennas.

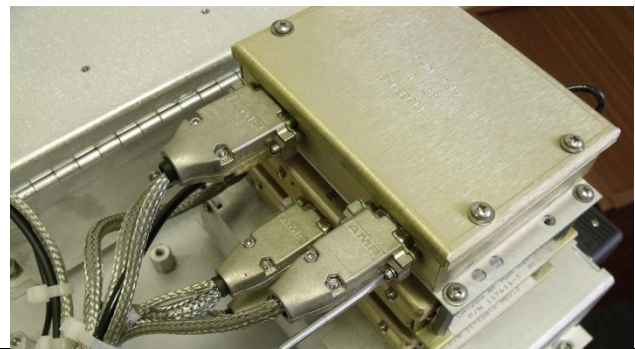
1. Using a 2mm flat blade screwdriver remove the harness connections from the pol aux relay.

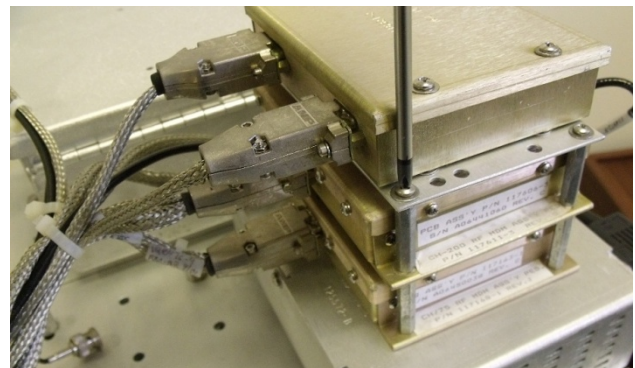
2. Now using a #1 Phillips screwdriver remove the 4 screws securing the pol aux relay to the assembly and remove it.

***Note:** if your system doesn't support RF communications you'll only have a single ADE modem.

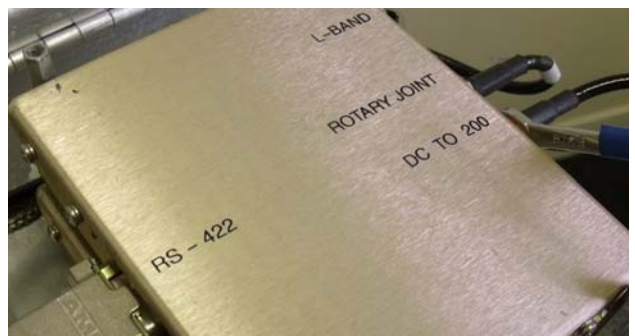
3. Using a 5/16" wrench undo the SMA cables from the modem, noting their orientation.

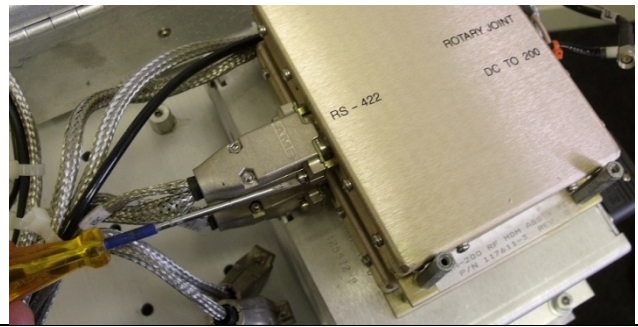
4. Using a 2mm flat blade screwdriver disconnect the harness connection from the modem.

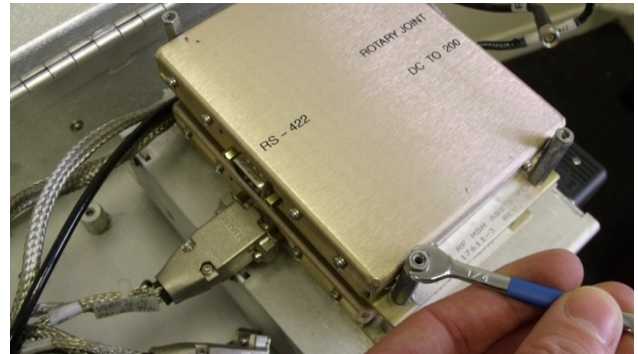
5. Using a ¼" wrench undo the standoffs to remove the modem (repeat the above procedures if the lower modem is to be replaced).

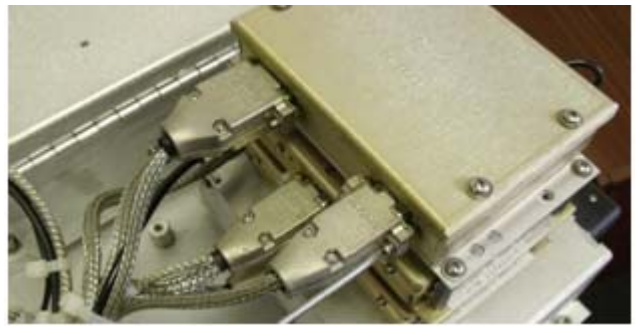
6. Install the replacement modem and reinstall the hardware, applying Loctite 242 to the standoffs.
7. Reconnect the harnesses D-sub connector(s).
8. Reconnect the SMA cable(s).
9. Reinstall the pol aux relay, apply Loctite 242 to the screws and reconnect the harness connections.
