Field Service Spares Replacement Procedure – DAC-2302

Field Service Procedure – DAC-2302

Troubleshooting document for diagnosing a fault with the DAC-2302 control unit.

Procedure for replacing the DAC-2302 control unit.

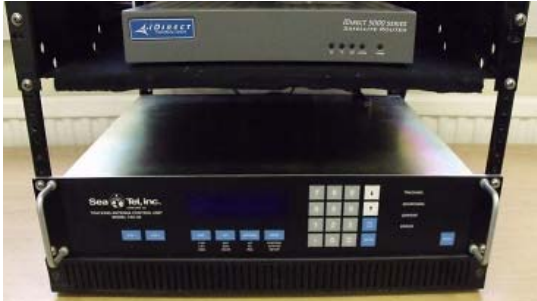
<p>1. Disconnect the AC power cable to the DAC.</p>

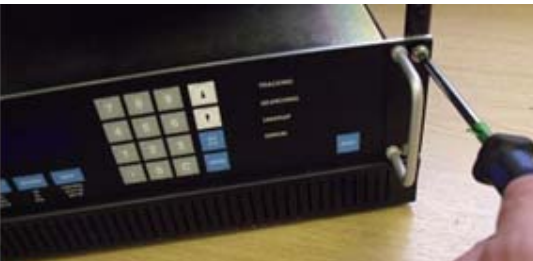
<p>7. Install the replacement DAC using the hardware removed in the previous step.</p> <p>8. Reinstall the cables from the previous steps following this procedure in reverse.</p>
