**Field Service Spares Replacement Procedure – AZ Encoder Kit, XX97,  
XX97A & XX00**

# ***Field Service Procedure – AZ Encoder Kit, XX97, XX97A & XX00***

Troubleshooting document for diagnosing a fault with and replacing the azimuth encoder on the XX97, XX97A and XX00 series antennas.

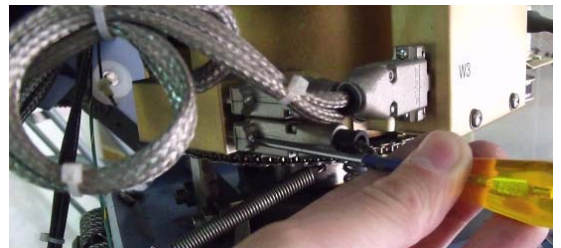
1. Using a 2mm flat blade screwdriver disconnect the encoder harness from the home switch assembly.

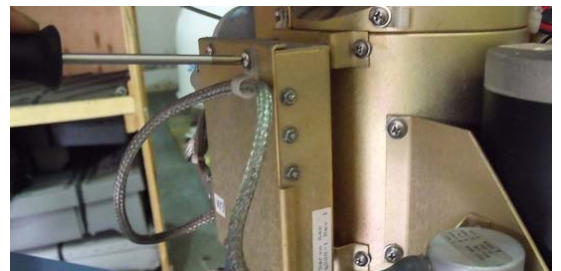
2. Remove the screw and P-clip securing the encoder harness to the servo amplifier using a #1 Phillips screwdriver. Take care not to lose the standoff in between the servo amp and mounting bracket.

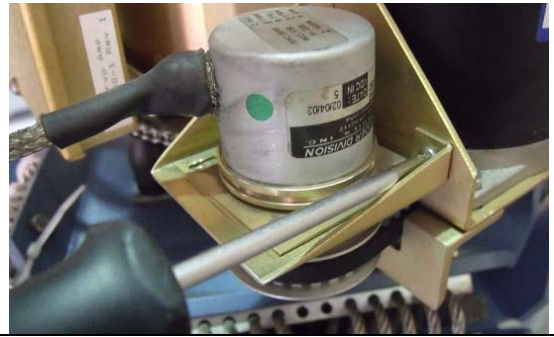
3. Remove the 3 screws securing the encoder mounting bracket to the side of the azimuth motor bracket using a #1 Phillips screwdriver.

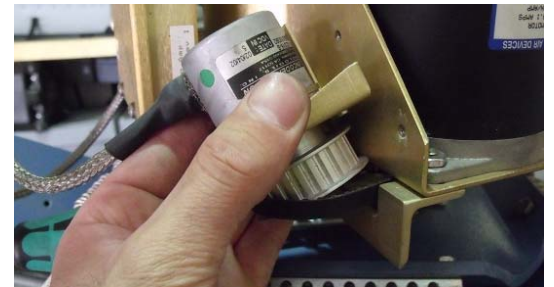
4. Disengage the pulley from the belt and remove the encoder assembly.

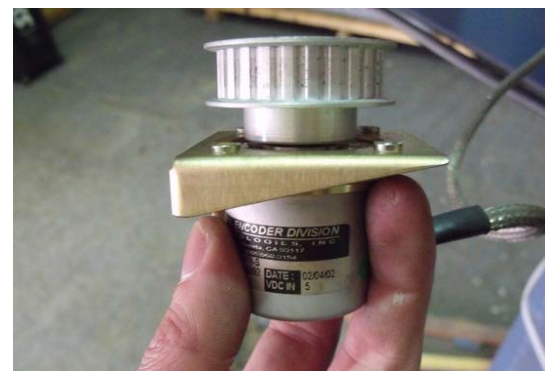
5. Remove the set screws from the encoder pulley using a 5/64" Allen wrench. Note the position the pulley is installed in and apply heat to the pulley and remove it from the defective encoder.

6. Take the mounting bracket and plate from the defective motor and install them on the replacement encoder, with the harness exiting away from the bracket (as shown on the right).

7. Install the pulley to the replacement encoder, apply Loctite 638 to the shaft and secure the set screw with Loctite 222.

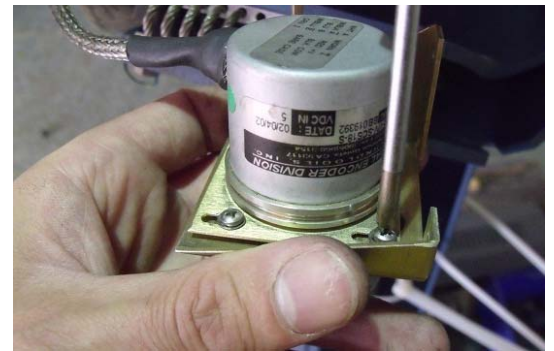
8. Apply Loctite 242 to the 4 screws securing the encoder to main bracket and install them loosely.

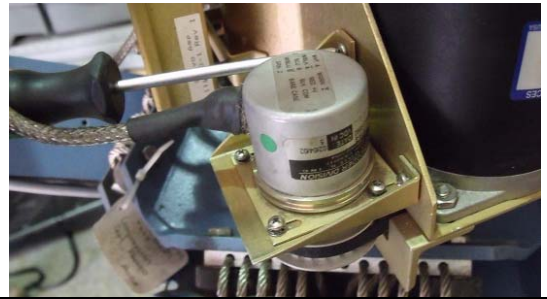
9. Slip the encoder assembly into the belt, making sure it's engaged with the azimuth motor pulley.

10. Apply Loctite 242 to the three mounting screws and reinstall the encoder assembly to the side of the azimuth motor bracket.

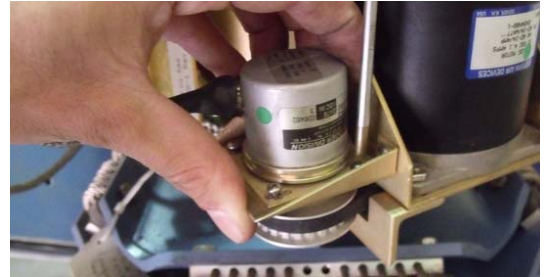
11. Pull the encoder away from the azimuth motor to tension the belt and tighten the four screws. Verify the tension of the belt and repeat this procedure if necessary.

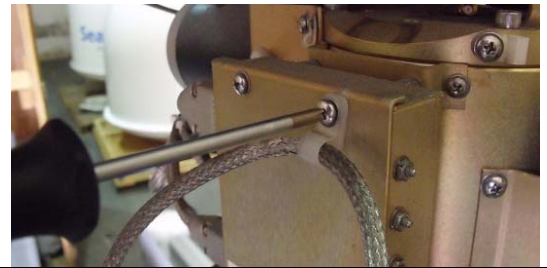
12. Apply Loctite 242 to the mounting screws and reinstall the P-clip, securing the encoder harness to the servo amplifier.

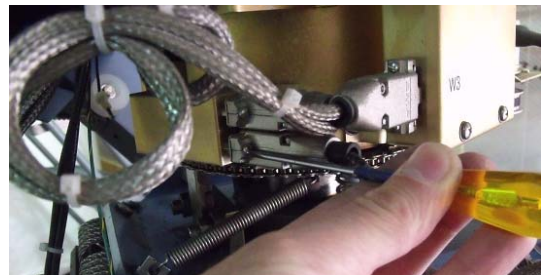
13. Reinstall the encoder D-sub connector to the home switch assembly.

**\*Note:** The encoder will automatically calibrate itself upon initialization when the home switch is engaged; therefore no physical calibration of the encoder is required.
