**Field Service Spares Replacement Procedure – EL & CL Motor Kit,
Braked, XX06RZA**

Field Service Procedure – Replacement EL & CL Motor Kit, Braked, XX06RZA

Troubleshooting document for diagnosing a fault with and replacing the braked elevation and cross level motors on the XX06RZA antenna.

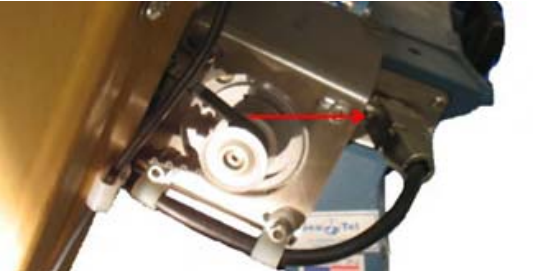
| <p>*CAUTION: Power down the pedestal before following this procedure.</p> <p>1. Using a 2mm flat blade screwdriver, loosen the two retaining screws on the EL motor harness and remove it from the CL beam.</p> | |

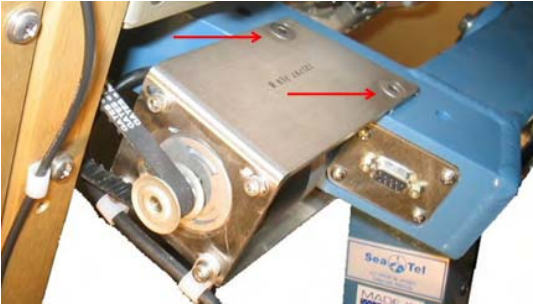
| <p>2. Using a 5/32" Allen wrench, remove the four Allen head screws attaching the EL motor bracket to CL beam and remove motor assembly.</p> | |

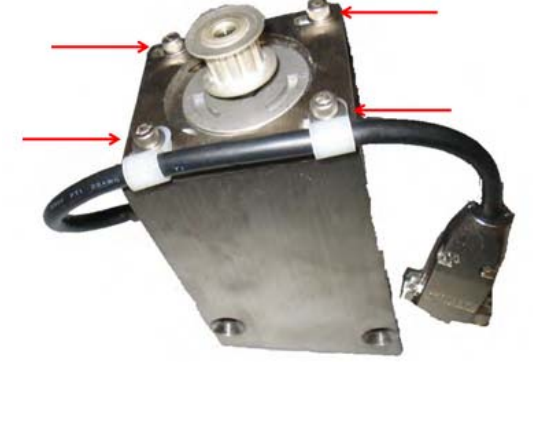
| <p>3. Observe the cable orientation and remove the motor from the bracket using a 9/64" Allen wrench, remove the four Allen head screws attaching the motor to the bracket.</p> <p>4. Apply Loctite 638 to the shaft of the replacement motor and fit the pulley in the same position as the one on the defective motor. Fit the set screws into the pulley with Loctite 222 and tighten with a 1/16" Allen wrench.</p> <p>*Note: For further information refer to the Loctite Procedure 121730 provided with this kit.</p> <p>5. Fit the replacement motor assembly onto the bracket using the four screws and P-clips removed earlier, apply Loctite 242 to the screws but do not fully tighten the screws at this time.</p> | |

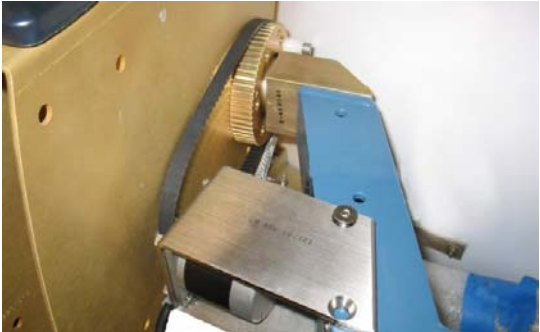
| <p>6. Re-install the bracket onto the CL beam using the front two countersunk Allen head screws with Loctite 242, do not fully tighten. Place the belt around the elevation drive sprocket and then elevation motor sprocket.</p> <p>7. Install the other two Allen head screws and secure the motor bracket onto CL Beam using Loctite 242.</p> | |

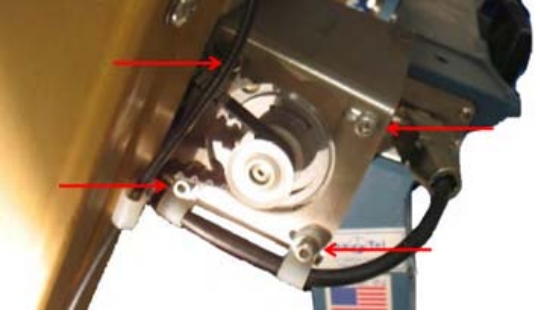
| <p>8. Reconnect the EL Motor harness and rotate the reflector to its upper physical stop to access the Elevation motor mounting hardware.</p> <p>9. Push back on the motor body to tension the elevation belt. Increase the belt tension until the belt can be easily twisted just $\frac{1}{4}$ turn with your fingers. When the belt tension is correct tighten the screws.</p> | |
| <p>10. Rotate the reflector in elevation and verify that the motor sprocket and the belt do not rub against the elevation pan and that the belt runs in-line with both sprockets.</p> <p>*Note: Failure of this step is normally due to incorrect sprocket placement on elevation motor assembly.</p> | |

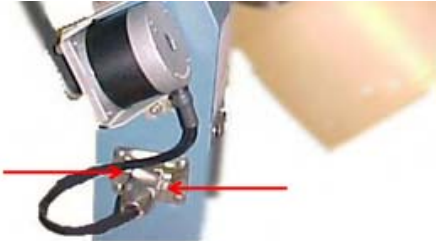
| <p>*CAUTION: Power down the pedestal before following this procedure.</p> <p>1. Using a 2mm flat blade screwdriver, loosen two retaining screws on the CL motor harness and remove it from the AZ post.</p> | |

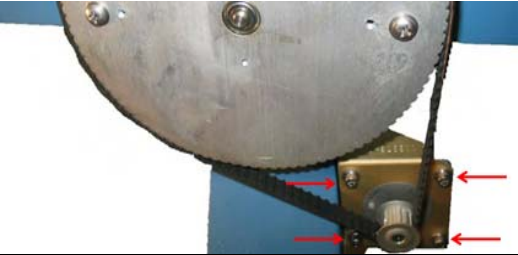
| <p>2. Using a 9/64" Allen wrench, remove the four Allen head screws securing the CL motor to its bracket and remove it.</p> | |

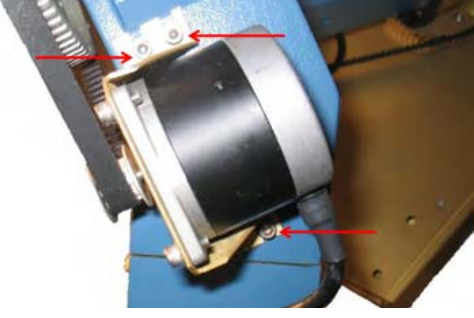
| <p>3. Apply Loctite 638 to the shaft of the replacement motor and fit the pulley in the same position as the one on the defective motor. Fit the set screws into the pulley with Loctite 222 using a 1/16" Allen wrench.</p> <p>4. Install the replacement motor assembly onto the CL motor bracket with Loctite 242.</p> <p>5. Loosen the four Allen head screws securing the CL motor bracket to the AZ post, complete removal of the hardware is not required.</p> | |

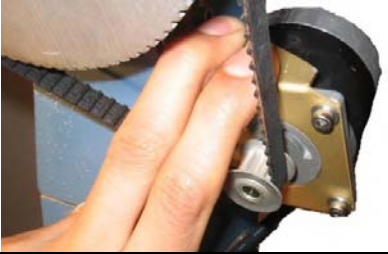
| <p>6. Install the belt around the CL motor pulley and tension it by pulling the motor bracket down towards the antenna base and tighten the four screws.</p> <p>7. Increase the belt tension until the belt can only be easily twisted just ¼ turn with your fingers.</p> | |

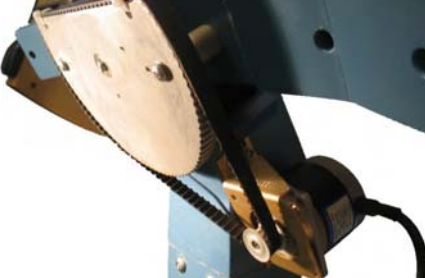
| <p>8. Rotate the CL beam from the CCW stop to the CW stop (Left to right) and verify the CL belt does not rub against the AZ post and runs in line with both sprockets.</p> <p>*Note: Failure of this step is normally due to incorrect sprocket placement on the CL motor shaft.</p> | |
