**Field Service Spares Replacement Procedure – EL Motor Kit, Braked
XX97B, XX00B & XX07**

Field Service Procedure - EL & CL Motor Kit, XX97B, XX00B & XX07

Troubleshooting document for diagnosing a fault with and replacing the elevation and cross level motor on the XX97B, XX00B & XX07 series antennas.

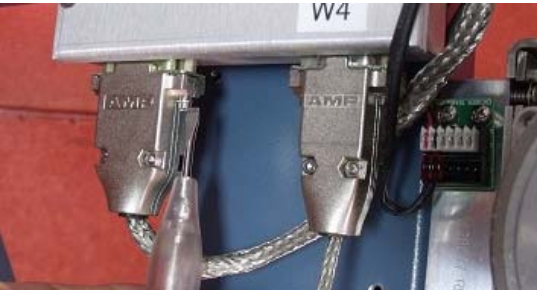
<p>*CAUTION: Power down the pedestal before following this procedure.</p> <ol style="list-style-type: none">1. Raise the system to 90 degrees of elevation for easy access to the motor assembly.2. Undo the Elevation motor D-sub connector from the servo Amplifier using a 2mm flat blade screwdriver.

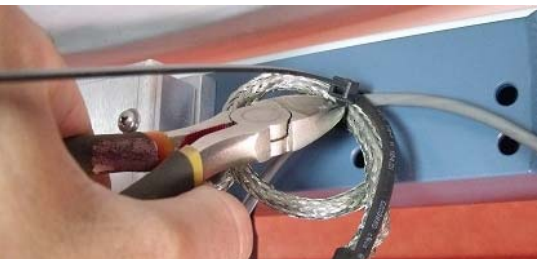
<ol style="list-style-type: none">3. Snip the cable tie securing the motor harness & brake harness to the equipment frame.

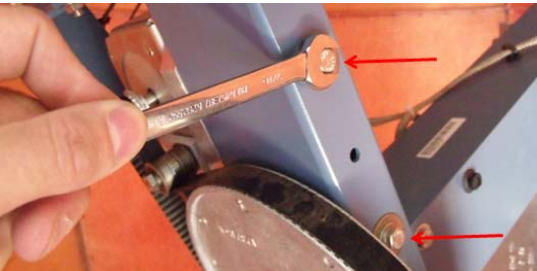
<ol style="list-style-type: none">4. Hold the weight of the motor and undo the two bolts securing the motor to the equipment frame using a 7/16" wrench (the upper nut is fixed in the assembly, take care not to drop the lower nut).

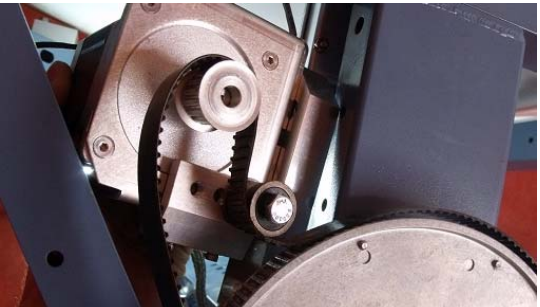
<p>*Note: The ground and motor brake harness is still connected to the motor assembly at this point!</p> <p>5. Support the motor assembly & slip it out of the elevation belt.</p>

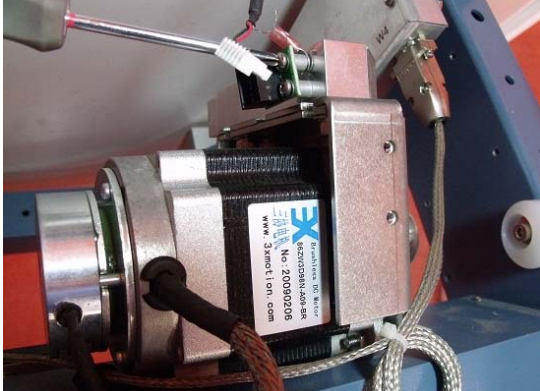
<p>6. Rest the motor assembly on the cross level beam to allow access to the brake harness and ground connection, taking care not to stress the harness.</p> <p>7. Disconnect the IDC connector from the brake harness to the termination block.</p>

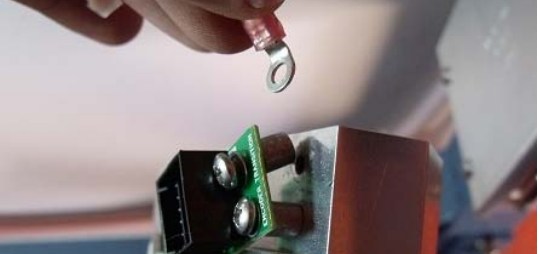
<p>8. Loosen the lower screw using a #1 Phillips screwdriver & undo the top one to allow removal of the ground connection from the assembly.</p>

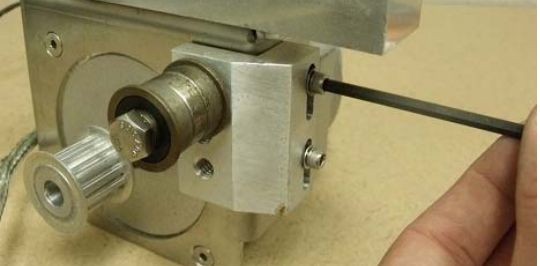
<p>9. Using a 9/64" Allen wrench remove the two bolts securing the tensioning pulley to the motor assembly.</p>

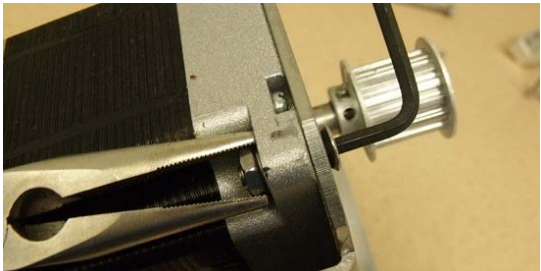
<p>10. Now using a pair of large long nose pliers secure the nut holding the motor to the bracket & undo the four countersunk screws using a 1/8" Allen wrench.</p>

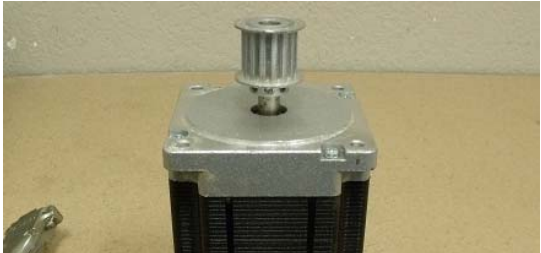
<p>11. Apply Loctite 638 to the shaft of the motor and fit the pulley in place.</p> <p>12. Align the pulley in the same position as on the defective motor & secure the dowel pin with Loctite 638.</p> <p>*Note: For further information refer to the Loctite Procedure 121730 provided with this kit.</p>

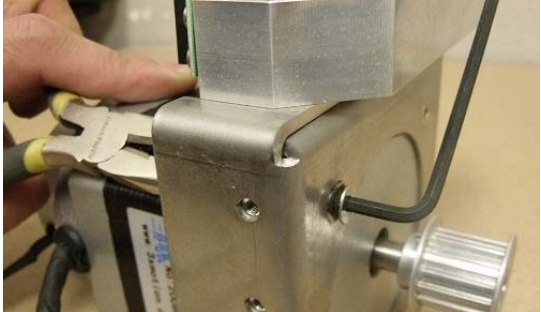
<p>13. Apply Loctite 242 to the threads of the four countersunk screws and secure the motor to the bracket using a larger pair of long nose pliers to secure the nuts.</p> <p>*Note: The orientation the harness exits in relation to the orientation of the bracket assembly (as shown on the right).</p>

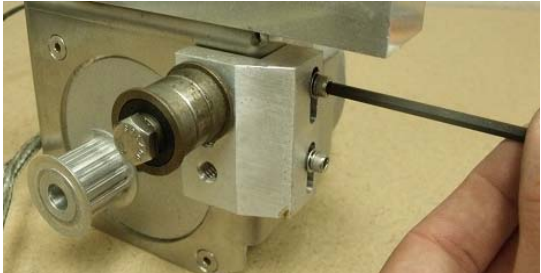
<p>14. Apply Loctite 242 to the screws securing the belt tensioning pulley assembly to the motor bracket. Do not fully tighten them at this time.</p>

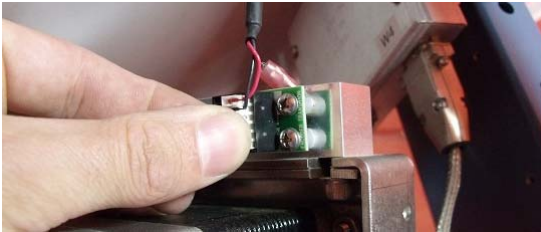
<p>15. Place the motor assembly on the cross level beam of the antenna and connect the brake harness IDC connector and ground point to the motor termination block.</p>

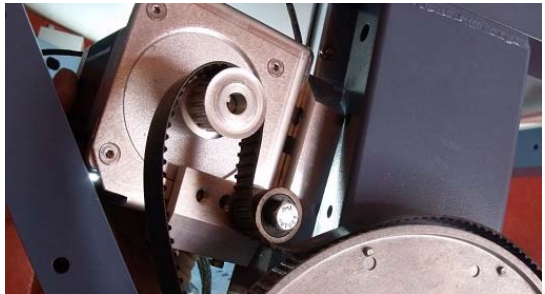
<p>16. Slot the motor assembly into place and engage the elevation drive belt around the motor pulley, tensioning wheel and main drive sprocket.</p> <p>*Note: The tensioning wheel can be adjusted for more clearance at this time.</p> <p>17. Apply Loctite 2760 to the threads of the upper bolt and install the motor assembly. Do not fully tighten at this time.</p>

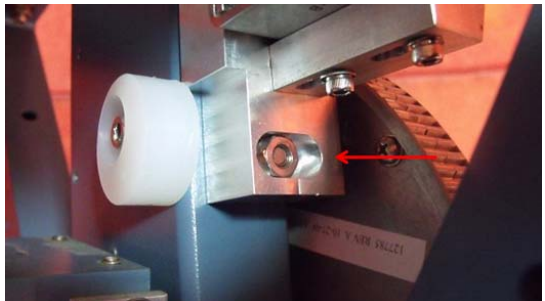
<p>18. Apply Loctite 2760 to the threads of the lower bolt and install it onto the nut removed earlier (as shown on the right). Do not fully tighten at this time.</p>

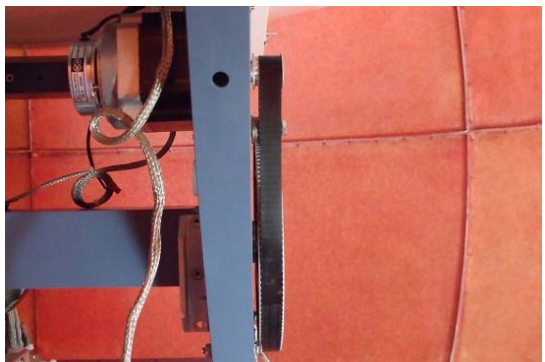
<p>19. Verify the alignment of the motor pulley to make sure the motor pulley and main drive sprocket run parallel with each other.</p> <p>20. Then verify that the motor bracket is aligned correctly by using the equipment frame as a guide and measuring the distance from the upper and lower points of the motor bracket to verify the motor assembly is square on the equipment frame.</p>

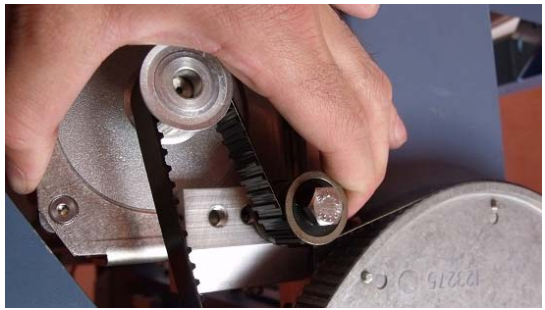
<p>21. Once the motor is aligned correctly apply pressure to the tensioning pulley and secure the tensioner assembly in place using a 9/64" Allen wrench.</p>

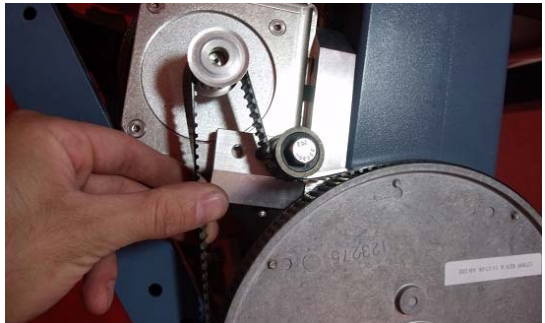
<p>22. Verify the tension of the belt and repeat the previous step if the belt tensioner isn't correctly adjusted.</p>

A close-up photograph showing a person's hand adjusting a metal belt tensioner. The tensioner is connected to a black rubber belt. The background shows a blue metal frame and a silver motor housing with some markings.
<p>23. Reconnect the IDC connector from the brake to the termination block.</p>

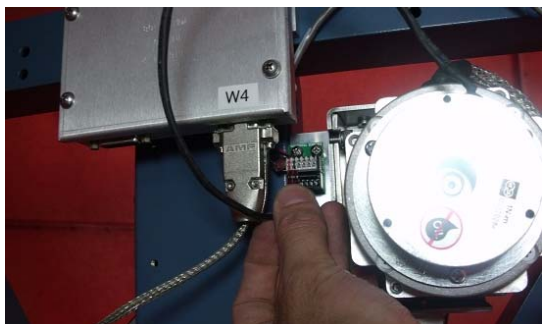
A close-up photograph showing a hand connecting a green IDC connector to a termination block. The block is labeled 'W4'. A silver motor housing is visible in the background.
<p>24. Reconnect the motor harness to the servo amplifier.</p>

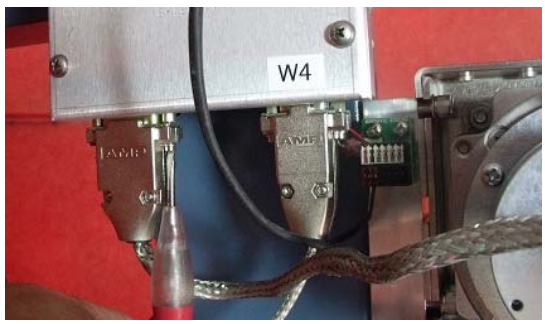
A close-up photograph showing a hand connecting a motor harness to a servo amplifier. The amplifier is labeled 'W4'. The harness is being plugged into a connector on the amplifier.
<p>25. Secure the excess motor and brake harness to the equipment frame using a cable tie.</p>

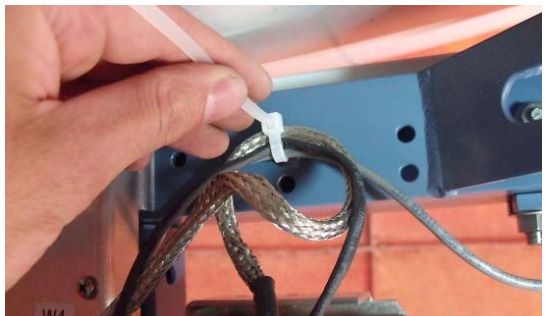
A close-up photograph showing a hand using a white cable tie to secure a bundle of cables. The cables are attached to a blue metal frame. A 'W4' label is visible on the frame.
