**Field Service Spares Replacement Procedure – EL, CL & AZ Motor Kit,  
XX97, XX97A & XX00**

# ***Field Service Procedure - EL, CL & AZ Motor Kit, XX97, XX97A & XX00***

Troubleshooting document for diagnosing a fault with and replacing the elevation, cross level and azimuth motor on the XX97, XX97A and XX00 series antennas.

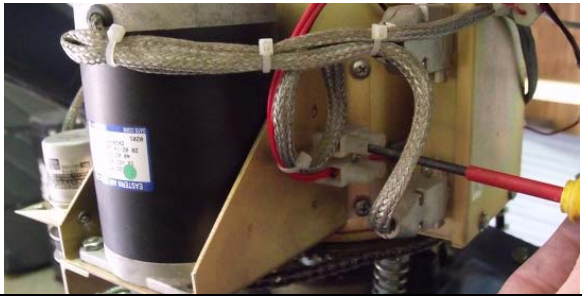
<p><b>*CAUTION:</b> Power down the pedestal before following this procedure.</p> <p>1. Using a 2mm flat blade screwdriver remove the AC cables from the termination block.</p>

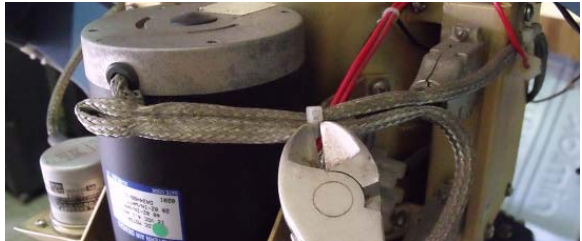
<p>2. Cut the cable ties securing the azimuth motor harness using a pair of snips.</p>

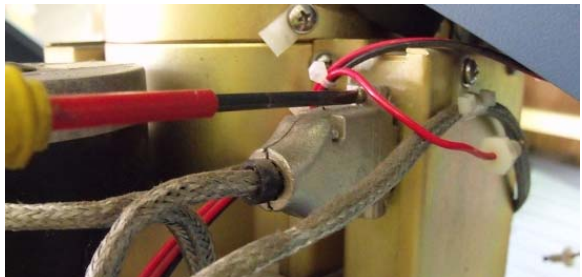
<p>3. Disconnect the azimuth motor D-sub connector from the servo amplifier using a 2mm screwdriver.</p>

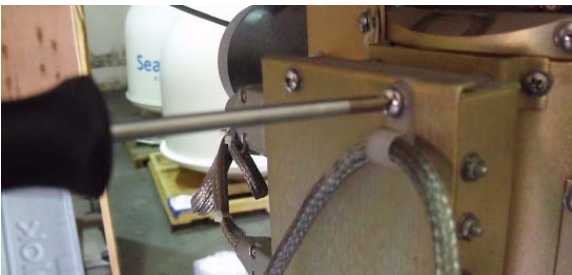
<p>4. Remove the screw securing the encoder harness to the servo amplifier using a #1 Phillips screwdriver.</p>

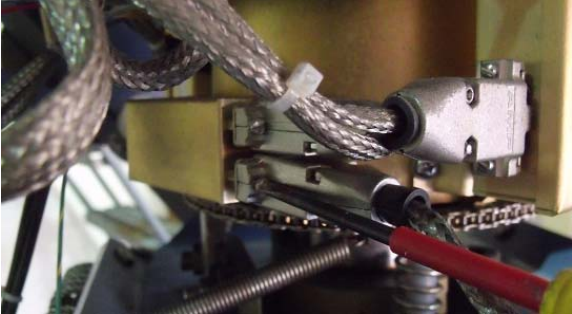
<p>5. Remove the encoder D-sub connector from the home switch assembly using a 2mm flat blade screwdriver.</p>

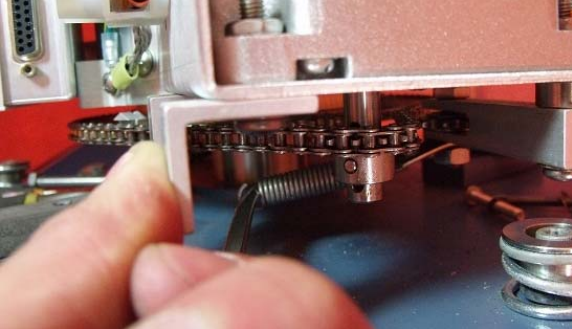
<p>6. Disconnect the spring from the azimuth chain tensioner using a 2mm flat blade screw driver to unhook it from the bracket.</p>

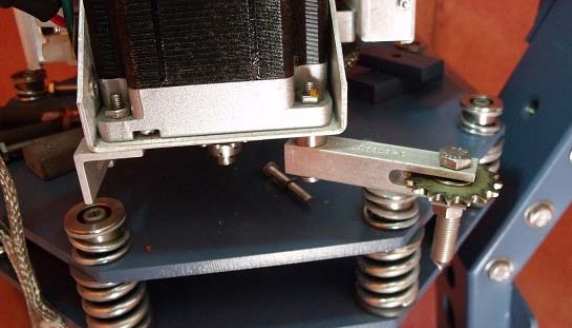
<p>7. Disengage the tensioning pulley from the azimuth drive chain.</p>

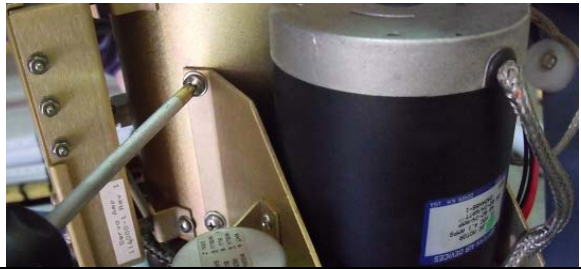
<p>8. Using a #2 Phillips screwdriver remove the four screws securing the azimuth motor assembly from the AZ canister.</p>

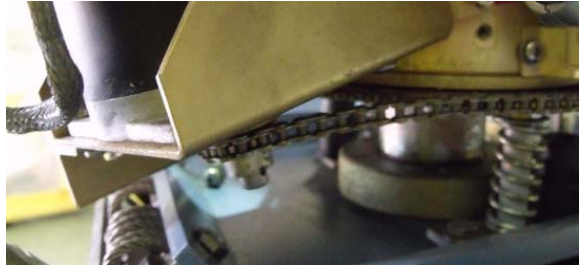
<p>9. Disengage the azimuth motor sprocket from the drive chain and remove the motor assembly (chain tensioner not shown).</p>

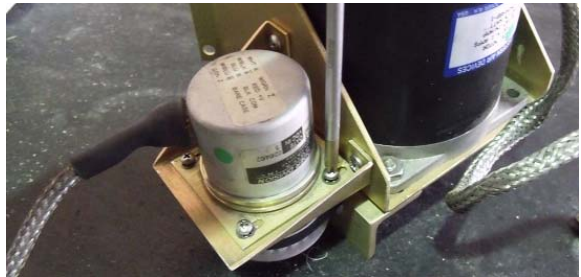
<p>10. Loosen the four screws securing the encoder to its bracket.</p>

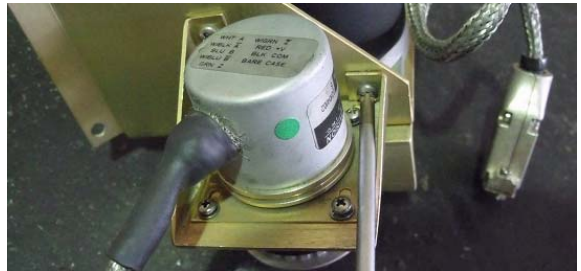
<p>11. Using a #1 Phillips screwdriver remove the 3 screws securing the encoder assembly to the azimuth motor assembly.</p> <p>12. Disengage the encoder pulley from the belt and remove the encoder assembly.</p>

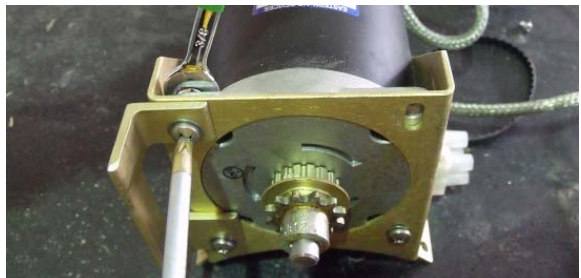
<p>13. Using a 3/8" wrench and #2 Phillips screwdriver remove the hardware securing the motor to the bracket and the chain tensioner assembly (not shown).</p> <p><b>*Note:</b> The orientation of the brackets and the orientation of the motor harness for future reference.</p>

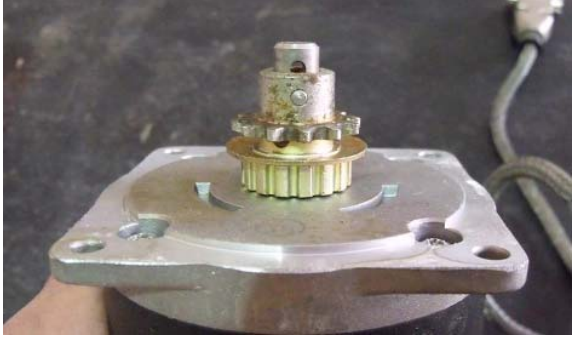
<p>14. Install the azimuth pulley to the replacement motor in the same position as on the defective motor. Apply loctite 638 to the dowel pin and insert it through the pulley and motor shaft. Allow 20 minutes for the Loctite to set.</p> <p><b>*Note:</b> For further information refer to the Loctite Procedure 121730 provided with this kit.</p> <p><b>*Note:</b> Two pulleys are provided in the kit, one for the azimuth and another for the Elevation and cross level axis. Verify you have the correct one before installing.</p>

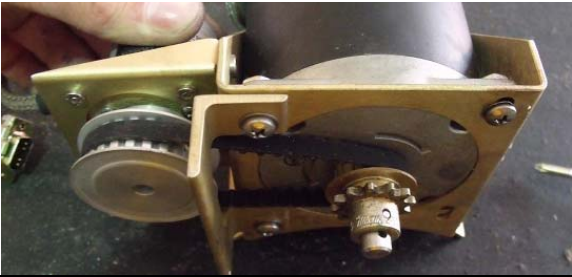
<p>15. Apply Loctite 242 to the three screws and reinstall the encoder assembly to the azimuth motor bracket.</p>

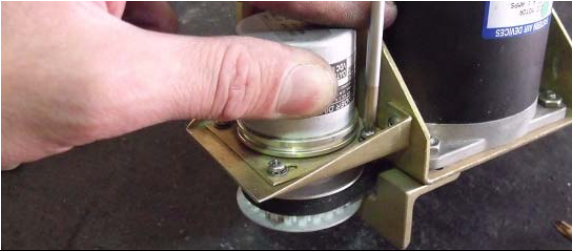
<p>16. Apply Loctite 242 to the four screws securing the encoder assembly and install loosely.</p> <p>17. Pull the encoder away from the motor to tension the belt and tighten the four screws. Verify the belt tension and repeat the procedure if necessary.</p>

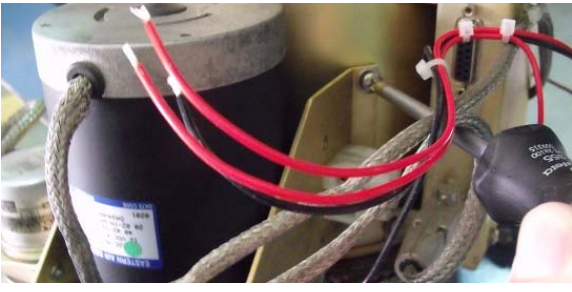
<p>18. Slip the azimuth motor sprocket into the drive chain and align the motor assembly.</p> <p>19. Apply Loctite 242 to the four motor screws and install the motor assembly to the azimuth canister.</p> <p>20. Reengage the chain tensioning sprocket to the drive chain and secure the tensioning spring to the bracket (not shown)</p>

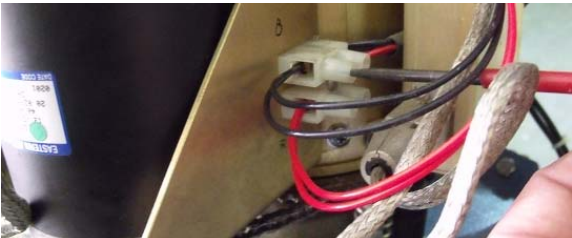
<p>21. Reconnect the AC cables to the termination block.</p>

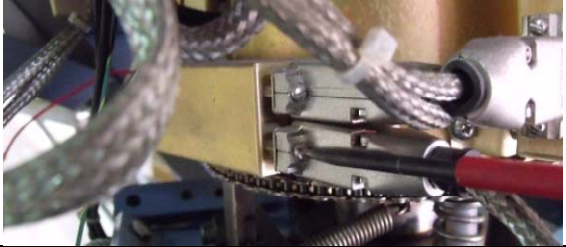
<p>22. Reinstall the encoder harness D-sub connector to the home switch assembly.</p> <p>23. Apply Loctite 242 to the mounting screw and install the P-clip securing the encoder harness to the servo amplifier.</p>

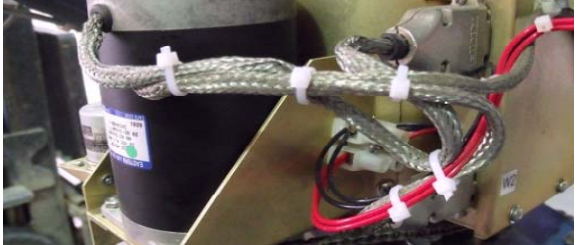
<p>24. Reconnect the azimuth motor harness D-sub connector to the servo amplifier.</p> <p>25. Secure the excess harness with cable ties.</p>

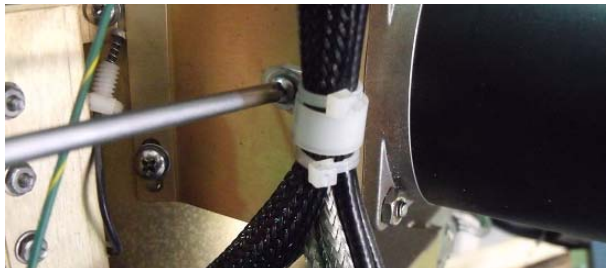
<p><b>*CAUTION:</b> Power down the pedestal before following this procedure.</p> <p>1. Using a #1 Phillips screwdriver remove the screw and P-clip securing the harness assemblies to the cross level motor bracket.</p>

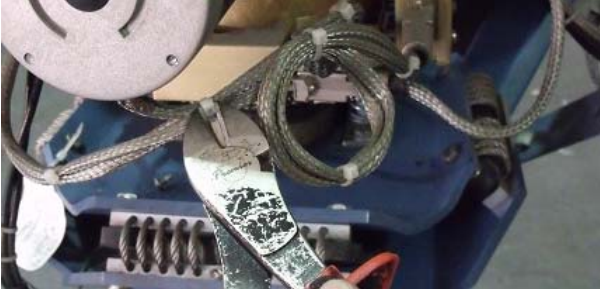
<p>2. Cut the cable ties securing the cross level motor harness using a pair of snips.</p>

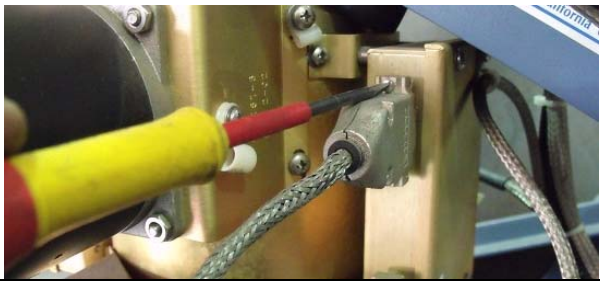
<p>3. Remove the cross level motor D-sub connector from the servo amplifier.</p>

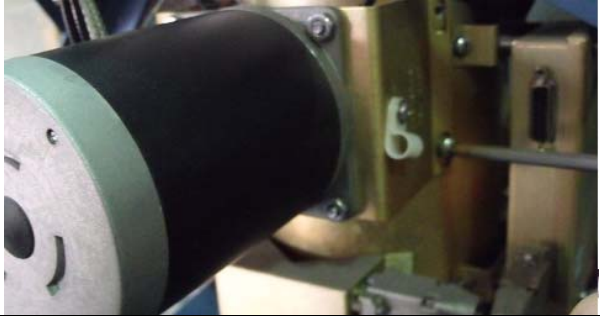
<p>4. Using a #2 Phillips screw driver remove the four screws securing the cross level motor assembly to the azimuth canister.</p> <p>5. Slip the cross level motor pulley out of the belt and remove the assembly.</p>

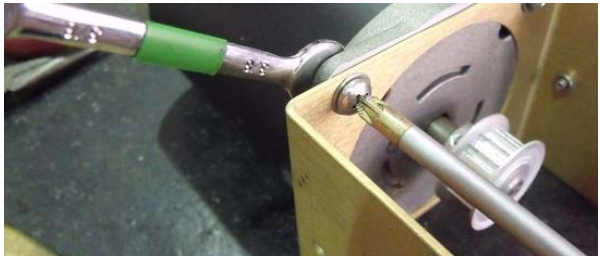
<p>6. Remove the four screws securing the cross level motor to the bracket using a #2 Phillips screwdriver and a 3/8" Allen wrench.</p>

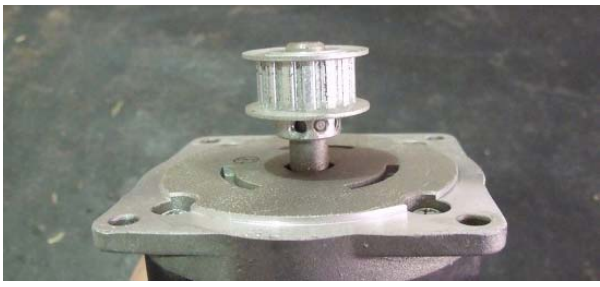
<p>7. Install the pulley to the replacement motor in the same position and orientation as the defective one. Apply Loctite 638 to the dowel pin and insert, allow 20 minutes for the Loctite to set.</p> <p><b>*Note:</b> For further information refer to the Loctite Procedure 121730 provided with this kit.</p>

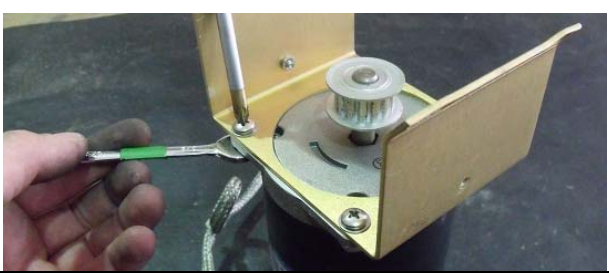
<p>8. Install the replacement motor assembly to the bracket with the harness in the correct orientation (as shown on the right).</p>

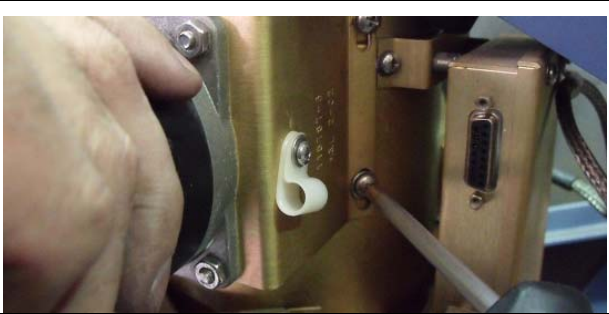
<p>9. Reinstall the motor assembly by slotting the pulley into the belt. Apply Loctite 242 to the 4 screws and loosely install them.</p> <p>10. Apply downward pressure on the motor to tension the belt and tighten two of the screws.</p>

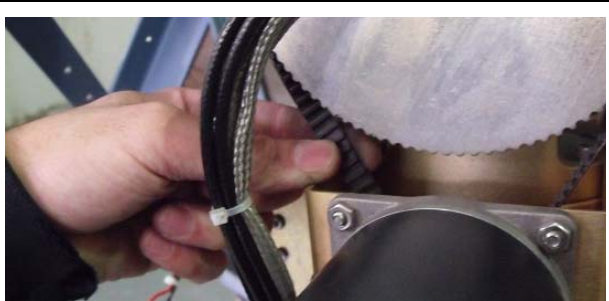
<p>11. Verify the belt tension, the belt should easily rotate, tightening at 90 degrees at the center point between both sprockets. If the belt can easily be rotated part 90 degrees it's too loose, if the belt cannot be rotated to 90 degrees it's too tight. If necessary repeat the above procedure then tighten all four of the retaining screws.</p>

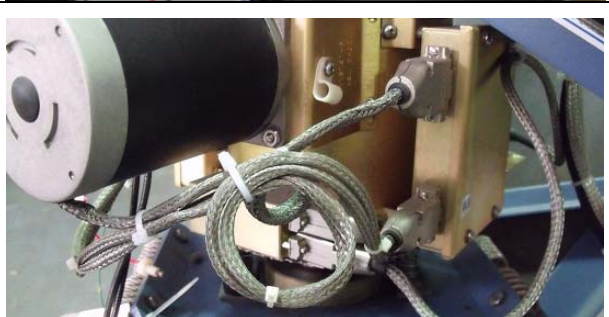
<p>12. Reconnect the azimuth motor harness D-sub connector to the servo amplifier.</p> <p>13. Secure the excess harnesses using cable ties.</p>
