**Field Service Spares Replacement Procedure – PCU Kit, XX97, XX97A  
& XX00**

# **Field Service Procedure – PCU Kit, XX97, XX97A & XX00**

Troubleshooting document for diagnosing a fault with and replacing the PCU assembly on the XX97, XX97A and XX00 series antennas.

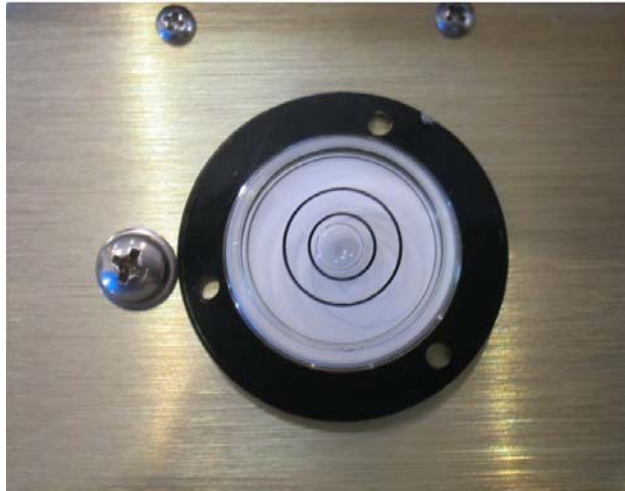
When correct the bubble should be as close to the center of the fluid as possible
