Field Service Spares Replacement – Servo Amplifier Kit

Field Service Procedure – Servo Amplifier Kit

Troubleshooting document for diagnosing a fault with and replacing the servo amplifiers on the XX97, XX97A, XX97B, XX00 and XX00B series antennas.

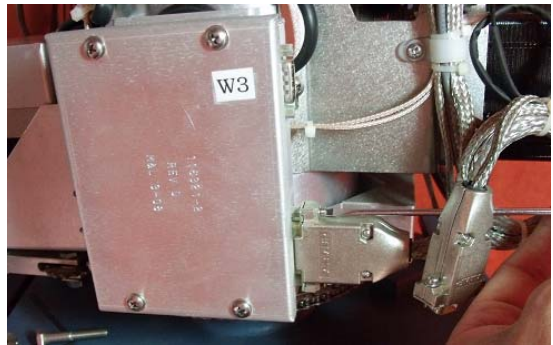
1. Disconnect the harness D-sub connectors from the servo amplifier using a 2mm flat blade screwdriver.

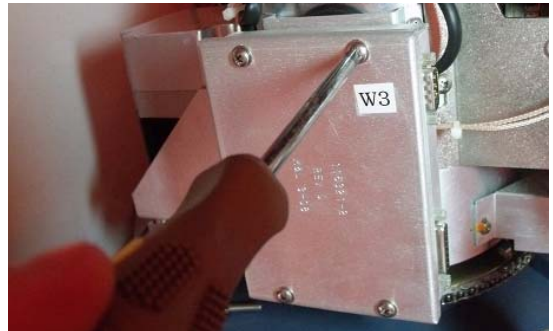
2. Using a #1 Phillips screwdriver remove the 4 screws securing the servo amplifier to the canister or equipment frame.

3. Install the replacement servo amplifier applying Loctite 242 to the threads.

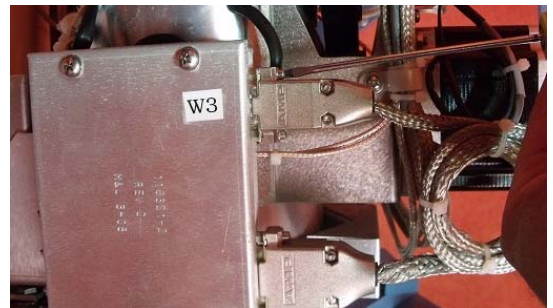
4. Reconnect the harness D-sub connectors to the replacement servo amplifier assembly.
