**Field Service Spares Replacement – Tone Generator Kit, XX06RZA**

## Field Service Procedure – Tone Generator Kit, XX06RZA

Troubleshooting document for diagnosing a fault with and replacing the tone generator on the XXo6RZA & XXo9 MK1 series antennas.

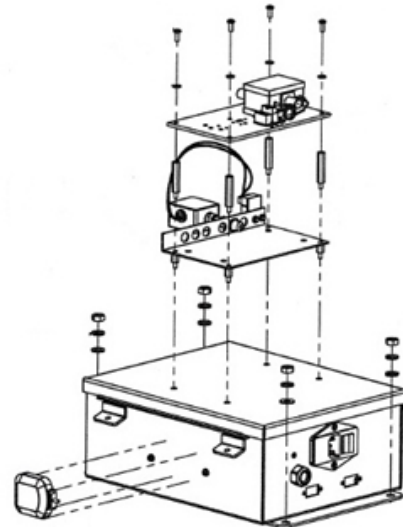
5. Install the replacement tone generator assembly securing the standoffs with Loctite 242.
6. Reconnect the coax cables with the connection from the modem running into the input of the tone generator and the coax that will run into the input of the switch to the output. Reconnect the harness IDC connector.
7. Apply Loctite 242 to the 4 screws and reinstall the coax switch assembly.
8. Reconnect the coax from the tone generator to the input of the coax switch. Connect the X-Pol coax to the J1 connection of the coax switch and the Co-Pol coax to the J2 connection. Reconnect the IDC connector.
