**Field Service Spares Replacement Procedure – 13V/18V ADE MUX,  
XX06RZA**

# ***Field Service Procedure – 13V/18V ADE MUX, XX06RZA***

Troubleshooting document for diagnosing a fault with and replacing ADE MUX on the XXo6RZA series antennas.

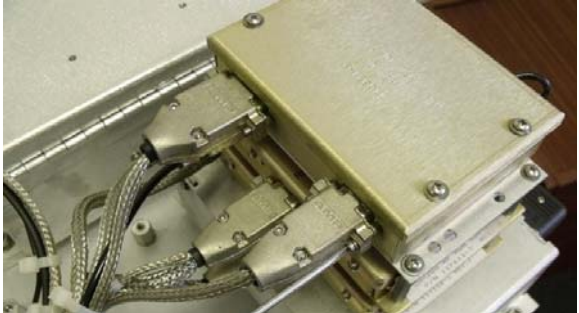
<p><b>*CAUTION:</b> Power down the pedestal before following this procedure.</p> <p>1. Using a 2mm flat blade screwdriver remove the harness connections from the pol aux relay.</p>

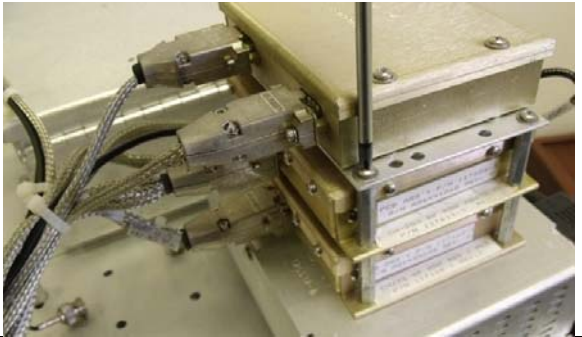
<p>2. Now using a #1 Phillips screwdriver remove the 4 screws securing the pol aux relay to the assembly and remove it.</p>

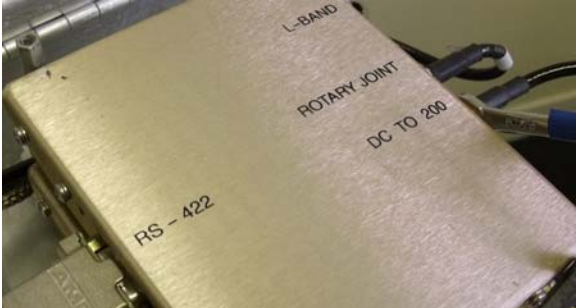
<p>3. Using a 7/16" wrench undo the coax cable from the pedestal modem to the tone generator.</p> <p>4. Now using a 5/16" wrench remove the SMA from the pedestal modem to the RF modem.</p>

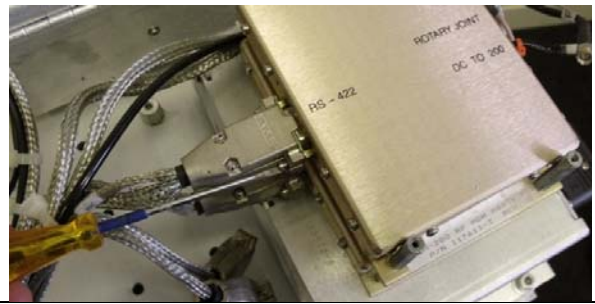
5. Using a 2mm flat blade screwdriver disconnect the harness connection from the modem.

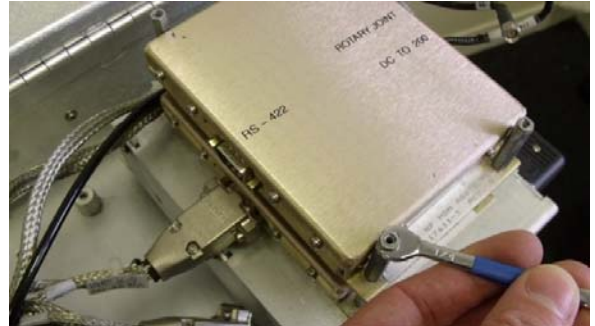
6. Using a 1/4" wrench undo the standoffs to remove the modem.

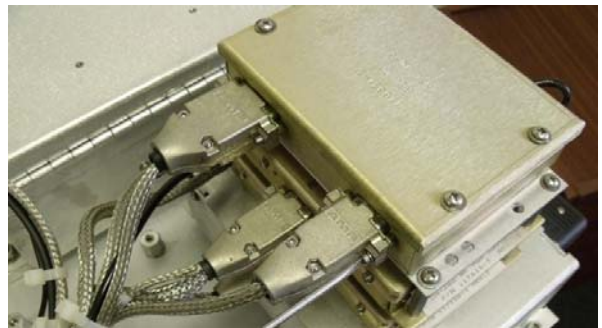
7. Install the replacement modem and reinstall the hardware, applying Loctite 222 to the standoffs and screws.  
8. Reconnect the harnesses D-sub connector.  
9. Reconnect the coax cable from the tone generator.  
10. Reconnect the SMA cable to the RF modem.  
11. Reinstall the pol aux relay applying Loctite 222 to the screws & reconnect the harness connections.
