**Field Service Spares Replacement Procedure – CL Motor Kit, Braked,
XX97B, XX00B & XX07**

Field Service Procedure - CL Motor Kit, XX97B, XX00B & XX07

Troubleshooting document for diagnosing a fault with and replacing the elevation and cross level motor on the XX97B, XX00B & XX07 series antennas.

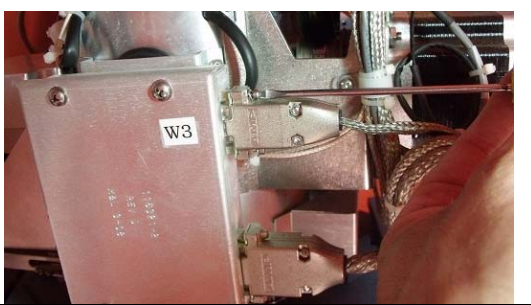
<p>*CAUTION: Power down the pedestal before following this procedure.</p> <p>1. Using a 2mm flat blade screwdriver undo the harness D-sub connectors from the servo amplifier.</p>

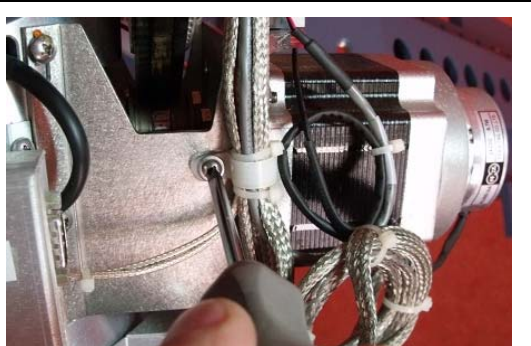
<p>2. Undo the screw securing the P-clip and motor harness to the cross level motor bracket.</p>

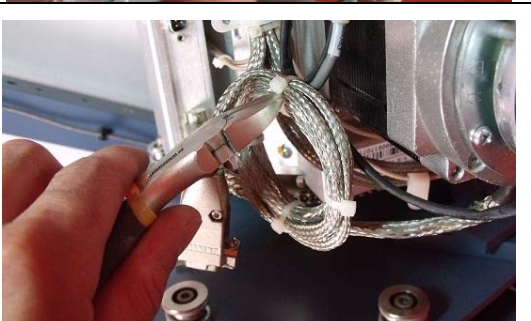
<p>3. Remove the cable ties securing the motor harness.</p>

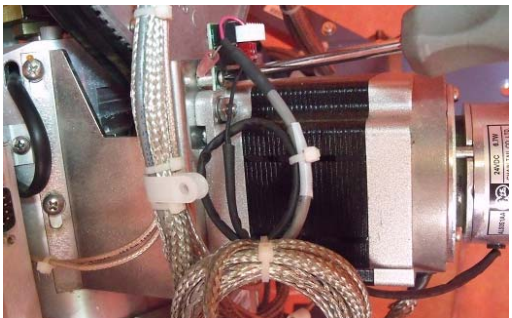
<p>4. Using a #1 Phillips screwdriver undo the hardware securing the ground point for the brake harness</p>

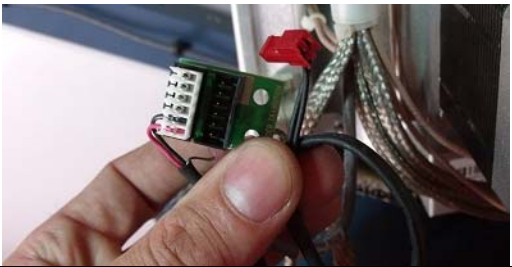
<p>5. Disconnect the IDC connector for the cross level motor brake from the termination block (leave the main harness connected). Take care not to lose the hardware.</p>

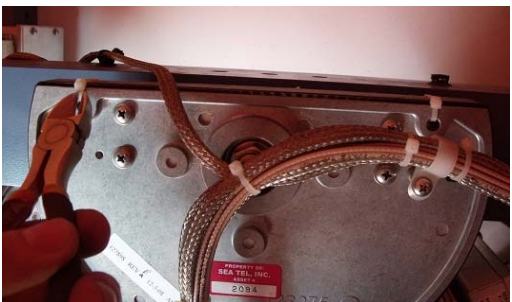
<p>6. Cut the cable ties securing the cross level belt to the drive sprocket.</p>

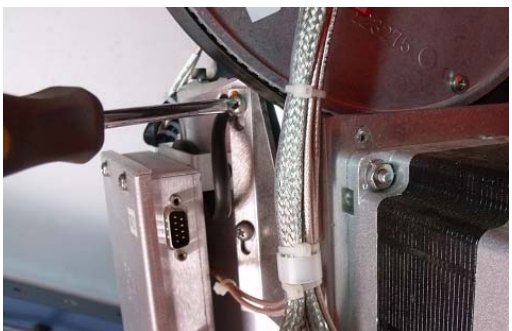
<p>7. Using a #2 Phillips screwdriver undo the four screws securing the cross level motor bracket to the canister.</p> <p>8. Support the motor and slip the belt off the main sprocket to allow access to remove the motor assembly.</p>

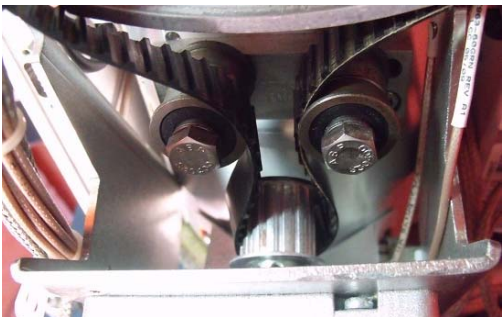
<p>9. Slot the replacement motor assembly into the belt and align the belt between the tensioners.</p>

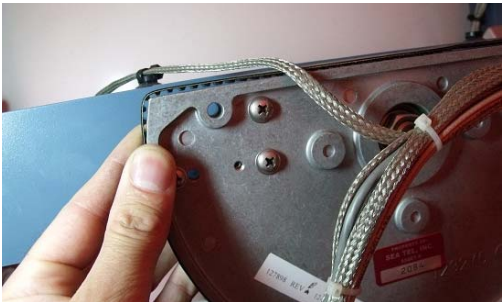
<p>10. Support the motor and pull the belt over the top of the cross level sprocket, then rotate the cross level axis from left to right and work the belt onto the main sprocket.</p>

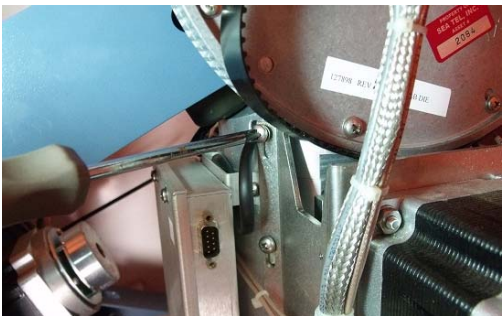
<p>11. Apply Loctite 242 to the four screws and loosely install the cross level motor assembly.</p>

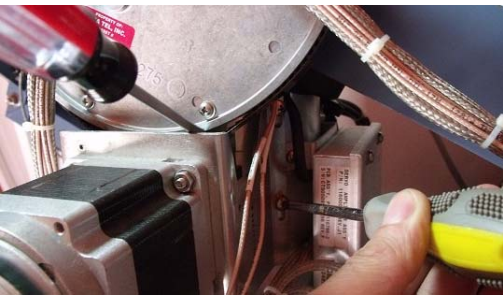
<p>12. Apply downward pressure on the motor assembly and tighten two of the screws.</p> <p>13. Verify the belt tension. If the belt tension is correct tighten the remaining two screws, if not repeat until correct.</p>

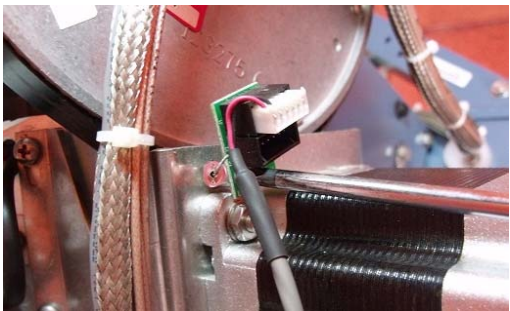
<p>14. Reinstall the termination PCB and ground point to the motor bracket.</p>

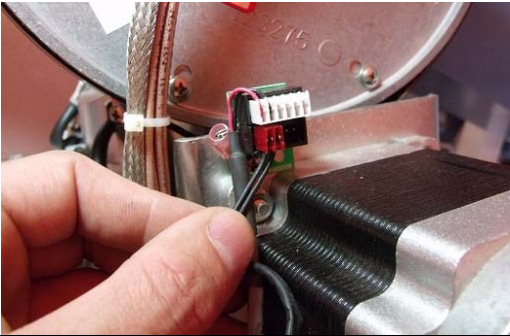
<p>15. Reconnect the IDC connector from the motor to the termination PCB.</p>

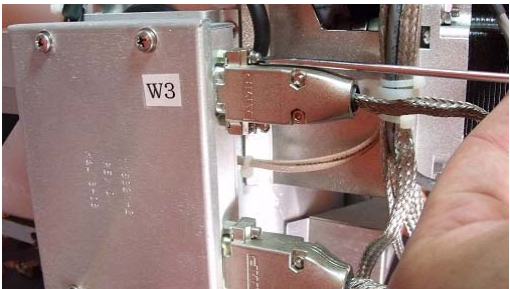
<p>16. Reinstall the harness D-sub connectors to the servo amplifier.</p>
