**Field Service Spares Replacement Procedure – GACP Control Panel Kit,
ST24**

Field Service Procedure – Replacement GACP Control Panel Kit, ST24

Troubleshooting document for diagnosing a fault with and replacing the Graphic Antenna Control Panel (GACP) for the ST24 antenna.

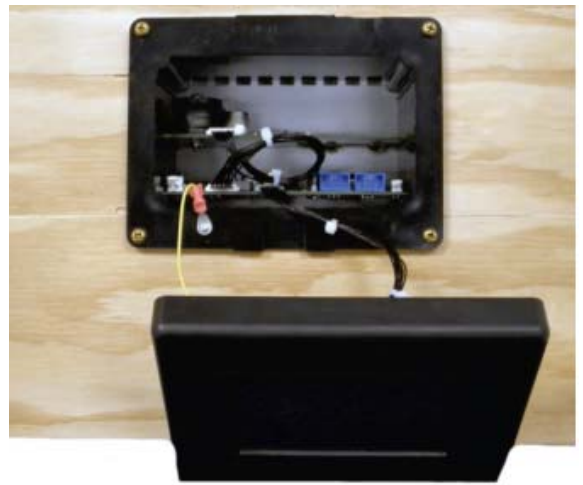
1. Carefully remove GACP front screen by unclipping it from the underside of its mount to provide access to the four mounting holes.

***Note:** Use caution as to not damage or pull out the cabling which connects to the touch screen display.

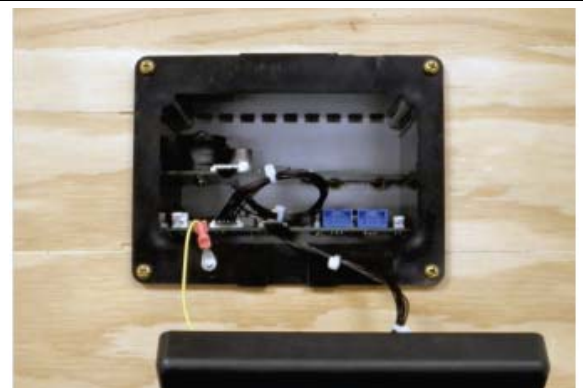
2. Remove the 4 mounting screws securing the GACP using a #1 Phillips screwdriver.

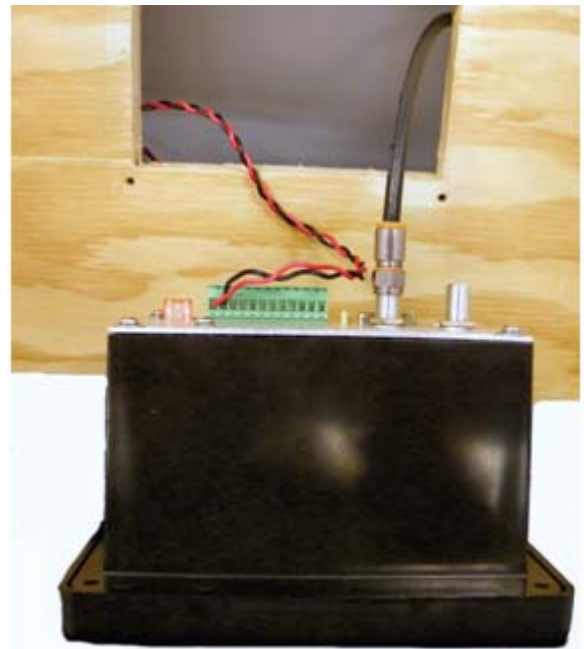
3. Secure and disconnect the red (+) and black (GND) DC power cables from the cables from the "BATT" terminal on the rear of the GACP using a 2mm flat blade screwdriver.

4. Secure the antenna communications coax cable from the RF-In connector on the rear of the GACP control panel.

5. Remove the defective GACP and install the replacement in the same configuration, connecting the coax cable to the RF-IN port and the DC power cables to the "+" and "-" connections.

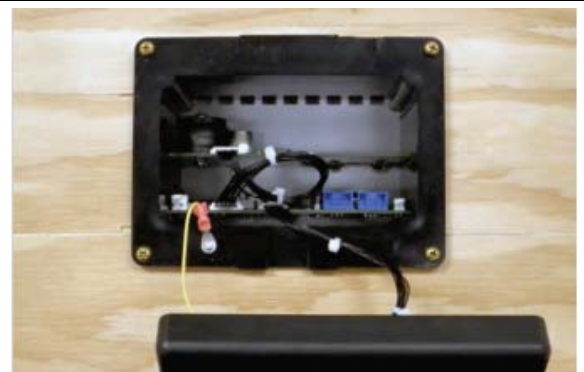
6. Secure the replacement GACP to the mounting points by removing the front panel (as per step 1 of this procedure) and secure to the mounting points with the hardware removed in step 2 using a #1 Phillips screwdriver.

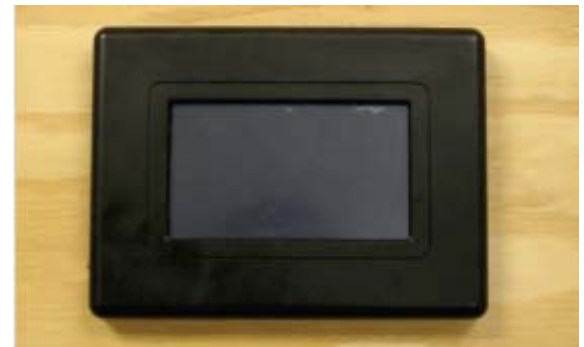
7. Reinstall the GACP front panel to the enclosure, by slipping the top of the screen into its locating clip and then locating the two lower mounting points.
