**Field Service Spares Replacement Procedure - EL Motor Kit, W-Encoder, Hi-Torque, Coastal 20, 24 & 30**

# ***Field Service Procedure – Replacement EL Motor Kit, W-Encoder, Hi-Torque, Coastal 24 & 30***

Troubleshooting document for diagnosing a fault with and replacing the hi-torque elevation motor with encoder on the Coastal series antennas.

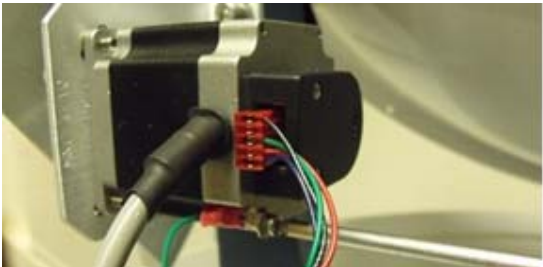
<p><b>*Caution:</b> Power down the pedestal before following this procedure.</p> <p>1. Using a #1 Phillips screwdriver remove the ground connector from the body of the motor, save the hardware for future use.</p>

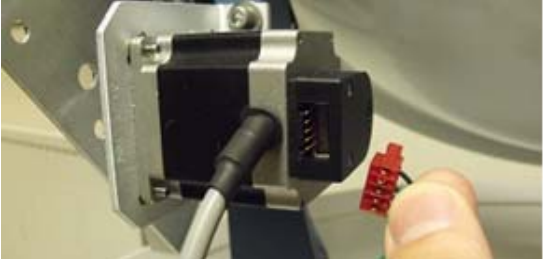
<p>2. Disconnect the IDC connector from the encoder on the elevation motor.</p>

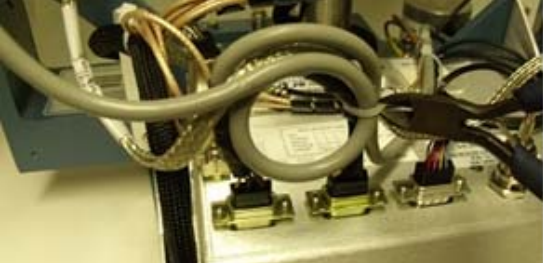
<p>3. Snip the cable ties securing the elevation motor and encoder harness.</p>

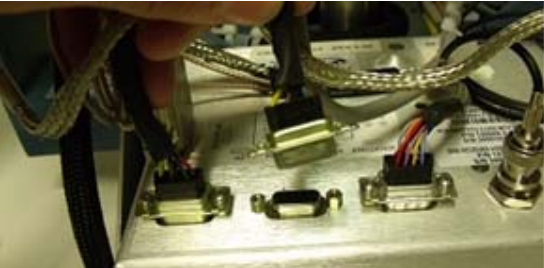
<p>4. Using a #1 Phillips screw driver remove the two screws securing the elevation motor connector to the PCU. Save the hardware for future use.</p>

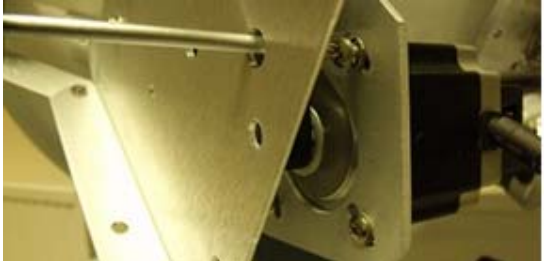
<p>5. Using a #1 Phillips screwdriver remove the 4 screws securing the motor to its bracket. Holes allowing access are in the elevation pan, the system will need to be rotated in elevation to align them.</p>

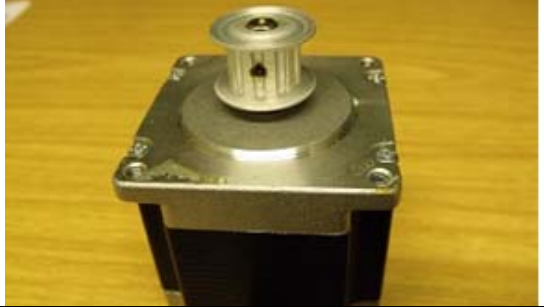
<p>6. Install the pulley to the replacement motor in the same position as on the defective motor. Apply Loctite 638 to the shaft of the motor and install the set screw with Loctite 222 using a 1/16" Allen wrench. Ensure the set screw is installed against the flat edge of the motor shaft. Save the hardware for future use.</p> <p><b>*Note:</b> For further information refer to the Loctite Procedure 121730 provided with this kit.</p>

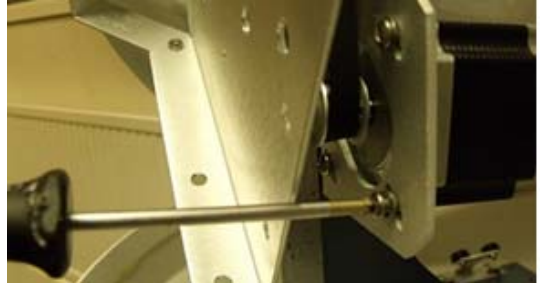
<p>7. Install the replacement motor assembly with harness exiting away from the antenna using the hardware removed in step 5. Apply Loctite 242 to the four screws but do not fully tighten at this time.</p>

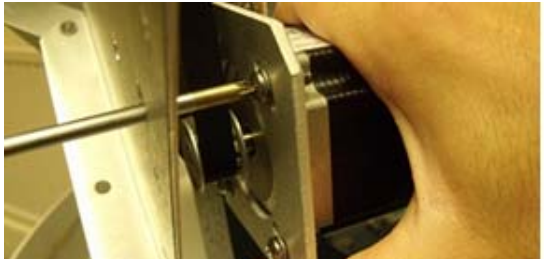
<p>8. Pressure the motor away from the main drive sprocket and tighten two of the screws. Verify the belt tension and if correct tighten the two remaining screws, if not repeat the previous step until the tension is correct.</p>

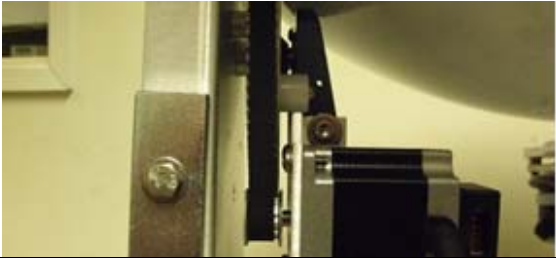
<p>9. Verify the alignment between the two sprockets is correct and the belt runs straight; rotate the system up and down in elevation to verify the system moves freely. Failure of this step is down to improper alignment of the motor pulley.</p>

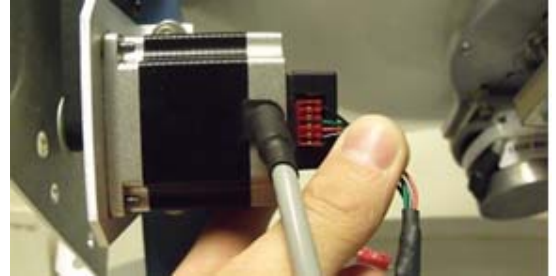
<p>10. Reinstall the encoder harness and ground connection to the motor assembly using the hardware removed in step 1.</p>

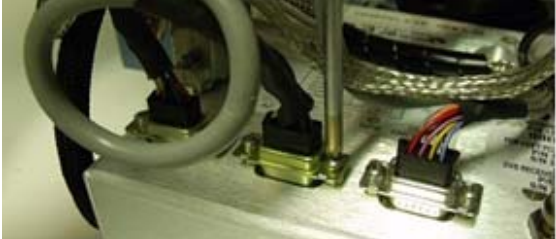
<p>11. Reconnect the elevation motor harness to the PCU, ensuring the split washers are installed (no need to Loctite).</p>
