Field Service Spares Replacement Procedure - EL & AZ Motor Kit, Non-Encoder, Coastal

Troubleshooting document for diagnosing a fault with and replacing the azimuth motor on the Coastal series antennas and the elevation motor on the Coastal 18 antenna.

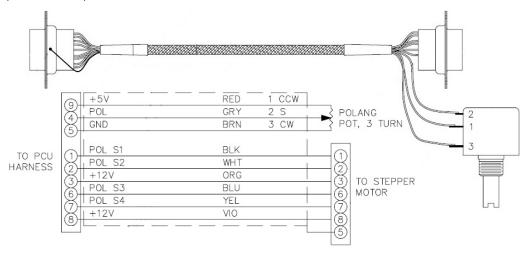
Check the harness for good continuity from point-to-point and that there are no shorts from wire-to-wire or from wire-to-ground that are not supposed to be there as per the above diagram. Repair any harness problems found and re-run the BIT tests. If there are no problems with any of the steps above, replace the PCU and re-run the BIT tests.

Check continuity of the pot from the wiper and both the clockwise and counter-clockwise contacts. Clockwise to counter-clockwise ends and vice versa, a steady resistance from o-5 or 5-o ohms should be measured (depending on the direction of rotation) from wiper to clockwise, or counter-clockwise, to verify proper operation. The pot is a three turn potentiometer, rotate the sprocket to find one end stop and then rotate it exactly 1½ turns away from that stop to the center of rotation. Hold the sprocket in place while re-coupling the belt, tension the belt as you tighten the pot mounting bracket. If this check found a problem, and you have corrected it, re-run the BIT tests.
