Field Service Spares Replacement Procedure – PCU Kit, ST24

Field Service Procedure – Replacement PCU Kit, ST24

Troubleshooting document for diagnosing a fault with and replacing the main PCU PCB on the ST24 antenna.

Procedure for replacing the ST24 Main PCU PCB, Sea Tel kit part number: 135913 (ST24 PCU PCB part number: 132362-1).

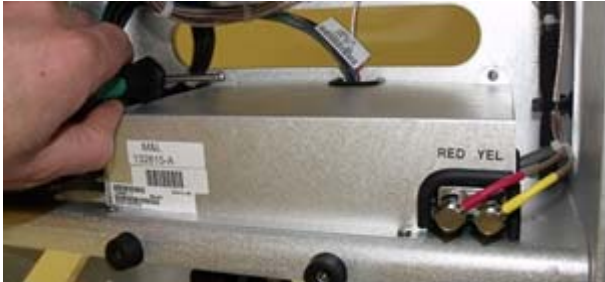
<p>*Caution: Power down the pedestal before following this procedure.</p> <p>1. Remove the four screws securing the PCU PCB cover using a #1 Phillips screwdriver. Save the hardware for future use.</p>

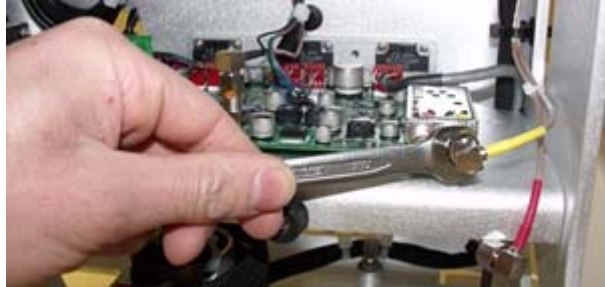
<p>2. Disconnect the RF coax cables from the DVB receiver using a 7/16" wrench.</p>

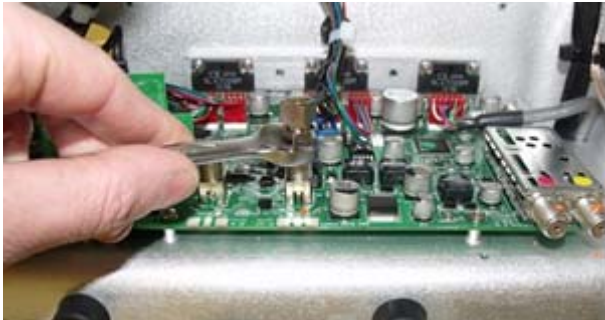
<p>3. Now disconnect the communications cable from the main PCU PCB using a 7/16" wrench.</p>

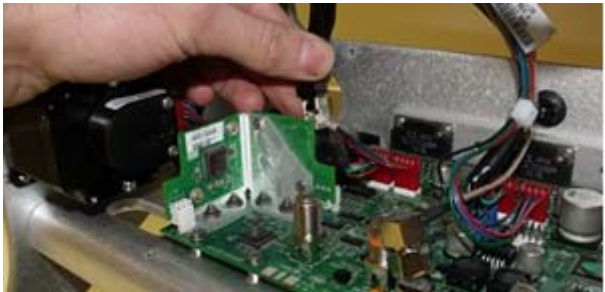
<p>4. Remove the GPS antennas RJ-45 connector from the PCU PCB.</p>

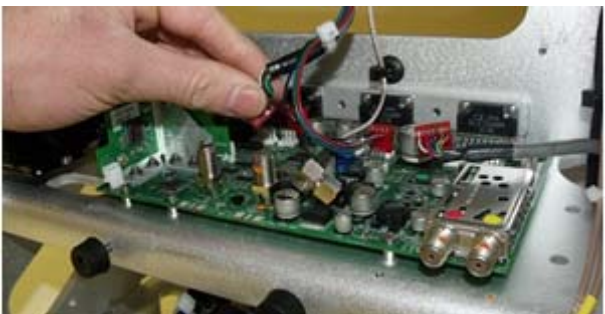
<p>5. Disconnect the azimuth elevation and pol motor and encoder IDC connectors from the PCU PCB.</p>

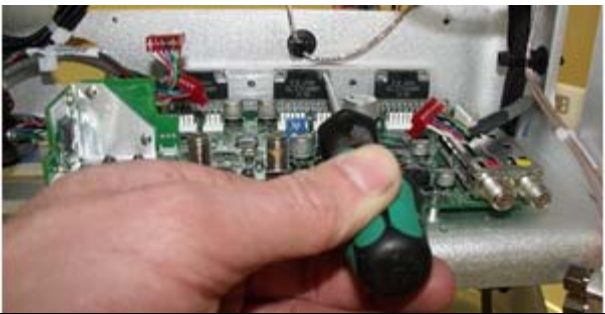
<p>6. Remove the six screws securing the PCU PCB's heat sinks to the back of the yoke using a #1 Phillips screwdriver. Save the hardware for future use.</p>

<p>10. Reinstall the six screws removed in step 6 to secure the heat sinks to the yoke.</p>

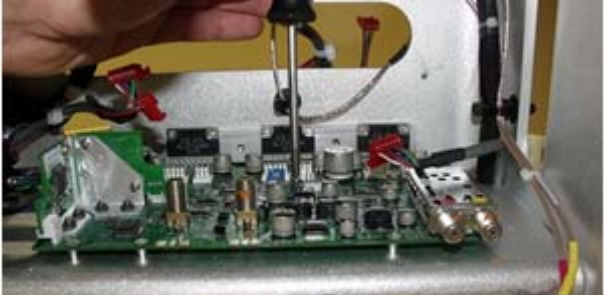
<p>7. Remove the 8 screws securing the PCU PCB to the yoke, save the hardware for future use.</p> <p>*Note: The orientation of the screws is shown below.</p>

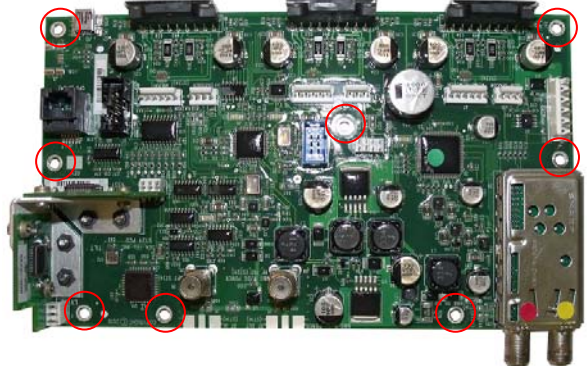
<p>8. The 8 mounting points of the PCU PCB.</p>

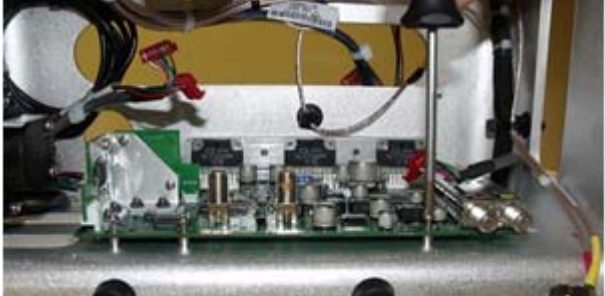
<p>9. Install the replacement PCU PCB using the hardware removed in the previous step applying Loctite 248 to the threads.</p>

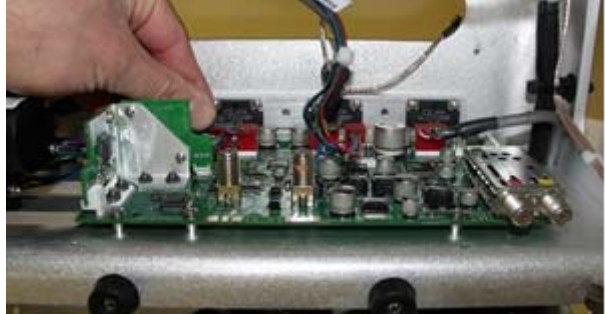
<p>11. Connect the azimuth, elevation and pol motor and encoder IDC connectors to the PCU PCB.</p>

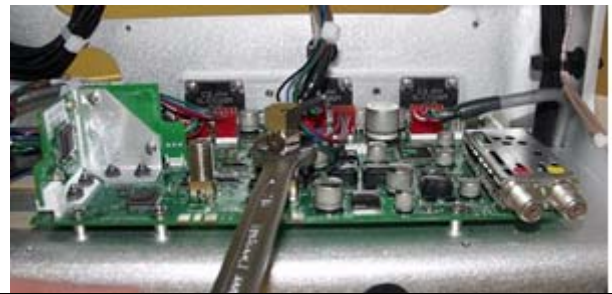
12. Reconnect the communication coax cable to the PCU PCB.

***Note:** The communications connector is the one in the center of the PCU PCB.

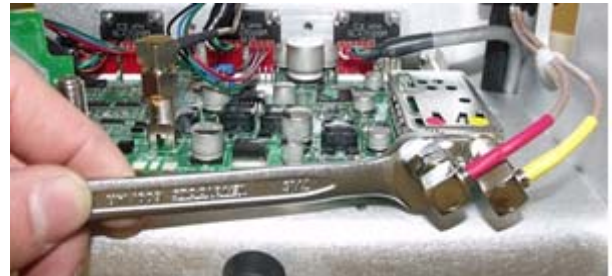
13. Reconnect the RF coax cables to the DVB tuner, with the yellow cable on the right & the yellow on the left. Angle the cables as shown in the image on the right.

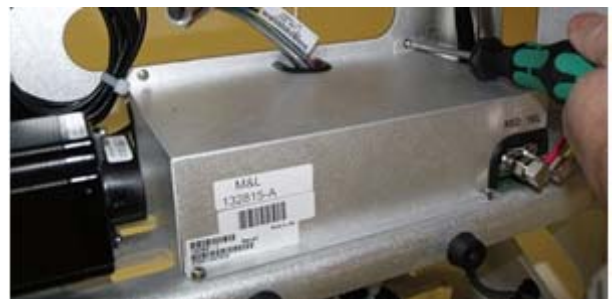
14. Apply Loctite 248 to the hardware removed in step 1 and reinstall the PCU PCB cover to the yoke.
