**Field Service Spares Replacement Procedure – Pol Motor Kit, ST24**

# ***Field Service Procedure – Replacement Pol Motor Kit, ST24***

Troubleshooting document for diagnosing a fault with and replacing the pol motor on the ST24 antenna.

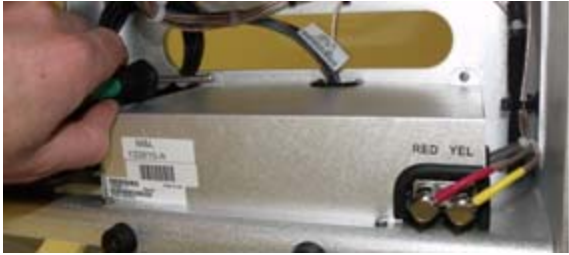
<p><b>*Caution:</b> Power down the pedestal before following this procedure.</p> <p>1. Using a #1 Phillips screwdriver remove the 4 screws securing the PCU cover to the yoke and remove it. Save the hardware for future use.</p>

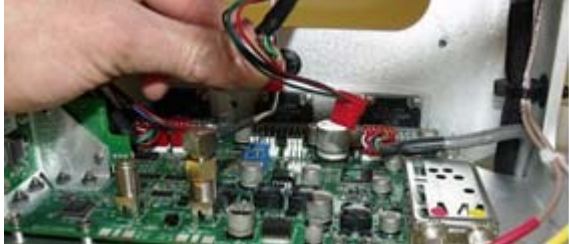
<p>2. Disconnect the pol motor and encoder IDC connectors from the PCU PCB.</p>

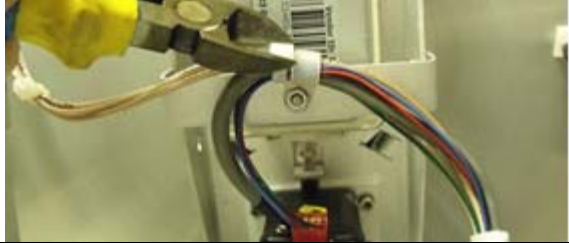
<p>3. Using a pair of snips cut the cable ties securing the pol motor harness to the coax cables.</p>

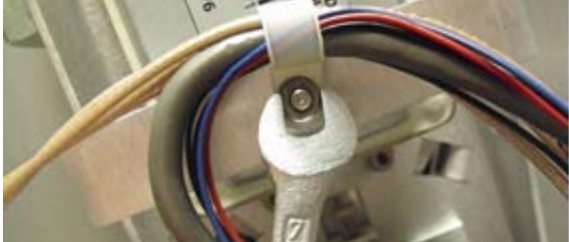
<p>4. Remove the P-clip securing the pol motor harness to the bracket using a 7mm wrench. Save the hardware for future use.</p>

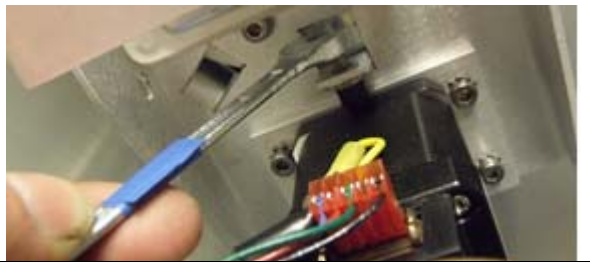
<p>5. Back off the pol motor tensioning screw by undoing the bolt using a 7mm wrench.</p>

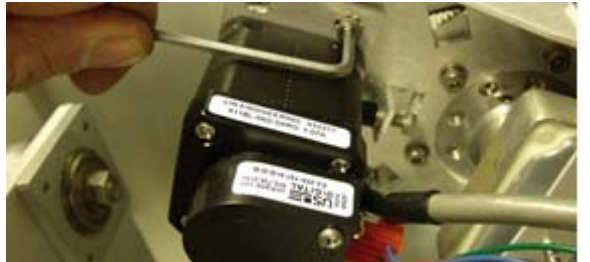
<p>6. Remove the four screws which mount the pol motor assembly to the feed using a 3mm Allen wrench.</p>

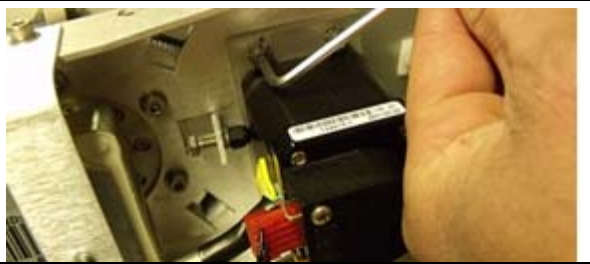
<p>7. Install the replacement motor assembly with the motor and coax cable pointing upwards. Install with the hardware removed from the previous step and apply Loctite 242 to the threads. Do not fully tighten at this time.</p>

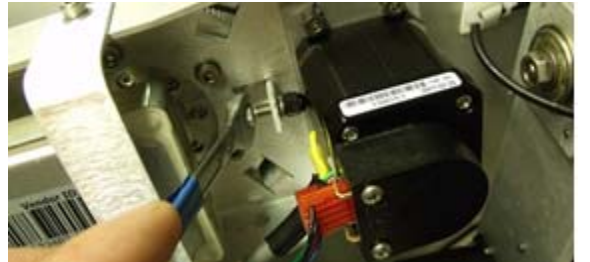
<p>8. Apply Loctite 242 to the thread of the tensioner bolt and adjust the belt tension by tightening the screw, checking the tension periodically as per the next step.</p>

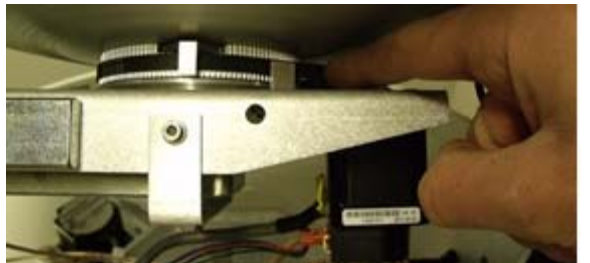
<p>9. Verify the belt tension by pressing the central point between the main drive sprocket and motor pulley. The belt tension should have some give in it being tight enough that the belt won't skip on the teeth of the sprockets.</p>

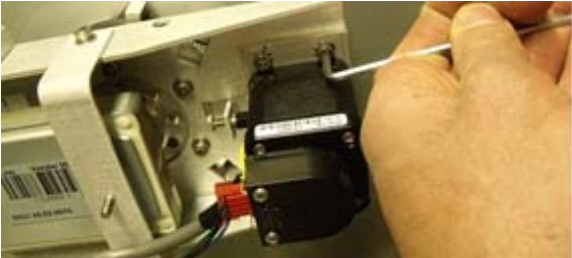
<p>10. Once complete tighten the four screws and verify the tension again. If the tension needs adjusting repeat steps 8 and 9.</p>

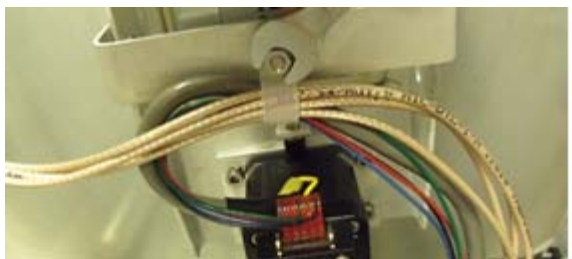
<p>11. Secure the pol motor, encoder and coax cables, with the P-clip removed in step 4 and install the securing nut and washer. Apply Loctite 242 to the thread.</p>

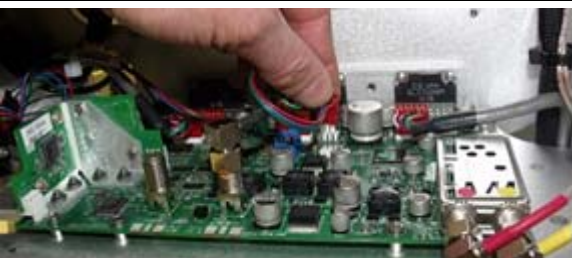
<p>12. Connect the replacement pol motor and encoder IDC connectors to the PCU PCB.</p>

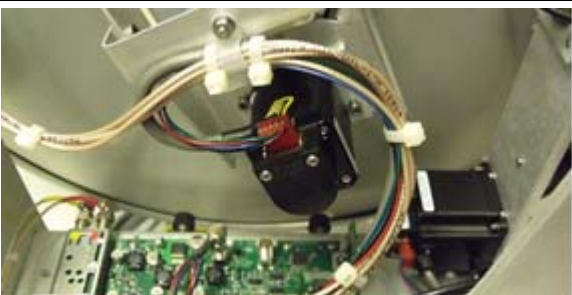
<p>13. Secure the pol motor, encoder harnesses and coax cables with cable ties.</p> <p><b>*Note:</b> ensure the feed assembly has enough slack on the cables to rotate full, check and adjust if necessary.</p>
