Field Service Spares Replacement Procedure – EL Motor Kit, ST24

Field Service Procedure – Replacement EL Motor Kit, ST24

Troubleshooting document for diagnosing a fault with and replacing the elevation motor and encoder on the ST24 antenna.

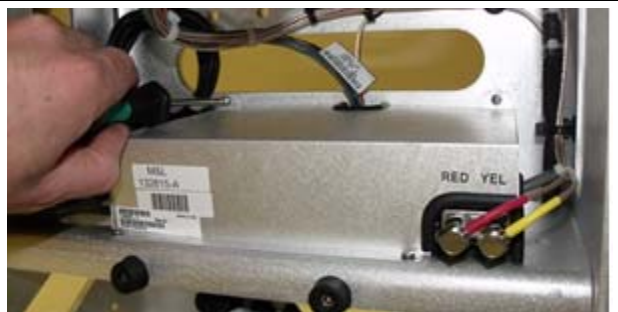
1. Using a #1 Phillips screwdriver remove the 4 screws securing the PCU PCB cover to the yoke. Save the hardware for future use.

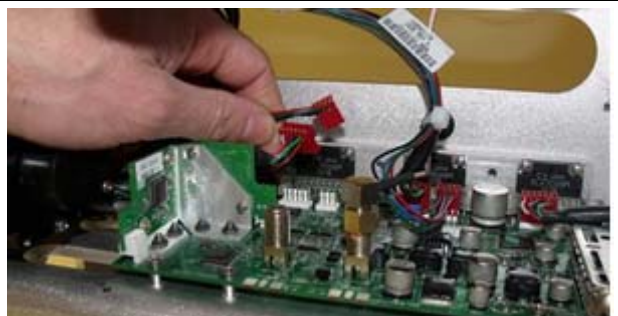
2. Disconnect the elevation motor and encoder IDC connectors from the PCU PCB.

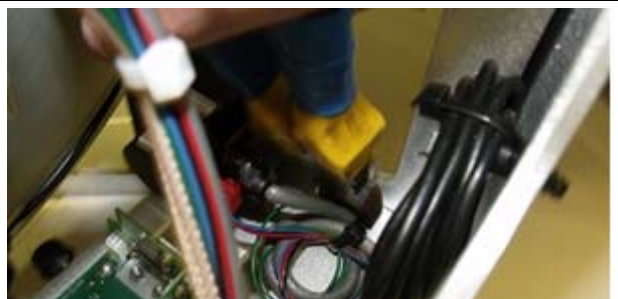
3. Cut the cable ties securing the elevation motor and encoder harnesses to the yoke using a pair of snips.

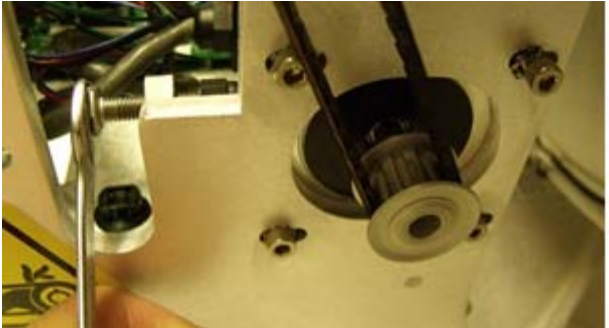
<p>4. Back off the tensioning bolt using a 10mm wrench.</p>

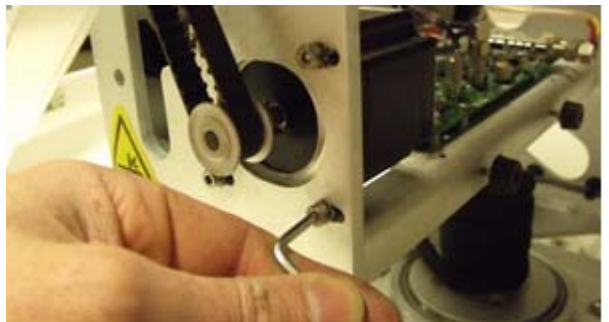
<p>5. Remove the 4 screws securing the motor assembly to the yoke and remove the defective motor. Save the hardware for future use.</p>

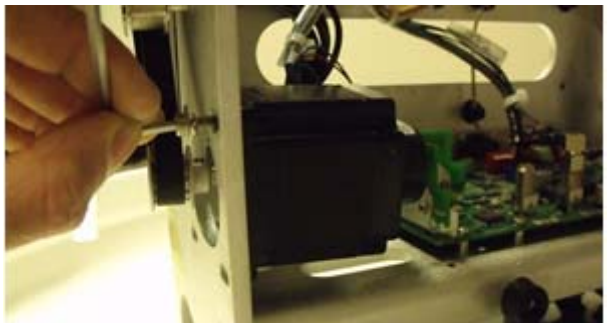
<p>6. Install the replacement motor assembly with the harness pointing to the rear or the pedestal. Apply Loctite 242 to the threads of the hardware removed in the previous step. Do not fully tighten them at this time.</p>

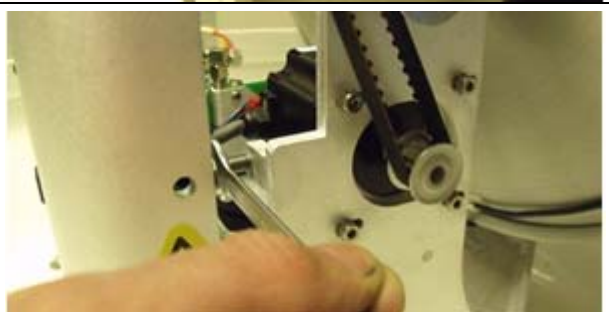
<p>7. Apply Loctite 242 to the thread of the tensioning screw and tighten it, checking the belt tension periodically as per the following step.</p>

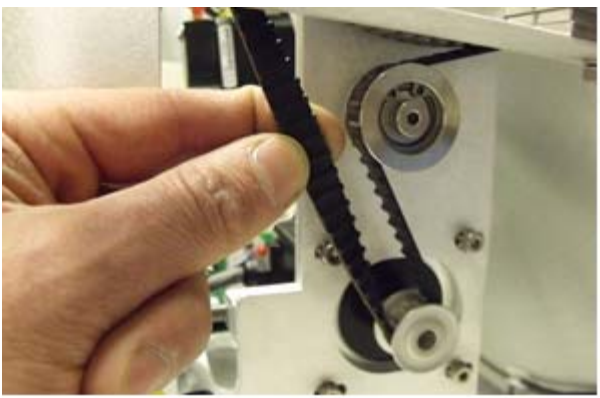
<p>8. Verify the belt tension by rotating the belt at the central point between the main drive sprocket and motor pulley. The belt should be easily rotated through to 90 degrees at which point it should become tight.</p> <p>If the belt can easily be rotated past 90 degrees the tension is too loose, if it can't be rotated to 90 degrees the tension is too tight.</p> <p>9. Once complete tighten the 4 motor mounting screws and re-check the belt tension. Adjust if necessary.</p>

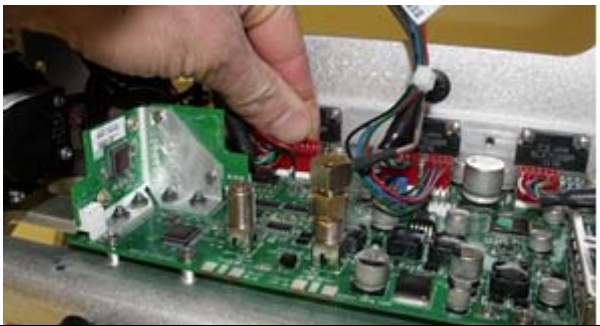
<p>10. Connect the elevation motor and encoder IDC connectors to the PCU PCB.</p>

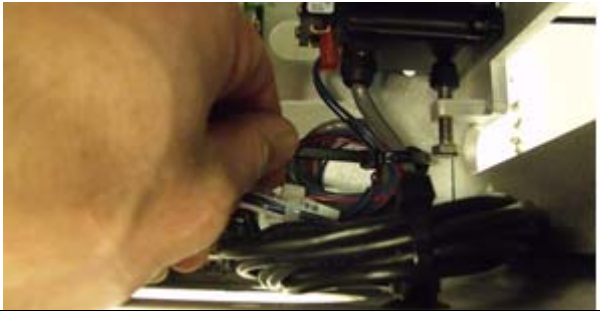
<p>11. Secure the elevation motor and encoder harnesses to the yoke using a cable tie.</p>
