Field Service Spares Replacement Procedure – AZ Motor Kit, ST24

Field Service Procedure – Replacement AZ Motor Kit, ST24

Procedure for replacing the azimuth motor, Sea Tel kit part number: 135919 (azimuth motor assembly part number: 132499-1).

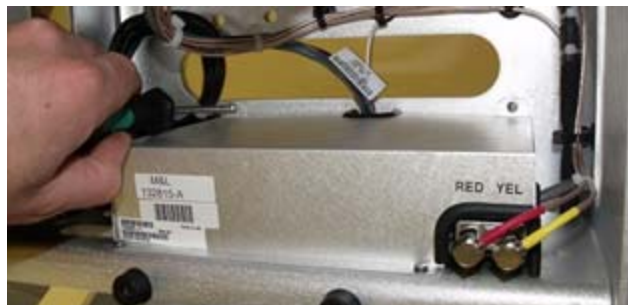
<p>*Caution: Power down the pedestal before following this procedure.</p> <p>1. Using a #1 Phillips screwdriver remove the four screws securing the PCU PCB cover to the yoke and remove it. Save the hardware for future use.</p>

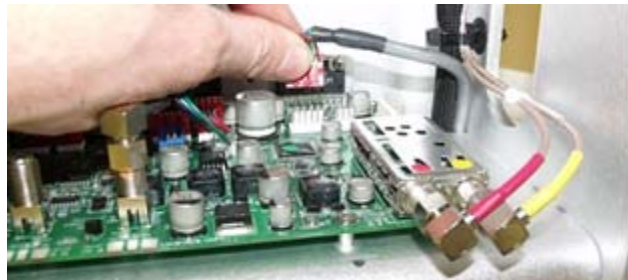
<p>2. Disconnect the azimuth motor IDC connector from PCU PCB.</p>

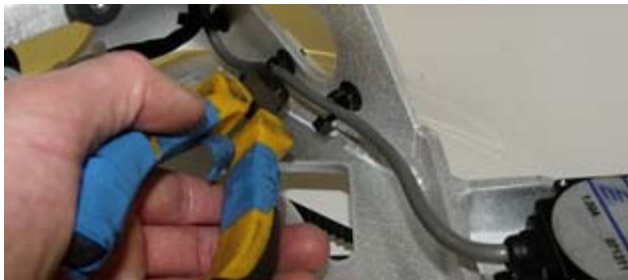
<p>3. Using a pair of cutters snip the cable ties securing the azimuth motor harness to the yoke.</p>

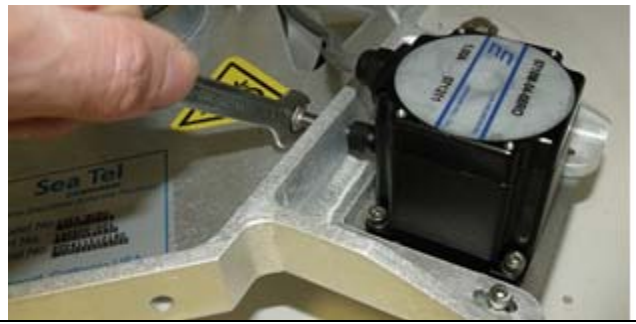
4. Using a 10mm wrench back of the tensioning nut from the azimuth motor.

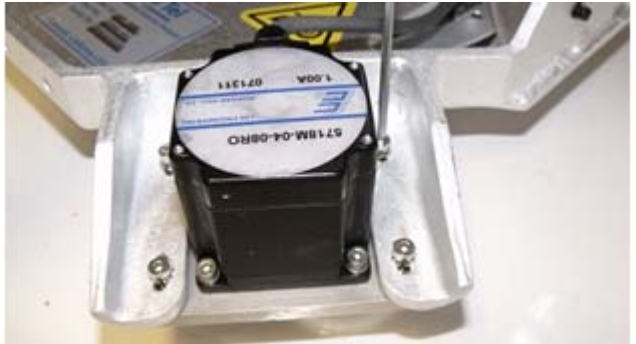
5. Undo the four screws mounting the azimuth motor assembly to the yoke. Save the hardware for future use.

***Note:** Undo the outer screws for the motor plate, not the screws mounting the motor to the plate (as shown on the right).

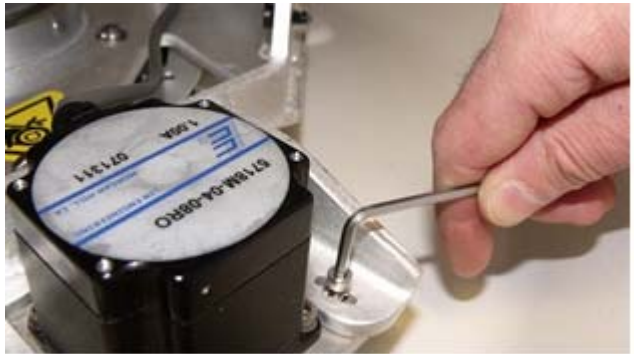
6. Install the replacement motor assembly by slipping the pulley through the belt ensuring it's correctly installed on the tensioning wheel (located under the yoke and in front of the motor mounting point).

7. Align the motor assembly with the harness facing towards the pedestal and apply Loctite 242 to the hardware removed in the previous step. Do not fully tighten the hardware at this time.

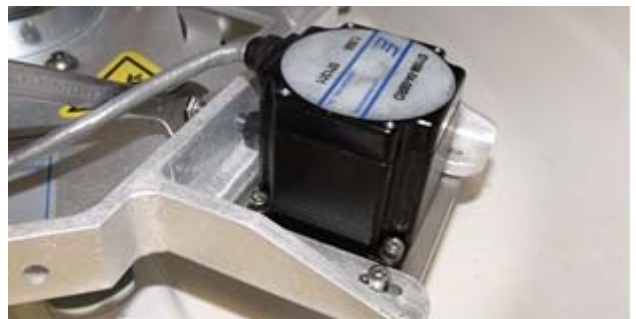
8. Apply Loctite 242 to the thread of the tensioning screw and tighten it using a 10mm wrench. Periodically check the belt tension as per the following step.

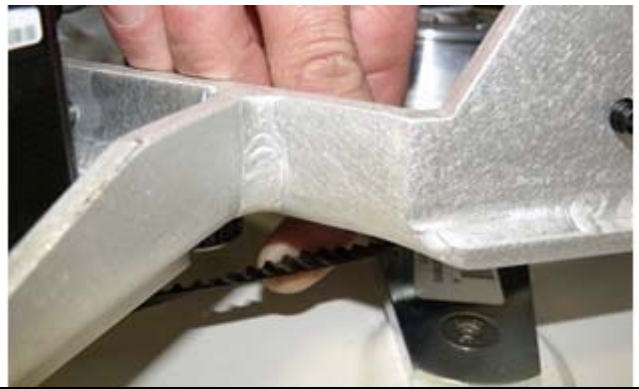
9. Verify the belt tension by rotating the belt at the central point between the main drive sprocket and motor pulley. The belt should be easily rotated through to 90 degrees at which point it should become tight. If the belt can easily be rotated past 90 degrees the tension is too loose, if it can't be rotated to 90 degrees the tension is too tight.
10. Once complete tighten the 4 motor mounting screws and re-check the belt tension. Adjust if necessary.

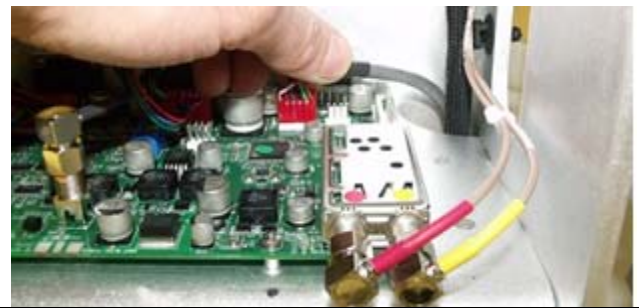
11. Connect the azimuth motor IDC connector to the PCU PCB.

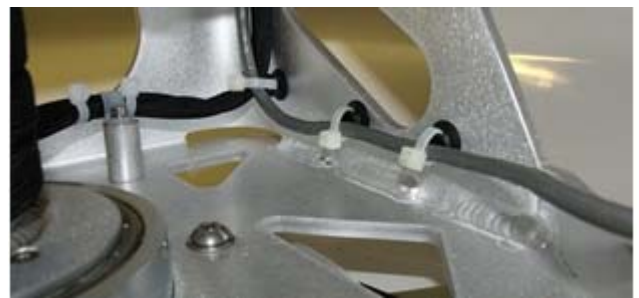
12. Secure the azimuth motor harness to the yoke, using cable ties.

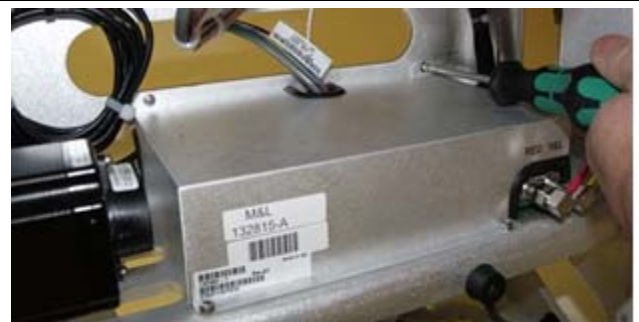
13. Refit the PCU PCB cover using the hardware removed in step 1. Apply Loctite 242 to the threads.
