## Field Service Spares Replacement Procedure - PCU Kit, Coastal

Document No 135553 Rev A
-------------	---	-----------------------------

# ***Field Service Procedure – Replacement PCU Kit, Coastal***

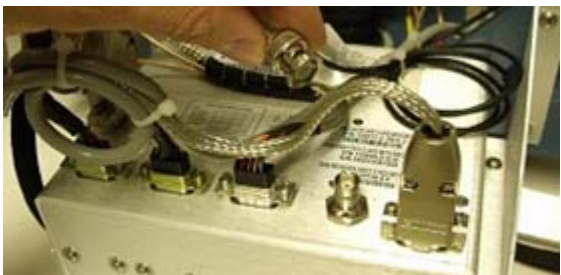
<p><b>*Caution:</b> Power down the pedestal before following this procedure.</p> <p>1. Disconnect the BNC connector for the GPS antenna from the PCU.</p>

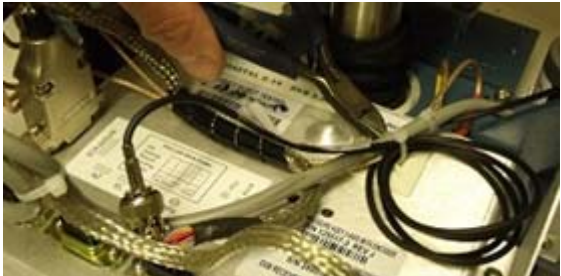
<p>2. Snip the cable tie securing the GPS antenna cable, coax cables and azimuth motor cable to the PCU.</p>

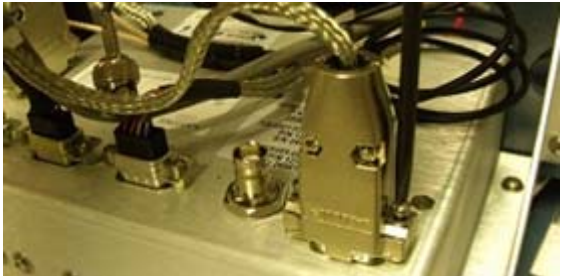
<p>3. Using a 2mm flat blade screw driver undo the two screws securing the encoder harness to the PCU.</p> <p><b>*Note:</b> The Coastal 18 and older model Coastal antennas do not have an encoder on the elevation motor.</p>

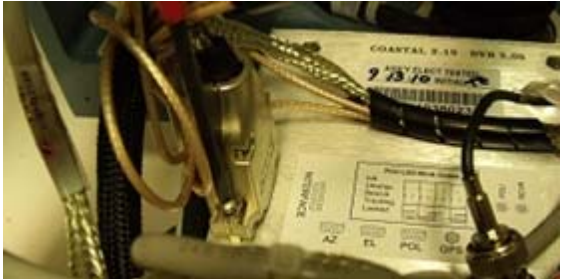
<p>4. Using a 2mm flat blade screwdriver disconnect the interface harness from the PCU.</p>

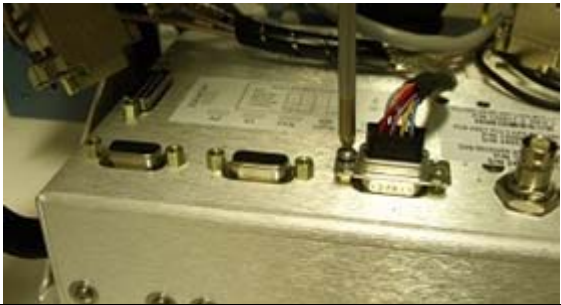
<p>5. Now using a #1 Phillips screwdriver remove the six screws securing the AZ, EL and POL motor connections to the PCU. Be careful not to lose the 6 split washers and save the hardware for future use.</p>

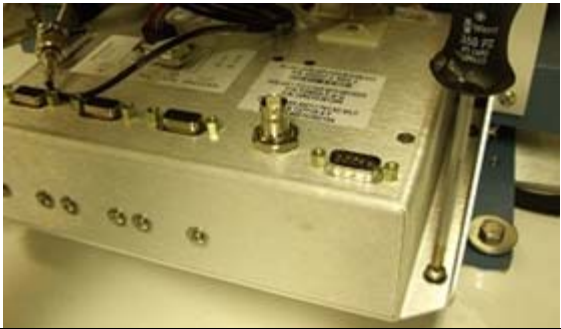
<p>6. Using a #1 Phillips screwdriver remove the four screws securing the PCU to the mounting plate.</p> <p><b>*Note:</b> Do not remove the PCU at this time as the coax cables are still connected.</p>

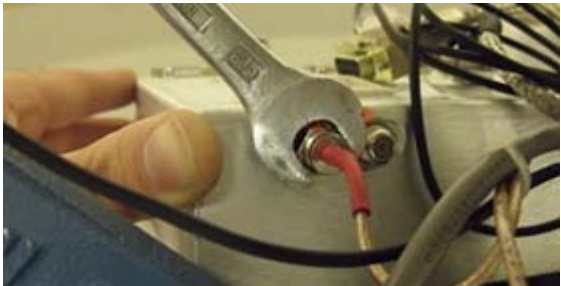
<p>7. Raise the PCU from the mounting plate to allow clearance and disconnect the two coax cables from the PCU using a 7/16" wrench, noting the orientation of the RF in and RF out cables.</p>

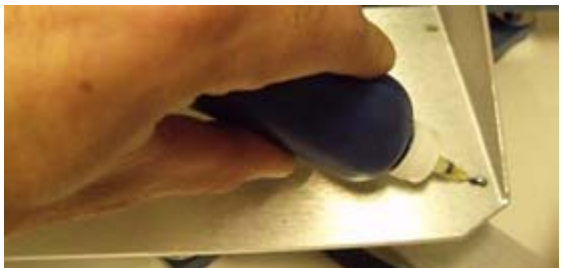
<p>8. Apply Loctite 242 to the four holes on the PCU mounting plate.</p>

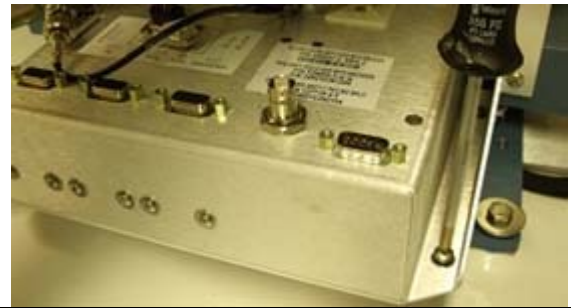
10. Reinstall the four screws and washers that secure the PCU to its mounting bracket.

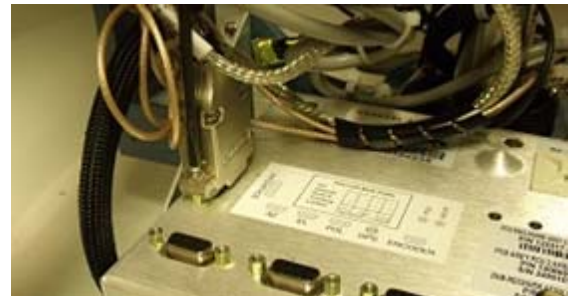
11. Connect the interface harness to the replacement PCU.

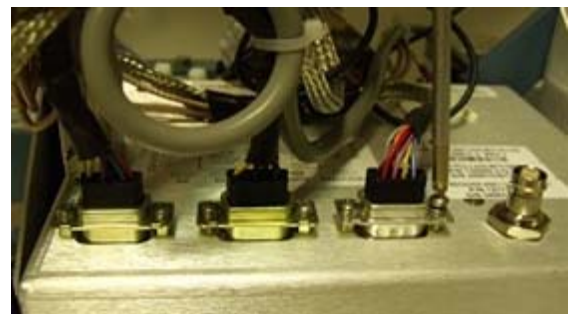
12. Install the 6 screws and washers to secure the AZ, EL and POL motor harnesses to the replacement PCU, no need to apply Loctite as split washers are used.

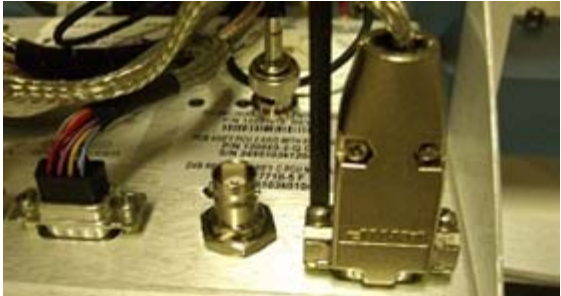
<p>13. Install the elevation encoder harness to the PCU.</p> <p><b>*Note:</b> If replacing the PCU on a coastal 18 or older model with no encoder this connection will be left empty.</p>

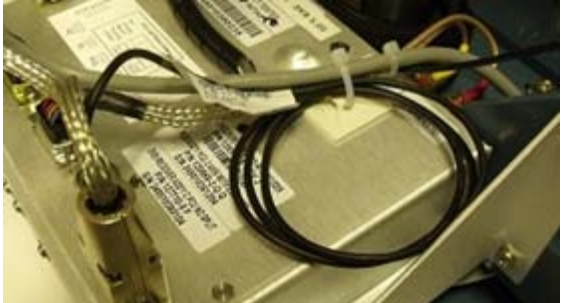
<p>14. Secure the coax cables, azimuth motor harness and GPS antenna cable to the tie holder installed on top of the PCU using a cable tie.</p> <p>15. Reconnect the GPS antennas BNC connector to the PCU.</p>
