**Field Service Spares Replacement Procedure – EL Motor Kit, USAT**

# ***Field Service Procedure – Replacement EL Motor Kit, USAT***

Troubleshooting document for diagnosing a fault with and replacing the elevation motor on the USAT series antennas.

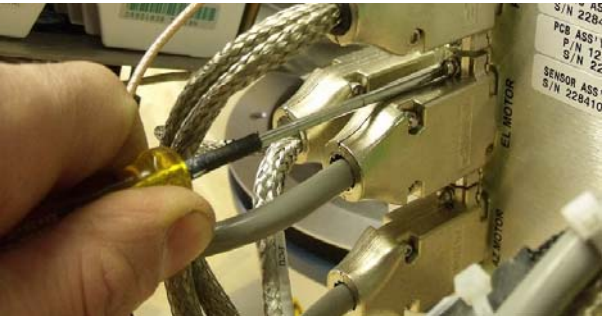
<p><b>*Caution:</b> Power down the pedestal before following this procedure.</p> <p>1. Using a 2mm flat blade screwdriver disconnect the elevation motors D-sub connector from the PCU.</p>

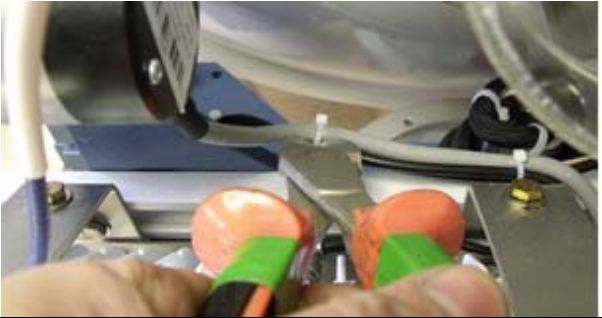
<p>2. Cut the cable ties securing the elevation motor harness using a pair of cutters.</p>

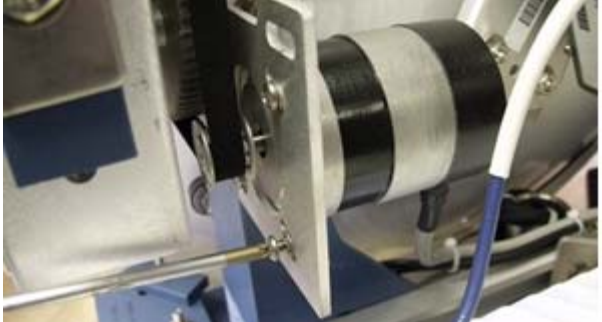
<p>3. Using a #1 Phillips screwdriver remove the 3 visible screws securing the elevation motor to its bracket. Save the hardware for future use.</p> <p><b>*Note:</b> Rotate the elevation axis to its upper end stop to allow access to the screws.</p>

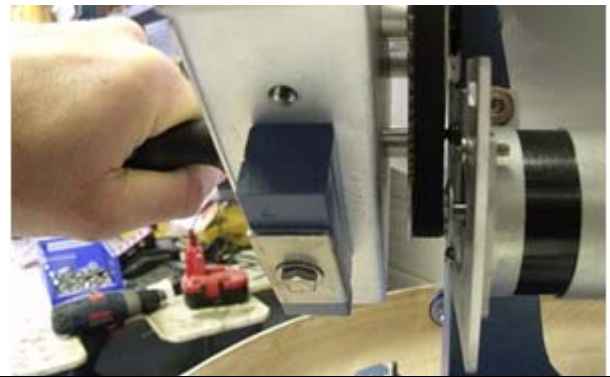
4. Remove the 4<sup>th</sup> screw by aligning the holes in the EL pan and elevation pulley to allow access to the screw head, undo using a #1 Phillips screwdriver and remove the motor.

**\*Note:** Once removed the 4<sup>th</sup> screw will rest on the inside of the elevation pulley.

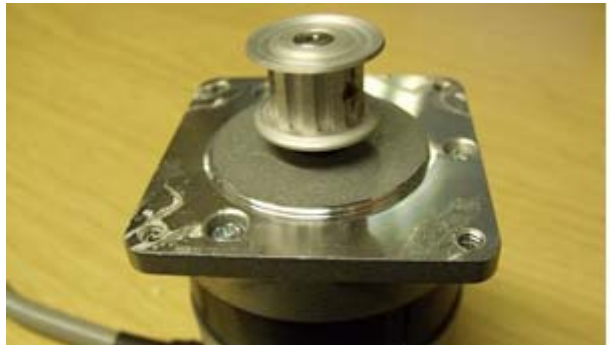
5. In the same orientation as on the defective motor install the new pulley to the replacement motor, applying Loctite 638 to the shaft. Apply Loctite 222 to the set screw and install it into the pulley, making sure it's aligned with the flat edge of the motor shaft. Tighten the set screw with a 1/16" Allen wrench.

**\*Note:** For further information refer to the Loctite Procedure 121730 provided with this kit.

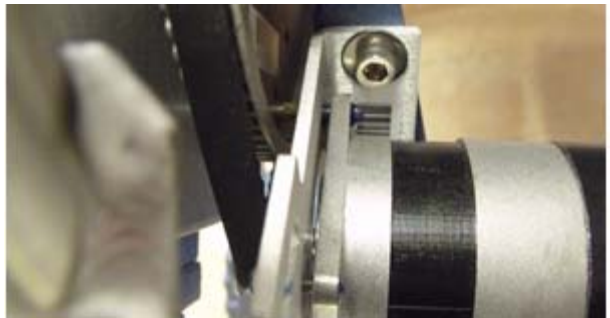
6. Apply Loctite 242 to the hardware removed in step 3 and install the replacement motor assembly, with the cable pointing downwards. For the 4<sup>th</sup> screw apply the Loctite to the thread of the motor. Do not fully tighten the screws at this time.

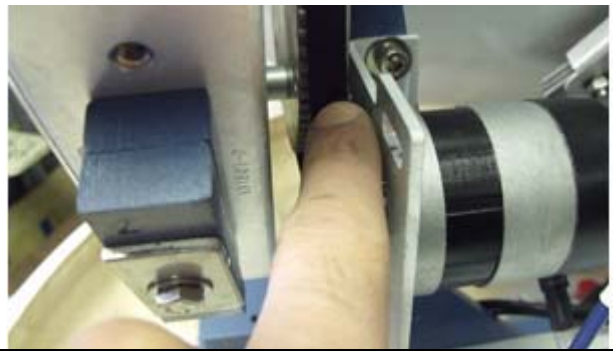
8. Verify the tension of the belt by pressing on it at the central position between the motor pulley and the main drive sprocket. There should be a little give, but the belt should be tight enough that the axis will drive correctly, without skipping on the teeth of the pulley.  
If the belt is too tight/loose repeat the previous step until the belt tension is correct and tighten all four of the screws.

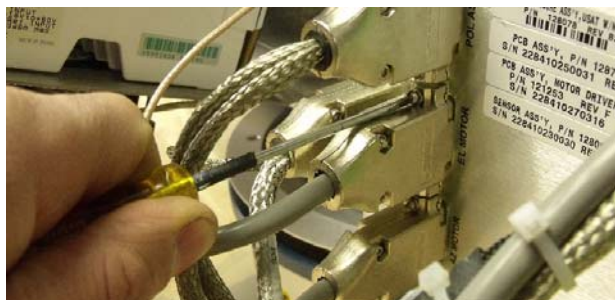
9. Install the elevation motors D-sub connector to the PCU using a 2mm flat blade screwdriver.

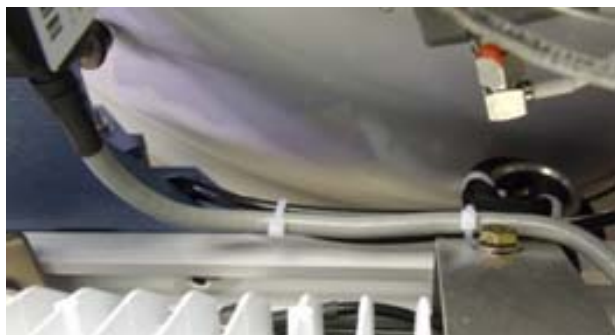
10. Secure the elevation motor harness using cable ties.
