Field Service Spares Replacement Procedure – AZ Motor Kit, USAT

Page 1 of 1	Sea Tel <small>COBHAM</small>	Document No 135931 Rev A
-------------	---	-----------------------------

Field Service Procedure – Replacement AZ Motor Kit, USAT

Troubleshooting document for diagnosing a fault with and replacing the azimuth motor on the USAT series antennas.

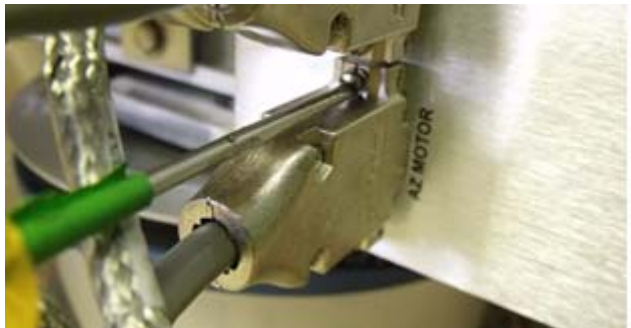
<p>*Caution: Power down the pedestal before following this procedure.</p> <p>1. Using a 2mm flat blade screw driver disconnect the azimuth motor D-sub connector from the PCU.</p>

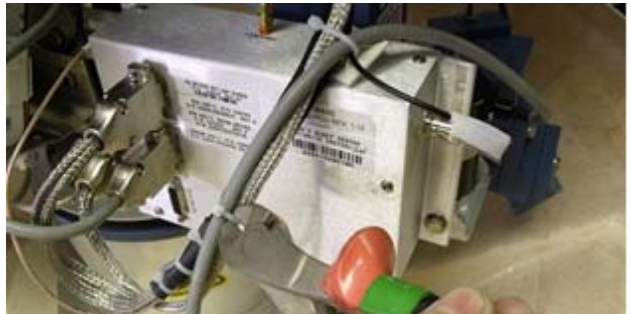
<p>2. Cut the cable ties securing the azimuth motor harness using a pair of cutters.</p>

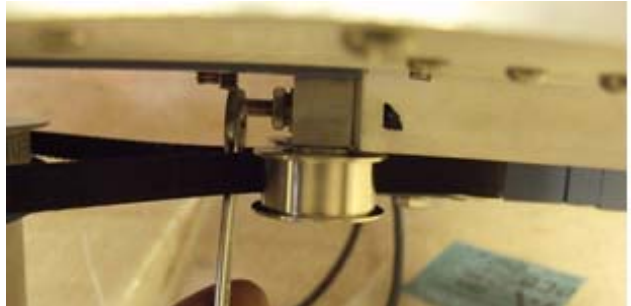
<p>3. Now using an 8mm wrench back of the tensioning screw on the underside of the motor bracket to allow the motor to be removed.</p>

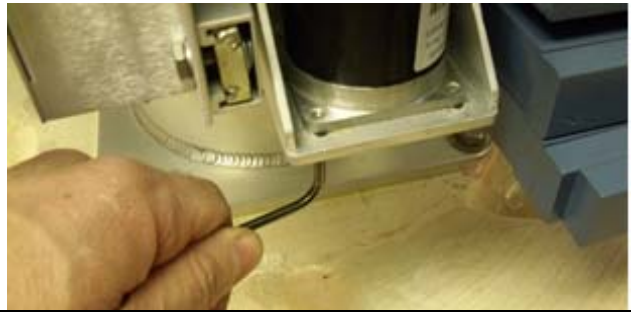
4. Now using a 9/64" Allen wrench remove the four screws securing the azimuth motor to its bracket and remove the motor assembly. Save the hardware for future use.

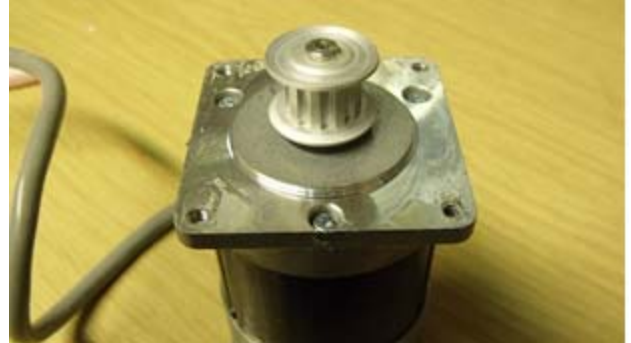
5. Apply Loctite 638 to the shaft of the replacement motor and fit the pulley in the same position as the one on the defective motor. Fit the set screw into the pulley with Loctite 222 using a 1/16" Allen wrench.

***Note:** For further information refer to the Loctite Procedure 121730 provided with this kit.

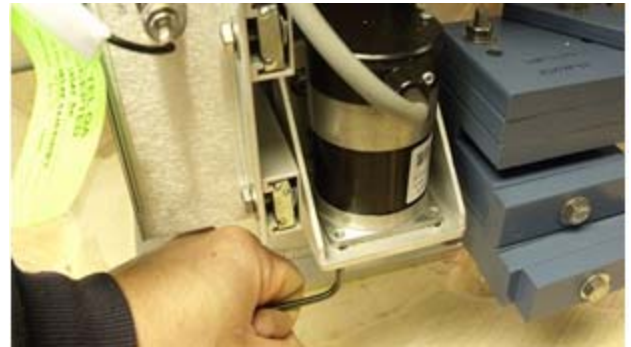
6. Apply Loctite 242 to the hardware removed in step 4 and loosely install the replacement azimuth motor assembly, slotting the motor pulley into the azimuth belt.

***Note:** Install the motor with the harness facing away from the pedestal (as shown on the right).

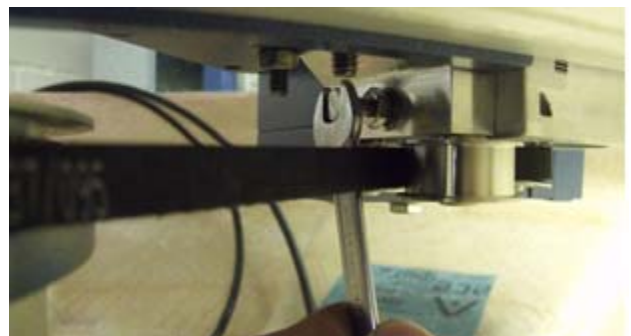
7. Ensure the belt is correctly installed over the motor pulley and in between the tensioning wheels and tighten the belt tensioning screw using an 8mm wrench.

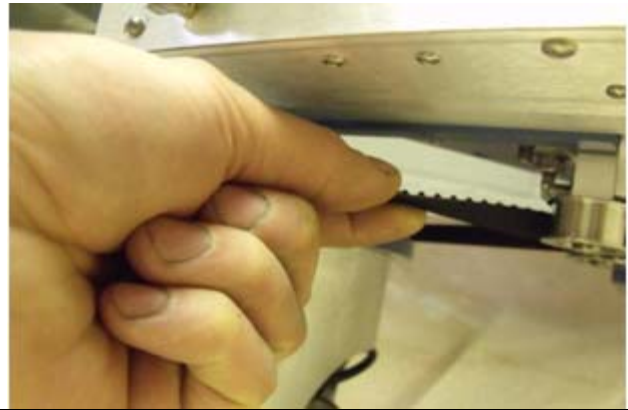
8. While adjusting the tensioning screw periodically verify the belt tension by rotating it at the central point between the tensioning wheel and main sprocket. The belt should easily rotate to 90 degrees and then become stiff, if the belt can easily be rotated past 90 degrees it's too loose, if the belt becomes stiff before 90 degrees it's too tight.

9. Once satisfied with the belt tension tighten the four motor screws using a 9/64" Allen wrench. Verify the belt tension is still correct and adjust if necessary.

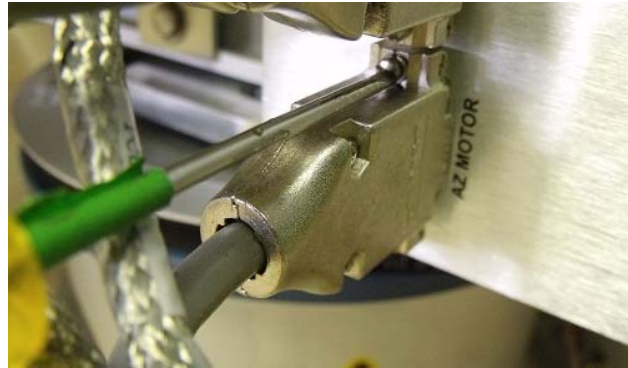
10. Connect the azimuth motor D-sub connector to the PCU tighten the retaining screws using a 2mm flat blade screw driver.

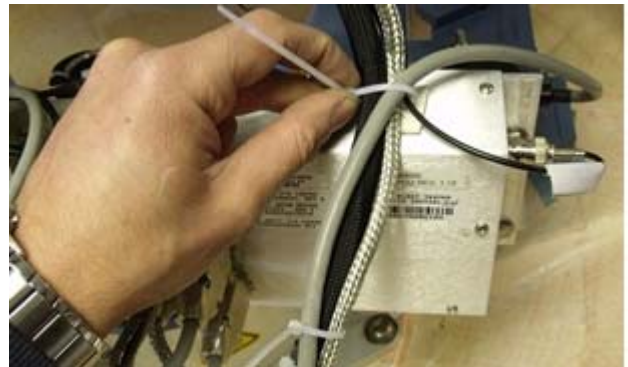
11. Secure the azimuth motor harness using cable ties.
