**Field Service Spares Procedure – Replacement PCU Assembly Kit,
XX09 MK2, XX10, XX11 & XX11QOR**

Field Service Procedure – Replacement PCU Assembly Kit, XX09 MK2, XX10, XX11 & XX11QOR

Troubleshooting document for diagnosing a fault with and replacing the PCU assembly on the XX09 MK2, XX10, XX11 and XX11QOR series antennas.

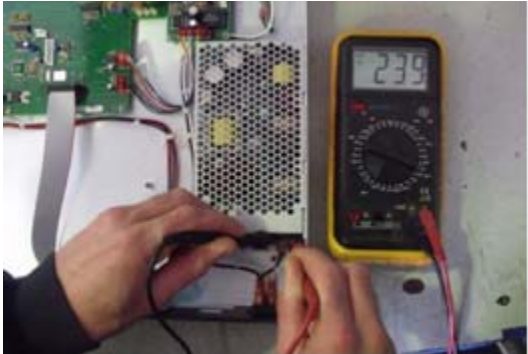
<p>*Caution: Electrical Hazard - Dangerous AC voltages exist on the power supply. Observe proper safety precautions when working on the power supply.</p> <ol style="list-style-type: none">1. Remove the cover from the PCU to allow access to the power supply for testing.2. Measure the input voltage into the power supply on the 2 pins to the right of the connection block, 110 - 240 volts AC should be present. If no AC voltage is present verify the unit is switched on. If there is still no voltage present troubleshoot the source.

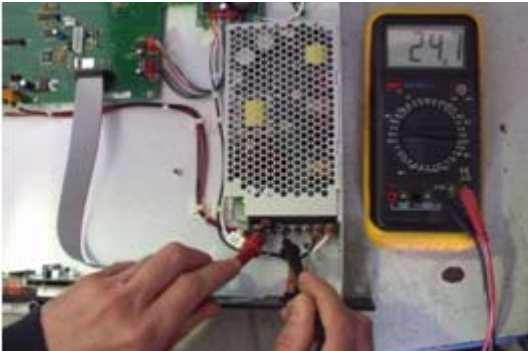
<ol style="list-style-type: none">3. Now measure the output voltage from the power supply on the 2 pins to the left of the connection block, the output should be 24VDC. <p>*Note: This procedure shows a DAC-2202 in the images; however the DAC and PCU power supply is the same component so the procedure is the same.</p>

If the units AC input has been verified and the 24VDC is not present, the power supply is defective. If the power supply is outputting the 24VDC consistently then the power supply is operational and the problem lies elsewhere (possible failure with the PCU, DAC motherboard or harness connection).

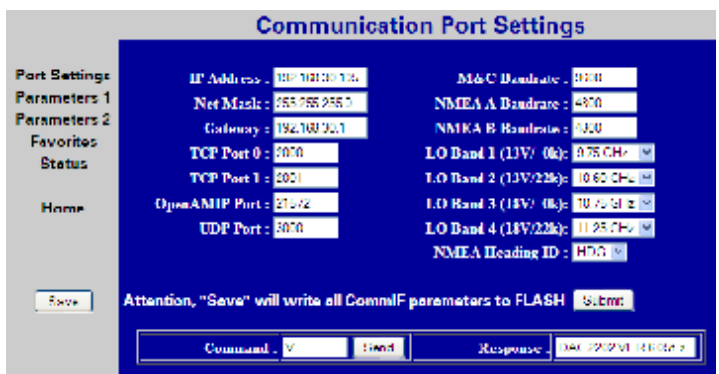
<ol style="list-style-type: none"> 1. Logon to the ACU's Internal HTML page. 2. Browse to the "Communication Port Settings" page.

3. In the Command Window, Type in the desired Modem Query and hit Send.

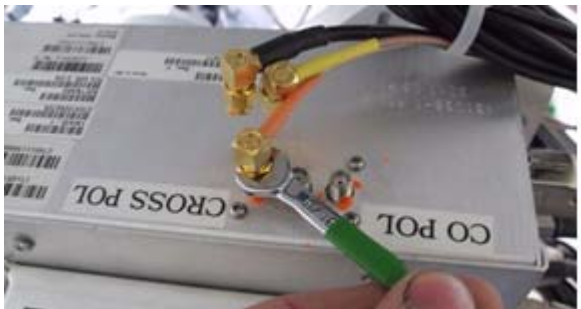
<p>*Caution: Power down the pedestal before following this procedure.</p> <p>1. Using a 5/16" wrench disconnect the three SMA cables from the coax switch inside the PCU assembly.</p>

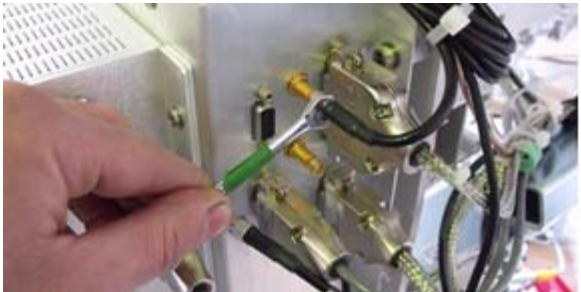
<p>2. Now disconnect the SMA cables from the rotary joint connector and L-band connector from the coax switch into the ADE 400MHz modem PCB inside the PCU assembly, using a 5/16" wrench.</p>

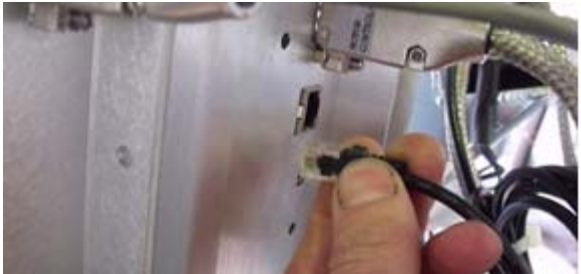
<p>3. By hand disconnect the RJ-45 connector for the GPS antenna from the socket on the PCU motherboard PCB inside the PCU assembly.</p>

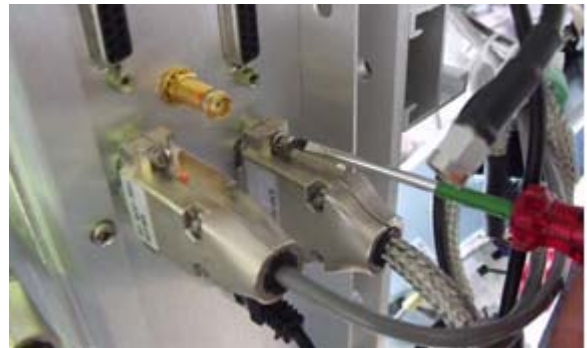
4. Using a 2mm flat blade screwdriver remove the 25-pin D-sub connector for the reflector harness and the 15-pin D-sub connector for the MDE harness from their termination points on the PCU motherboard PCB.

5. Now remove the 9-pin D-sub connector for the RF communications into the 400MHz modem PCB.

***Note:** The RF communications will only be connected if the BUC on the system supports this function.

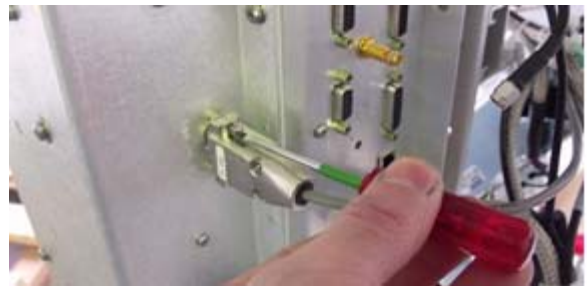
6. Now disconnect the 9-pin D-sub connector for the DC power to the BUC from the BUC power supply assembly which is installed on the XX09 MK2 PCU assembly, using a 2mm flat blade screwdriver.

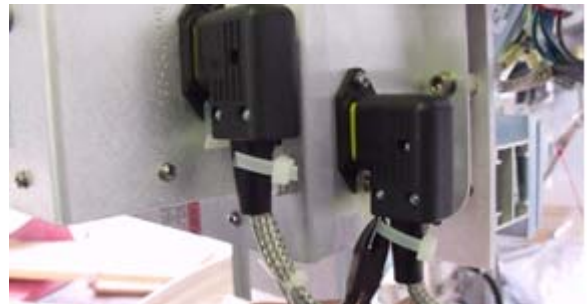
7. Using a pair of cutters cut the cable ties securing the AC power input connections to both the BUC power supply and the PCU assembly and disconnect the socket connectors.

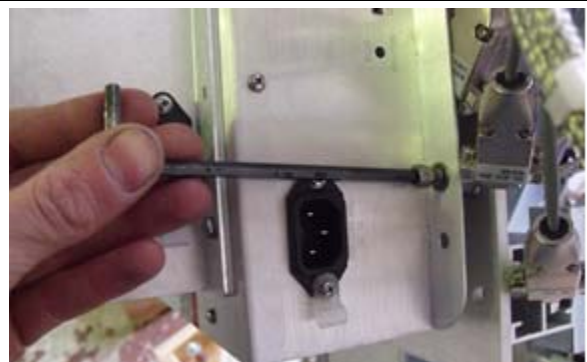
8. Verify all the connections from the PCU assembly and BUC power supply have been removed and undo the four screws securing the PCU assembly to the equipment frame, using a 3/16" Allen wrench.

***Note:** The BUC power supply will still be attached to the PCU assembly at this point. Support the weight of the PCU assembly and power supply whilst undoing the hardware and remove as one. Save the hardware for future use.

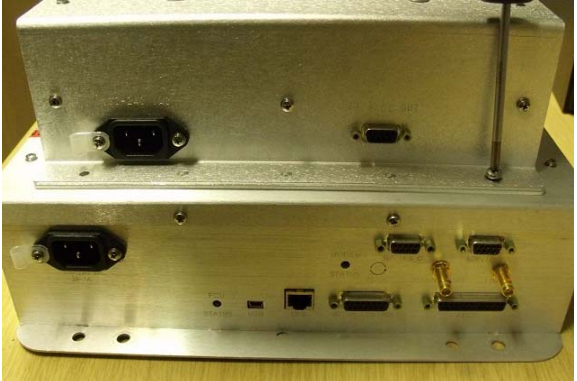
<p>9. Using a #1 Phillips screwdriver undo the four screws securing the BUC power supply to the top of the PCU assembly.</p> <p>10. Retain the hardware from the previous step and install the BUC power supply to the replacement PCU assembly, ensuring the AC input sockets are facing the same direction. Apply Loctite 242 to the threads.</p> <p>*Note: Depending on your antenna model the BUC power supply may not be installed on the PCU assembly.</p>

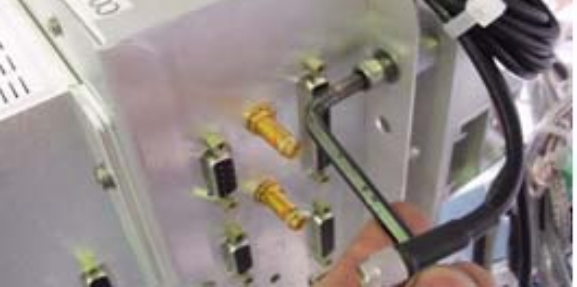
<p>11. Now using the hardware removed in step8 reinstall the replacement PCU and BUC power supply assembly to the equipment frame using a 3/16" Allen wrench, applying Loctite 242 to the threads.</p>

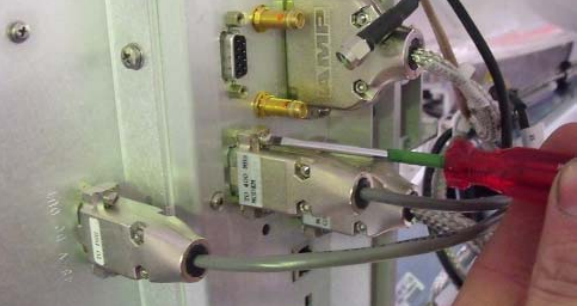
<p>12. Reconnect the harness D-sub connectors to the replacement PCU assembly and BUC power supply using a 2mm flat blade screwdriver.</p> <p>*Note: The RF communications (if supported by your system) and DC BUC power supply harnesses are both male 9-pin D-sub connectors, ensure the labels on the connectors are correct for the application.</p>

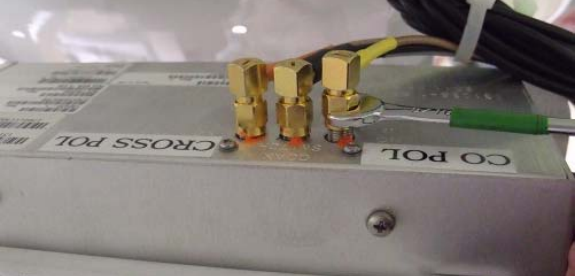
<p>13. Reconnect the SMA cables to the coax switch using a 3/8" wrench in the following order:</p>

Co-Pol	-	Yellow	400MHz Modem	-	Black	Cross-Pol	-	Orange

Co-Pol	-	Yellow								
400MHz Modem	-	Black								
Cross-Pol	-	Orange

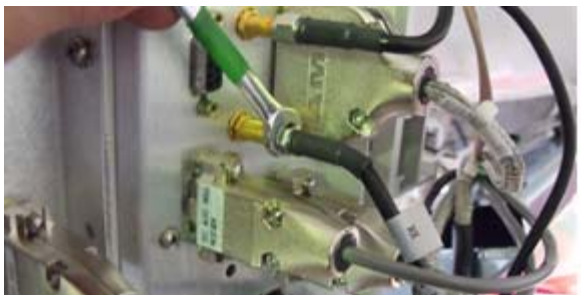
<p>14. Reconnect the SMA cable from the coax switch into the L-band SMA connector (as shown on the right using a 5/16" wrench and the coax cable from the rotary joint into the lower SMA connector on the 400MHz modem PCB.</p> <p>15. Reconnect the GPS antennas RJ-45 connector to the replacement PCU.</p>

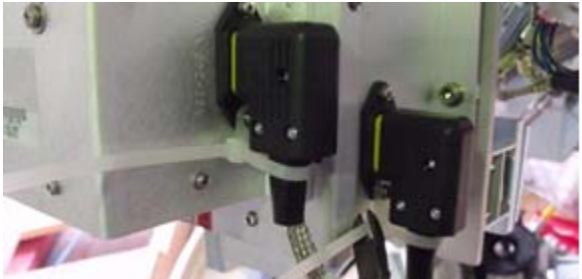
<p>16. Install the AC power connectors to both the PCU and BUC power supply and secure them in place with a cable tie through the P-clip installed on the mounting point. Snip the cable tie using a pair of cutters.</p>

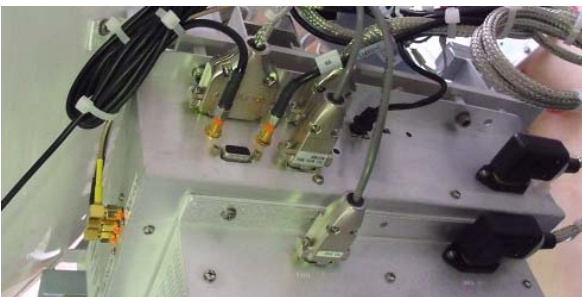
<p>17. Verify all connections are installed correctly and secure.</p> <p>18. Now energize the pedestal and configure the replacement PCU's No parameter as per the following procedure.</p>
