## Field Service Spares Replacement Procedure – Azimuth Motor Kit, 3011

# ***Field Service Procedure – Replacement Azimuth Motor Kit, 3011***

Troubleshooting document for diagnosing a fault with and replacing the azimuth motor on the 3011 antenna.

Procedure for replacing the azimuth motor, Sea Tel kit part number: 136814 (azimuth motor part number: 128209-2).

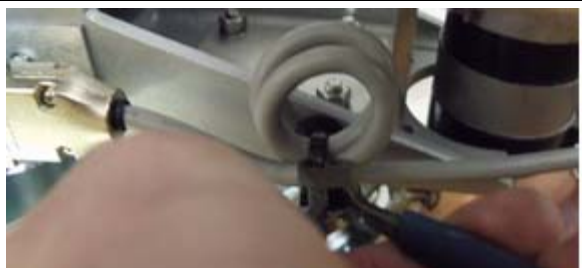
<p><b>*Caution:</b> Power down the pedestal before following this procedure.</p> <p>1. Snip the cable tie securing the motor harness to the azimuth post.</p>

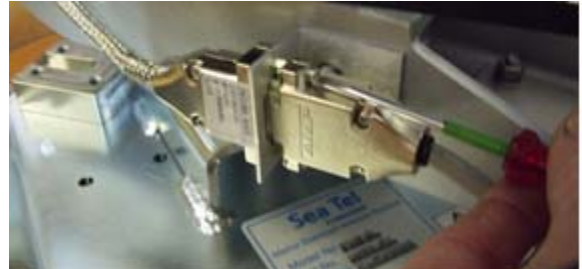
<p>2. Disconnect the azimuth motor D-sub connector from the bracket using a 2mm flat blade screwdriver.</p>

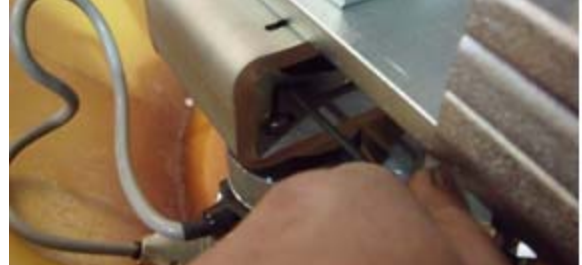
<p>3. Remove the 4 Allen head bolts securing the azimuth motor bracket using a 3/32" Allen wrench. Save the hardware for future use.</p>

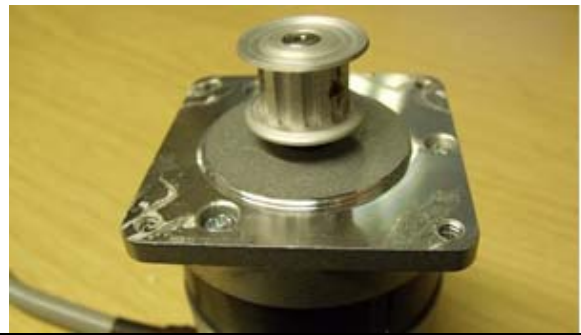
4. In the same orientation as on the defective motor install the new pulley to the replacement motor, applying Loctite 638 to the shaft. Apply Loctite 222 to the set screw and install it into the pulley, making sure it's aligned with the flat edge of the motor shaft. Tighten the set screw with a 1/16" Allen wrench.

**\*Note:** For further information refer to the Loctite Procedure 121730 provided with this kit.

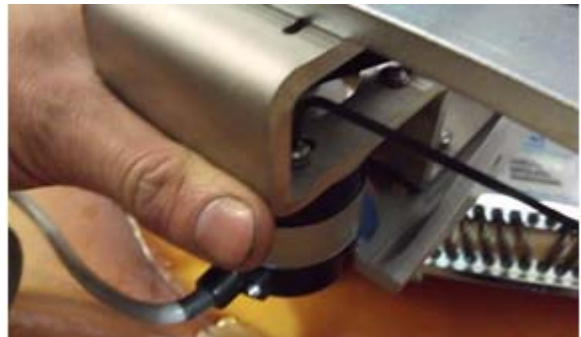
5. Locate the motor pulley into the azimuth belt and secure it to the bracket using the hardware removed in step 3, apply Loctite 242 to the threads. Pressure the motor away from the pedestal to tension the belt and tighten two of the screws.

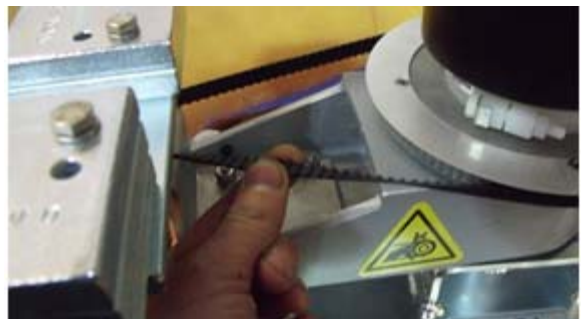
6. At the central position of the belt between the motor pulley and main drive sprocket the belt should easily rotate 90 degrees then become stiff. If the belt can be rotated past 90 degrees it's too loose, if it's difficult to rotate it to 90 degrees it's too tight.

7. If the belt is too tight/loose repeat steps 5-6 until the belt tension is correct and tighten all four of the screws.

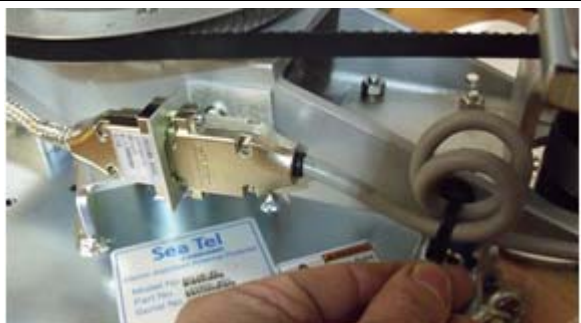
8. Connect the motor's D-sub connector to the bracket using a 2mm flat blade Allen wrench.

9. Secure the excess motor harness to the azimuth post using a cable tie.
