## **Field Service Spares Replacement Procedure – Media Xchange Port (MXP) PCB Kit**

# Field Service Spares Procedure – Replacement Media Xchange Port PCB Kit

Troubleshooting document for diagnosing a fault with and replacing the media exchange port (MXP) PCB.

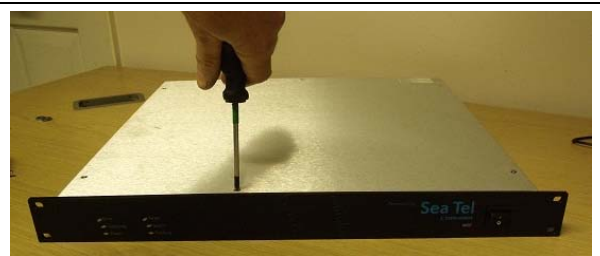
1. Using a #1 Phillips screwdriver remove the 6 screws securing the lid of the MXP. Save the hardware for future use.

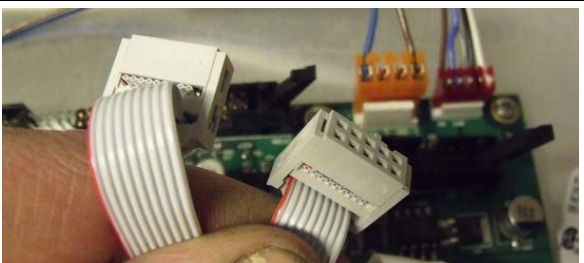
<p>2. Disconnect the two ribbon cables from the MXP PCB, noting their orientation.</p>

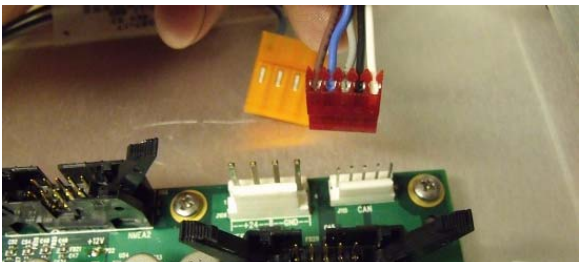
<p>3. Disconnect the IDC connectors from the MXP PCB.</p>

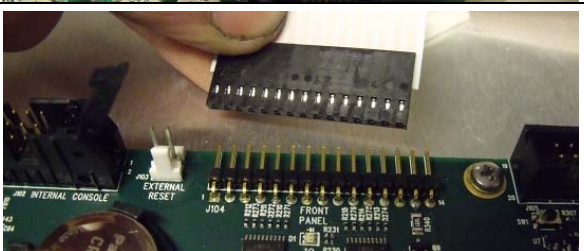
<p>4. Disconnect the front panel connector from the MXP PCB by hand.</p>

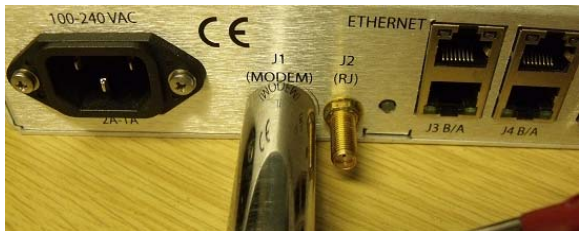
<p>5. Using a 1/2" drive socket/wrench remove the nut and star washer securing the J1 modem connection to the rear of the MXP. Save the hardware for future use.</p>

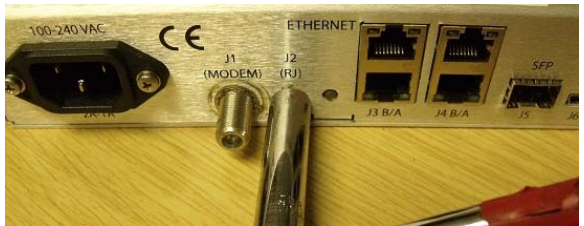
<p>6. Using a 5/16" socket/wrench remove the nut and star washer securing the J2 rotary joint connection from the rear of the MXP. Save the hardware for future use.</p>

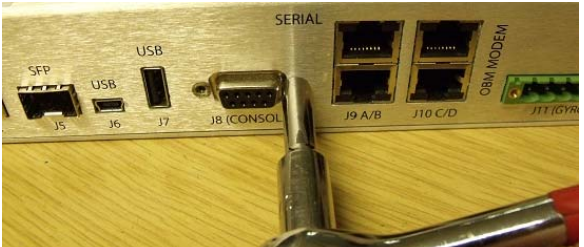
<p>7. Now using a 3/16" socket/wrench remove the two standoffs securing the J8 console port D-sub connector to the rear of the MXP. Save the hardware for future use.</p>

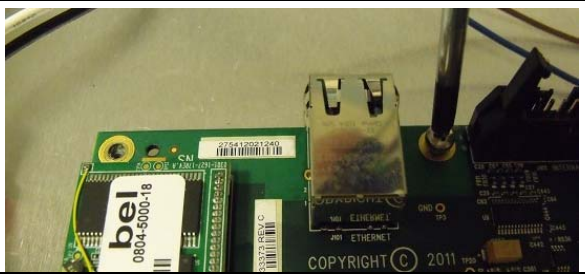
<p>8. Using a #1 Phillips screwdriver remove the 12 screws securing the MXP PCB.</p>

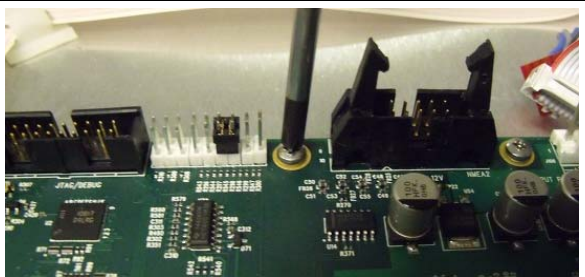
<p>9. Install the replacement MXP PCB using the 12 new screws provided in the kit. Apply Loctite 242/248 to the threads.</p>

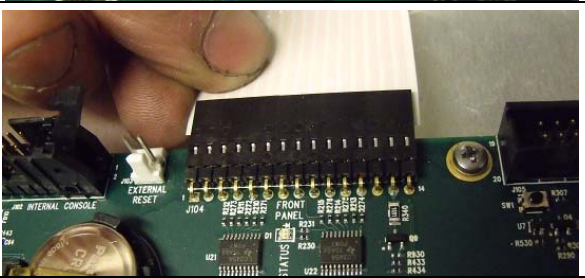
<p>10. Connect the display panel connector to the replacement MXP PCB.</p>

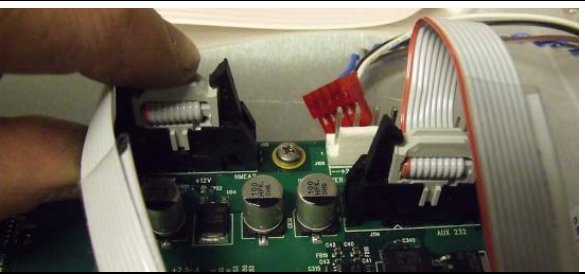
<p>11. Connect the ribbon cables to the replacement MXP PCB.</p>

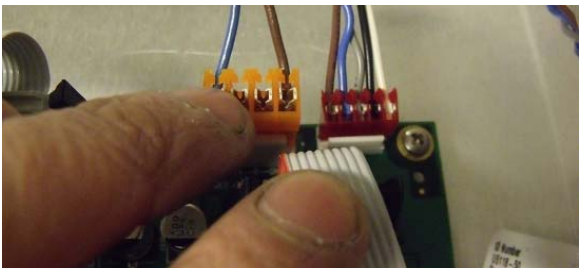
<p>12. Connect the IDC connectors to the replacement MXP PCB.</p>

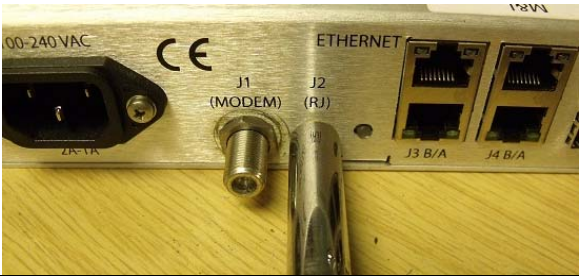
<p>13. Using a 1/2" socket/wrench install the nut and star washer to the J1 modem connector on the rear of the MXP.</p> <p>14. Using a 5/16" socket/wrench install the nut and star washer to the J2 rotary joint connector on the rear of the MXP.</p>

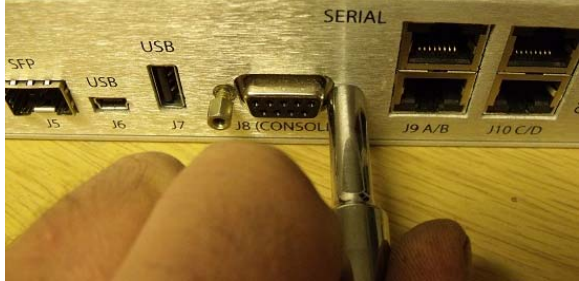
<p>15. Using a 3/16" socket install the standoffs to secure the J8 console port of the rear of the MXP.</p> <p><b>*Note:</b> It's advisable to tighten the socket by hand to avoid damaging the threads of the standoffs.</p>
