Field Service Replacement Procedure – ICU Assembly Kit, 4012

Field Service Spares Procedure – Replacement ICU Kit, 4012

Troubleshooting document for diagnosing a fault with and replacing the ICU assembly on the 4012 antenna.

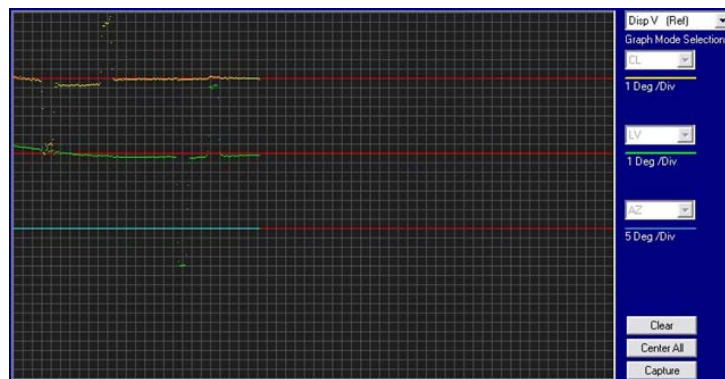
4. In the trace should look similar to the below image. Note how after each movement the system returns to its level position efficiently without taking time to settle. Should the system take time to settle, or not stabilize to the original position (not necessarily on the red line) then this is an indication that the antenna isn't maintaining its horizon reference correctly and further troubleshooting will need to be undertaken.

3. Verify Level (Elevation) response:
Push the reflector up in elevation and hold it in position. Verify that the LV trace moves down an equal amount to the movement exerted on the axis. Release the axis and verify the trace and system axis both return back to their original positions instantly, without deviating or taking time to settle. Push the reflector down in elevation and hold it in position. Verify that the LV trace moves up an equal amount to the movement exerted on the axis. Release the axis and verify the trace and system axis both return back to their original positions instantly, without deviating or taking time to settle.

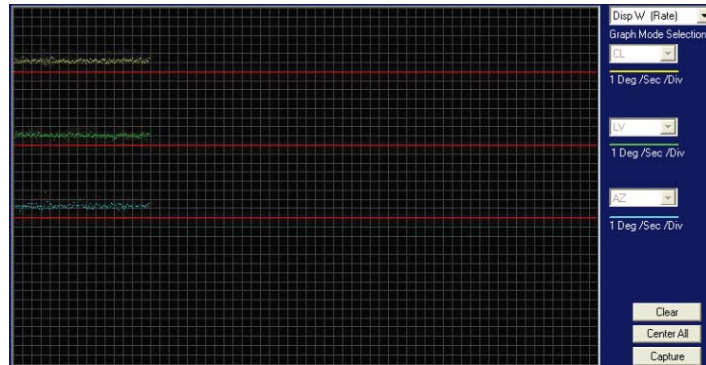
9. Rate Sensor Monitoring:

Rate sensor outputs can also be monitored using the DISP_W screen of DacRemP or from the graphs screen of the 4012 GUI to verify any deviations under static conditions. The traces should remain consistent; any drifting or spikes are an indication the sensors voltage output is changing and the sensor is defective (provided no forces are being exerted on the system).

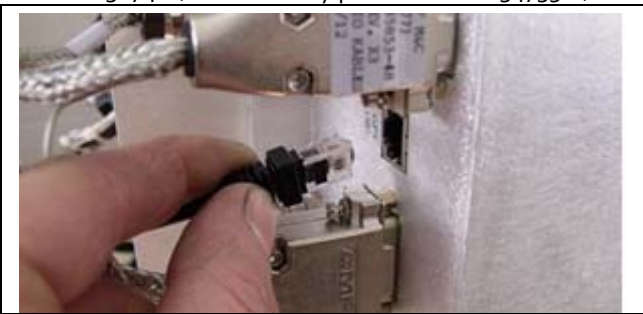
<p>*Caution: Power down the pedestal before following this procedure.</p> <p>1. Disconnect the GPS antennas RJ-45 connector from the ICU.</p>

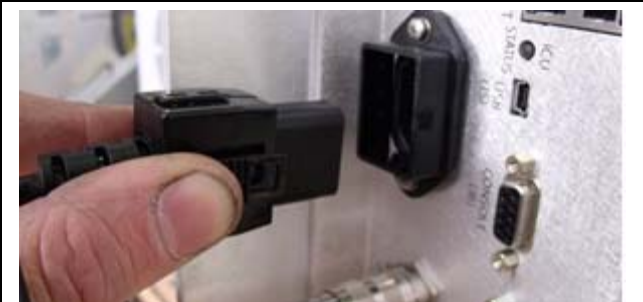
<p>2. Disconnect the AC power input socket from the ICU.</p>

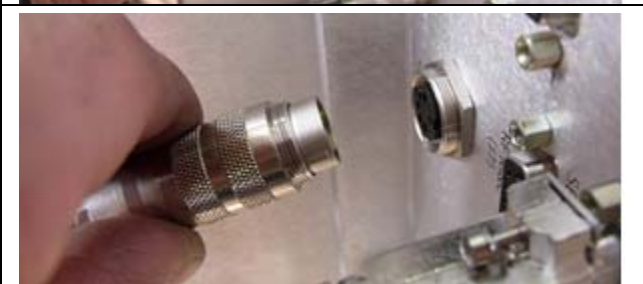
<p>3. Disconnect the RF power connection from the ICU.</p>

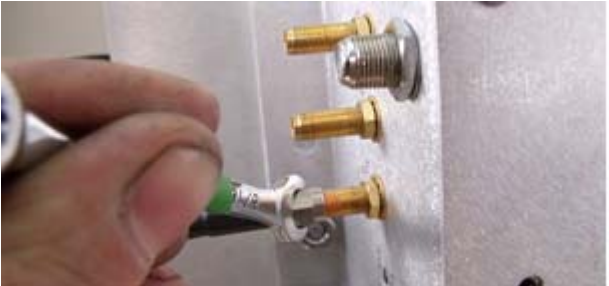
<p>4. Disconnect the 3 SMA cables from the ICU using a 5/16" wrench.</p>

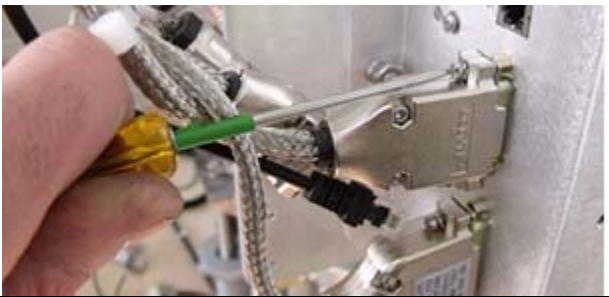
<p>5. Using a 2mm flat blade screw driver disconnect the D-sub connectors from the ICU.</p>

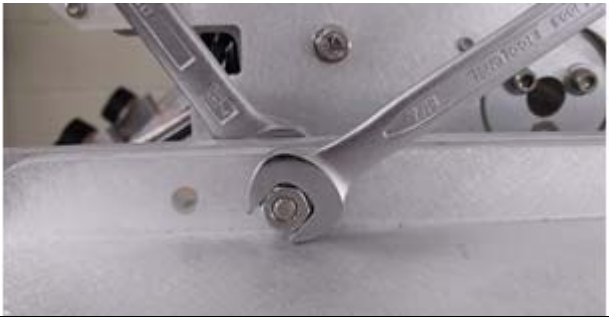
<p>6. Using a pair of 7/16" wrenches (or a wrench and socket) undo the 4 sets of hardware securing the ICU to the elevation pan and remove the defective ICU.</p> <p>*Note: Due to weight of the ICU removing it will affect the balance of the pedestal. Support the system in cross level as the ICU is removed.</p>

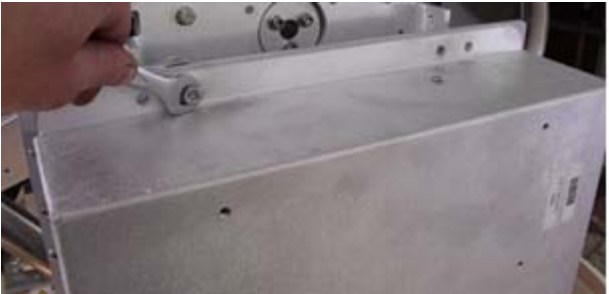
<p>7. Install the replacement ICU assembly using the new hardware provided in the kit, apply Loctite 242 to the threads and secure using a pair of 7/16" wrenches or a wrench and socket.</p>

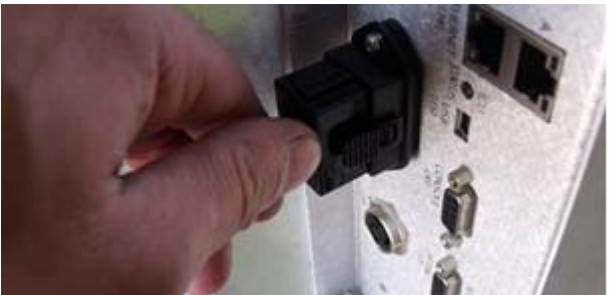
<p>8. Connect the AC power connector to the ICU.</p>

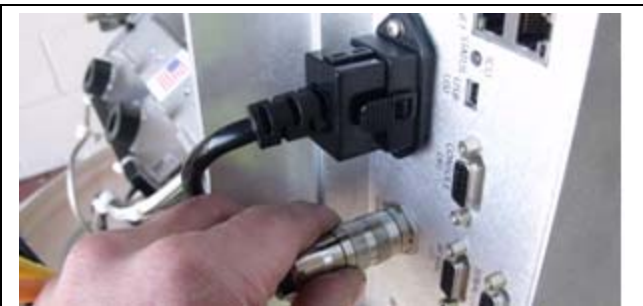
<p>9. Connect the RF power connector to the ICU.</p>

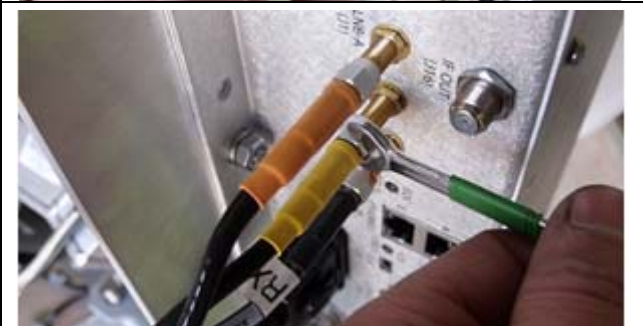
<p>10. Connect the SMA cables to the ICU with the orange X-pol IF cable into the "LNB A" port, the yellow Co-Pol IF cable into the "LNB B" port and the Black RX IF cable into the "RJ" port. As shown in the image on the right.</p>
