**Field Service Spares Replacement Procedure – PCU Assembly Kit,
ST88, ST94 & ST144**

Field Service Procedure – Replacement PCU Kit, ST88, ST94 & ST144

Troubleshooting document for diagnosing a fault with and replacing the PCU assembly on the ST88, ST94 and ST144 antennas.

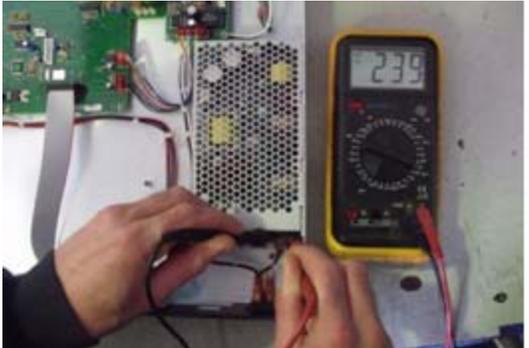
<p>*Caution: Electrical Hazard - Dangerous AC voltages exist on the power supply. Observe proper safety precautions when working on the power supply.</p> <ol style="list-style-type: none">1. Remove the cover from the PCU to allow access to the power supply for testing.2. Measure the input voltage into the power supply on the 2 pins to the right of the connection block, 110 - 240 volts AC should be present. If no AC voltage is present verify the unit is switched on. If there is still no voltage present troubleshoot the source.

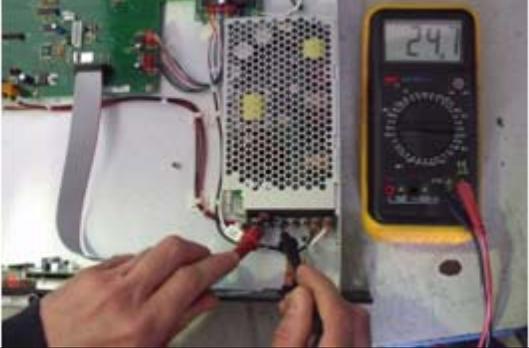
<ol style="list-style-type: none">3. Now measure the output voltage from the power supply on the 2 pins to the left of the connection block, the output should be 24VDC. <p>*Note: This procedure shows a DAC-2202 in the images; however the DAC and PCU power supply is the same component so the procedure is the same.</p>

If the units AC input has been verified and the 24VDC is not present, the power supply is defective. If the power supply is outputting the 24VDC consistently then the power supply is operational and the problem lies elsewhere (possible failure with the PCU, DAC motherboard or harness connection).

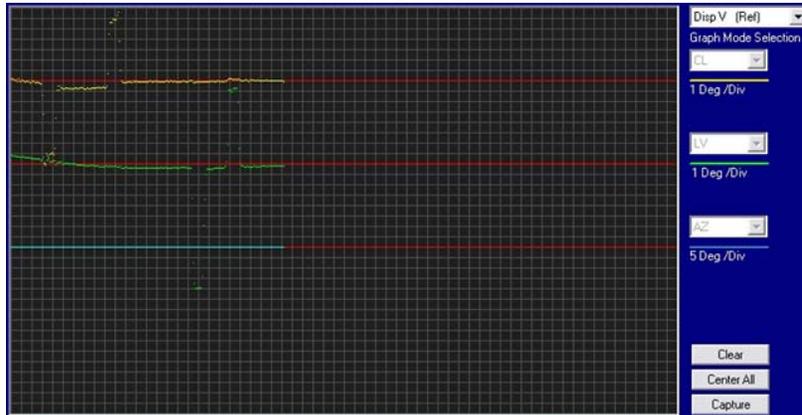
4. In DacRemP, the trace should look similar to the below image. Note how after each movement the system returns to its level position efficiently without taking time to settle.

3. Verify Level (Elevation) response:
Push the reflector up in elevation and hold it in position. Verify that the LV trace on DacRemP moves down an equal amount to the movement exerted on the axis. Release the axis and verify the DacRemP trace and system axis both return back to their original positions instantly, without deviating or taking time to settle. Push the reflector down in elevation and hold it in position. Verify that the LV trace on DacRemP moves up an equal amount to the movement exerted on the axis. Release the axis and verify the DacRemP trace and system axis both return back to their original positions instantly, without deviating or taking time to settle.

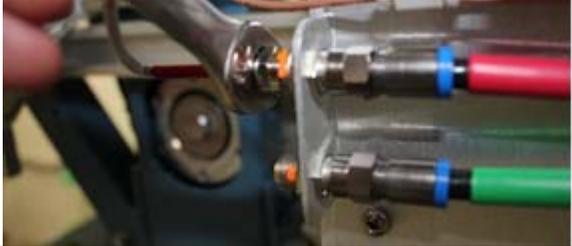
<p>3. Using a 7/16" wrench remove the two RG-179 coax cables from the lower mounting bracket installed on top of the PCU, noting their orientation.</p>

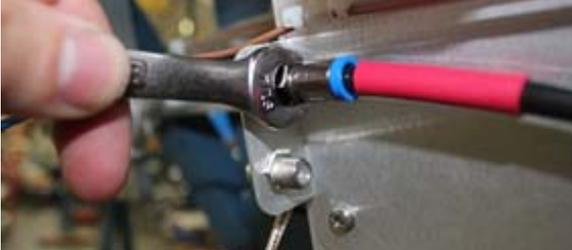
<p>4. Now disconnect the two RG-60 coax cables from the other side of the mounting bracket using a 7/16" wrench.</p>

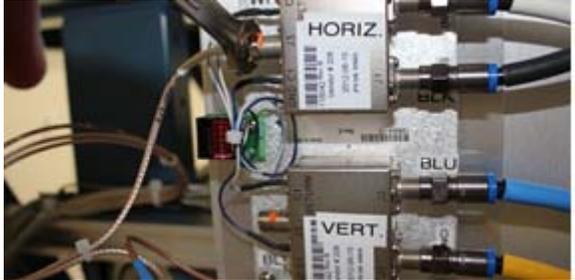
<p>5. Now disconnect the two RG-179 coax cables from the in output side of the coax switches using a 7/16" wrench.</p>

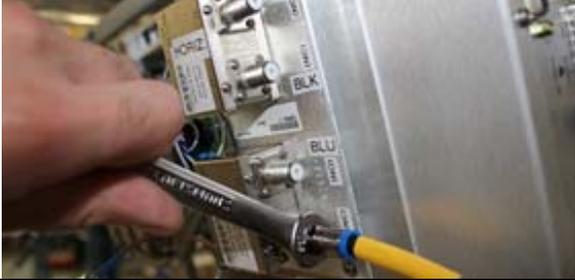
<p>6. Now disconnect the four RG-60 coax cables from the input side of the coax switches using a 7/16" wrench, noting their orientation.</p>

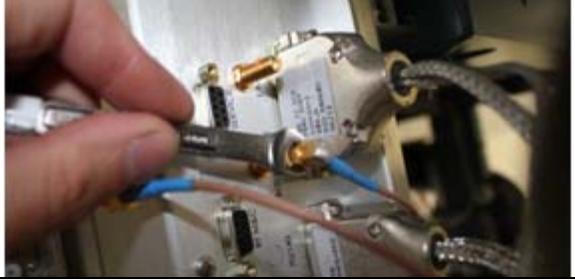
<p>7. Using a 5/16" wrench disconnect the two SMA cables from the 400MHz modem PCB.</p>

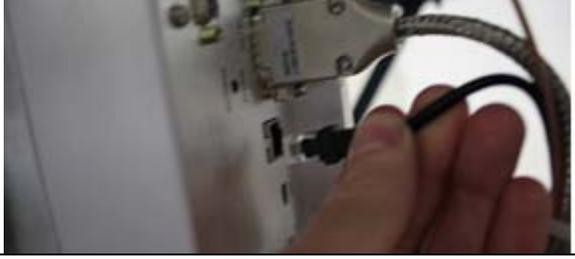
<p>8. Disconnect the GPS antennas RJ-45 connector from the PCU.</p>

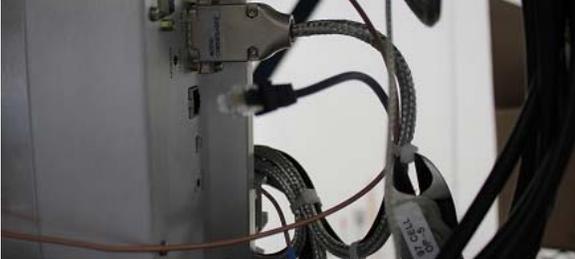
<p>9. Using a pair of snips cut the cable tie securing the RG-179 coax from the coax switch to the 400MHz modem (inside the PCU).</p>

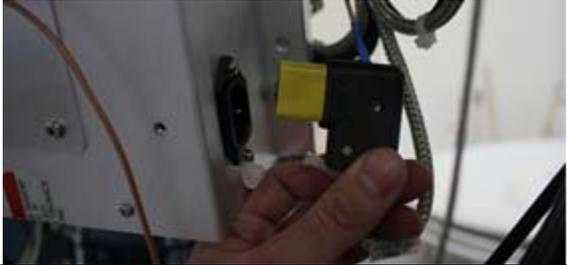
<p>10. Using a pair of cutters snip the cable securing the AC power connector to the PCU and disconnect the connector.</p>

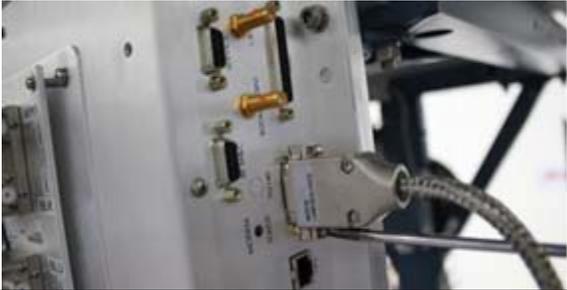
<p>11. Using a 2mm flat blade screwdriver undo the screws securing the reflector and motor driver D-sub connectors to the PCU and disconnect them.</p>

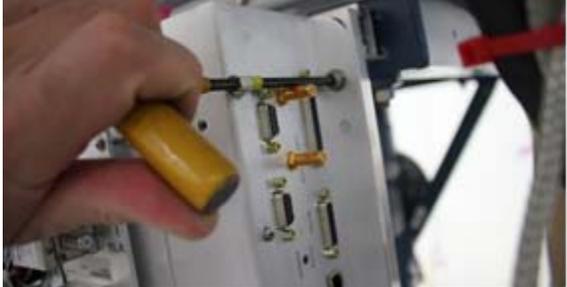
<p>12. Check all cabling from the PCU assembly and coax switch has been disconnected from the pedestal and remove the PCU and coax switch assembly using a 3/16" Allen wrench. Save the hardware for future use.</p> <p>*Note: Secure the weight of the assembly while removing the mounting hardware.</p>

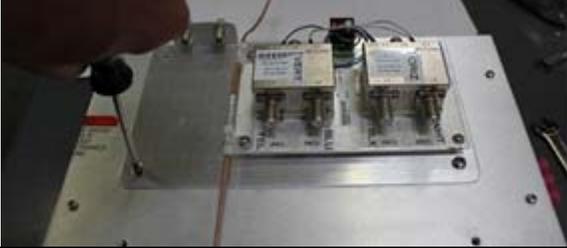
<p>13. With the defective PCU removed from the pedestal use a #1 Phillips screwdriver to remove the coax switch mounting plate from it. Save the hardware for future use.</p>

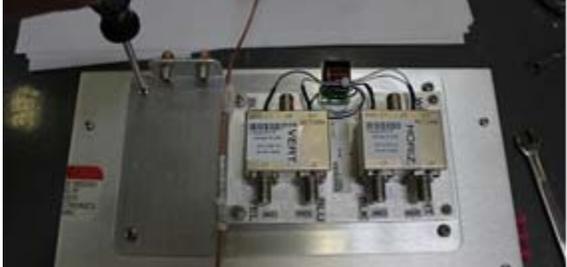
<p>14. Using the hardware removed in step 13 install the coax switch on the replacement PCU assembly, noting its orientation. Apply Loctite 242 to the threads.</p>

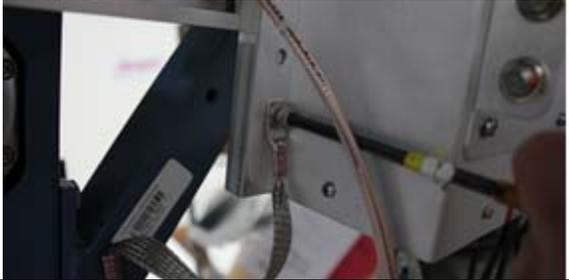
<p>15. With the coax switch installed install the replacement PCU to the equipment frame using the hardware removed in step 12. Ensure the screws are installed with both the washer and split washer and that Loctite 242 is applied to the threads. Ensure the ground point is connected to the lower left hand mounting point.</p>

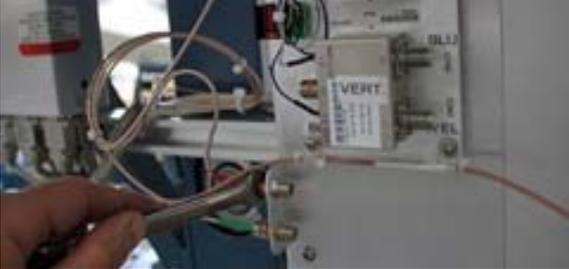
<p>16. Reconnect the red and green RG-179 coax cables to the lower mounting bracket</p>

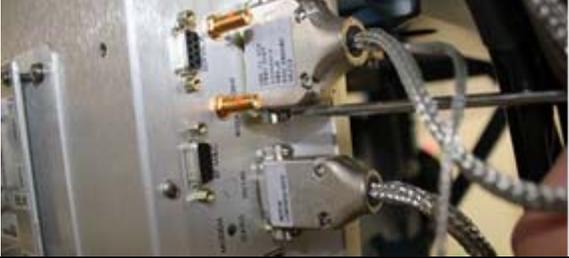
<p>18. Reconnect the D-sub connectors using a 2mm flat blade screwdriver.</p> <p>19. Connect the GPS antennas RJ-45 connector to the replacement PCU.</p>

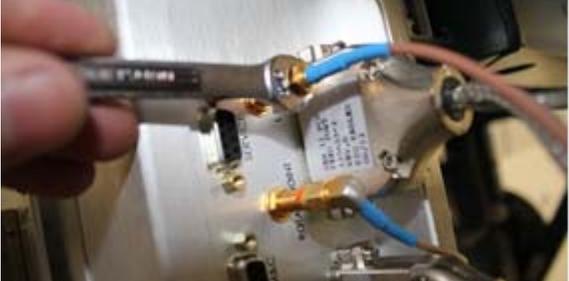
<p>20. Connect the blue RG-179 coax cable from the coax switch to the "L-band" port on the 400MHz modem connection.</p> <p>21. Connect the blue RG-179 coax cable from the rotary joint to the "rotary joint" port on the 400MHz modem connection.</p>

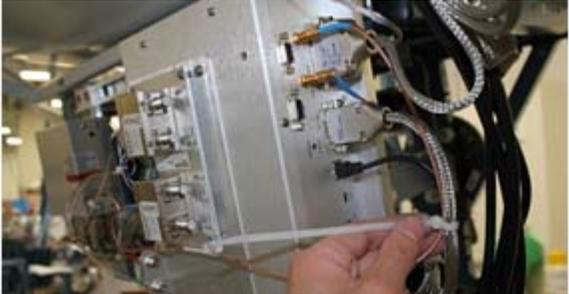
<p>22. Secure the RG-179 coax cable from the coax switch to the modem using a cable tie.</p>

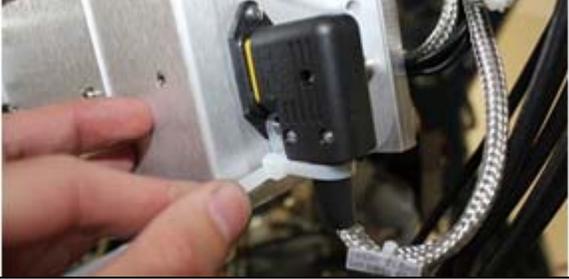
<p>23. Connect the AC input connection and secure the connection to the assembly using a cable tie.</p>

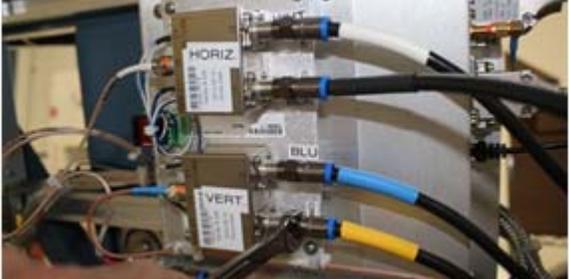
<p>25. Reconnect the four RG-60 coax cables to the coax switches matching the colors to the labels on the mounting plate.</p>

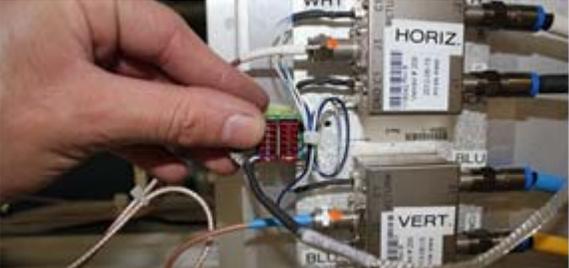
<p>26. Reconnect the IDC connector to the termination block on the PCB.</p> <p>27. Secure the grounding point to the screw securing the termination PCB using a #1 Phillips screwdriver. Apply Loctite 242 to the thread.</p>
